Rapid Coastal Zone Assessment Survey

Yorkshire and Lincolnshire: Phase 3

Historical Audit

Scarborough Harbour

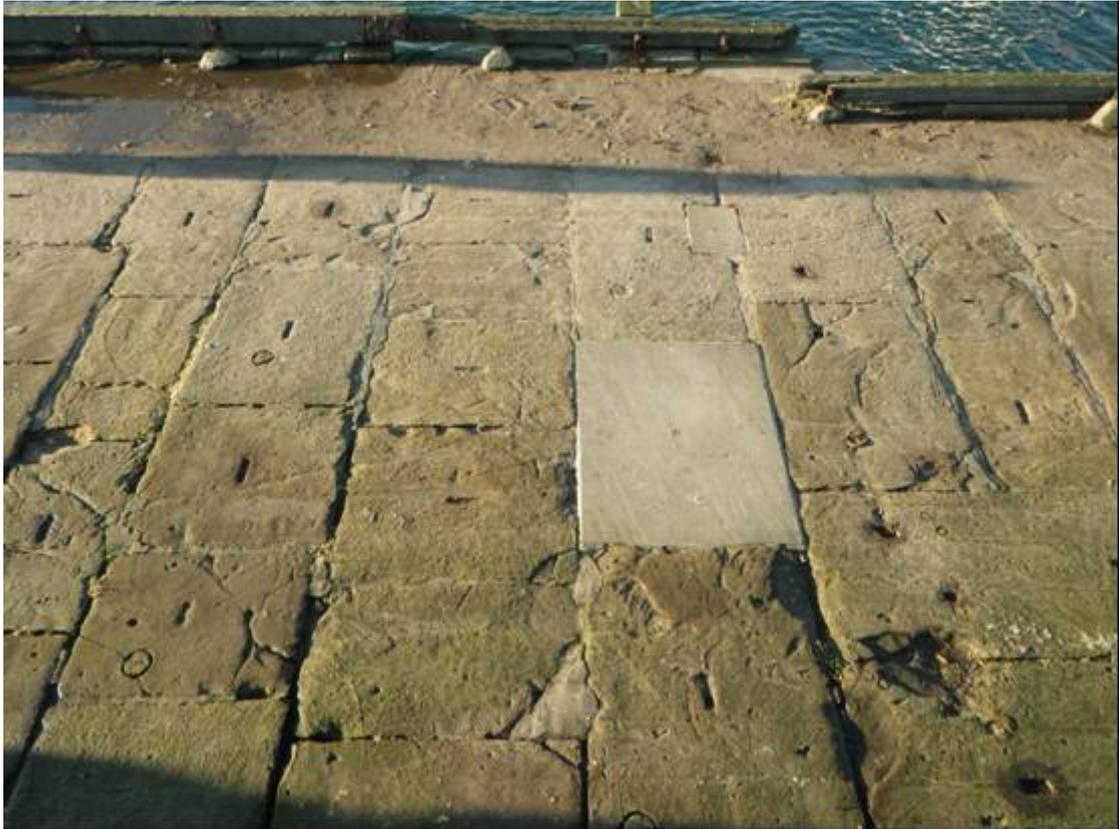
Plate 19 East Pier, stone blocks forming surface of southern section, showing lewis holes, with modern replacement

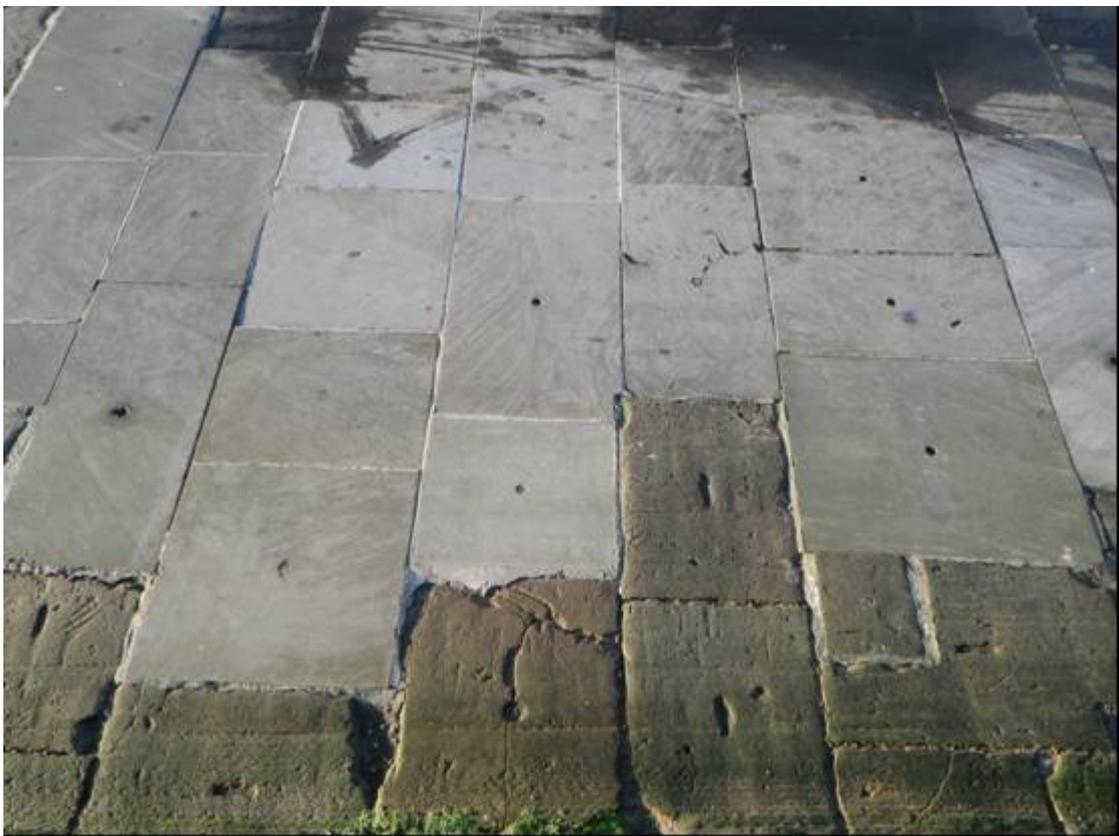
Plate 20 East Pier, repairs to stone surface, showing use of three-legged (rectangular) and split-pin (circular) forms of lewis on old and new sections

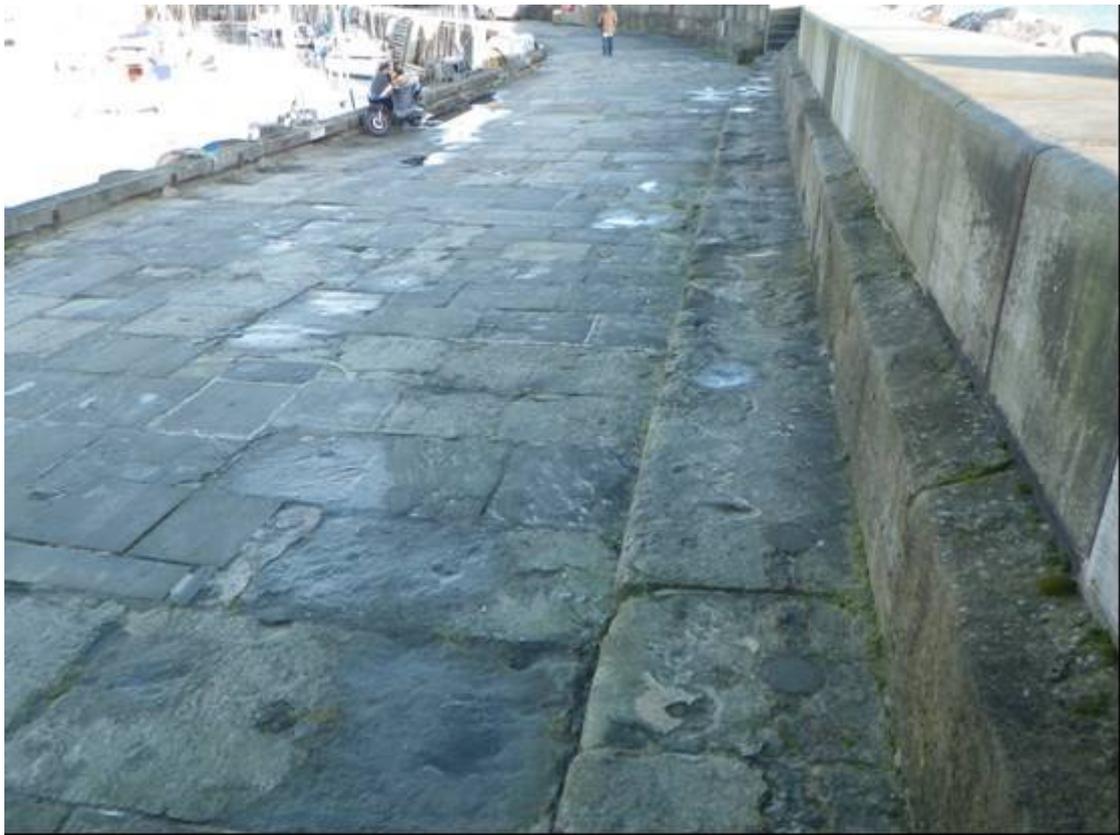
Plate 21 East Pier, showing stone block surface and new section of parapet at south end raised to accommodate rock armour

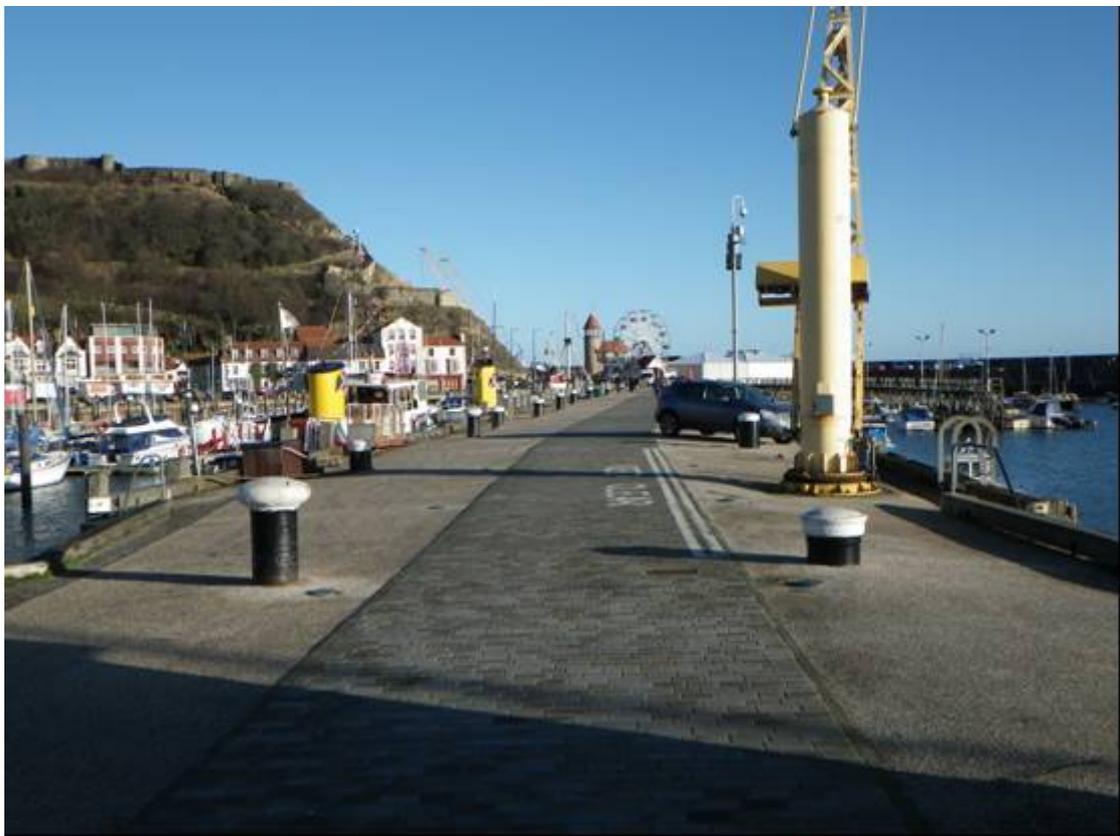
The Old Pier has largely been resurfaced with a strip of stone setts along the centre flanked either side by tarmac and wooden rails (Plate 42). An area of original or replaced stone flags or slabs still exists at the south end, however (Plate 37), where there is a small mid 19th-century Water House, of some historic interest (Plate 40); these slabs also entirely cover the surface of the Lighthouse Pier (Plates 56, 58).

Plate 42 Vincent's Pier, general view along 'Old Pier', with Type B bollard (left) and Type C (right) in front of modern crane, looking north-east

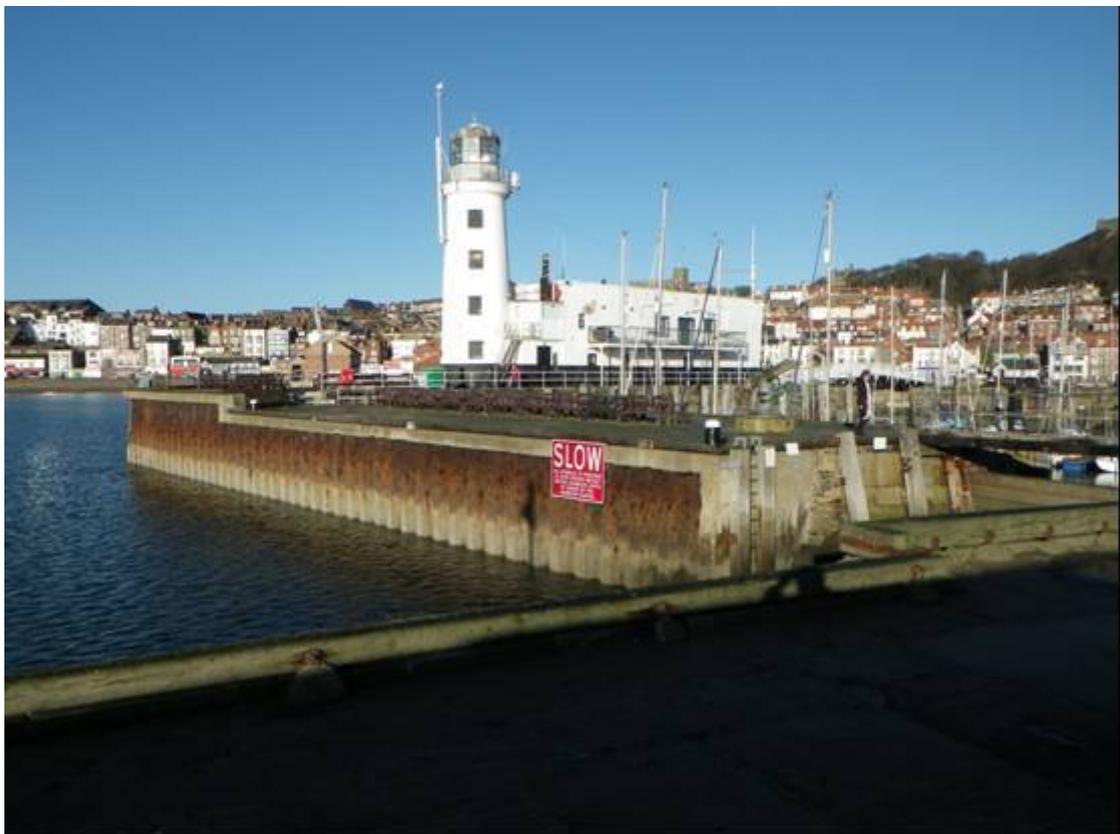
Plate 50 Vincent's Pier, south face of Lighthouse Pier, showing modern steel sheet and concrete refacing, looking north-west

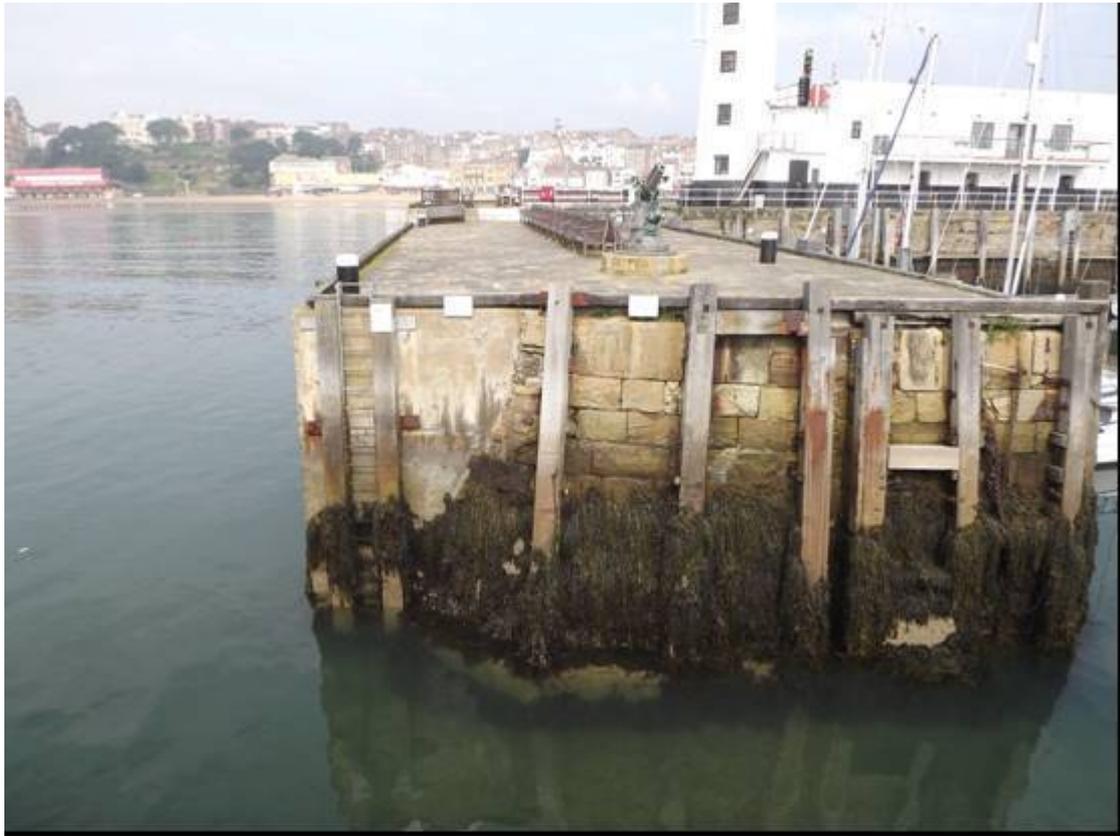
Plate 51 Vincent's Pier, end of Lighthouse Pier prior to construction of footbridge, showing batter of original masonry and vertical modern refacing (left)

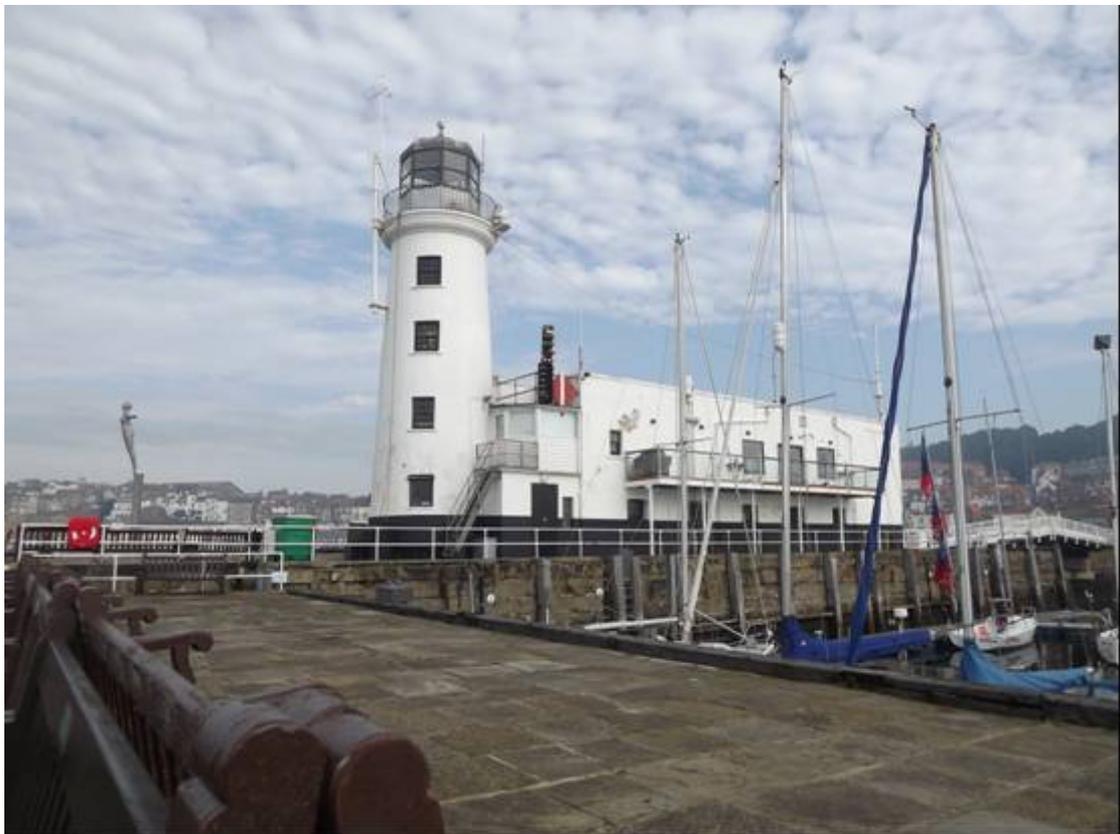
An important building specifically related to the development of the harbour is the Grade 2 listed lighthouse itself (LBS 443958: Plates 58–60). The present tower replaced the original 1801–06 version destroyed in 1914 by German shelling, and was completed in 1931, with a more recent lantern the light is now fully automated. The harbourmaster's house is the original mid 19th-century structure, with some rebuilding. The structure is in apparent good condition.

Plate 58 Vincent's Pier, the Grade II lighthouse, looking north

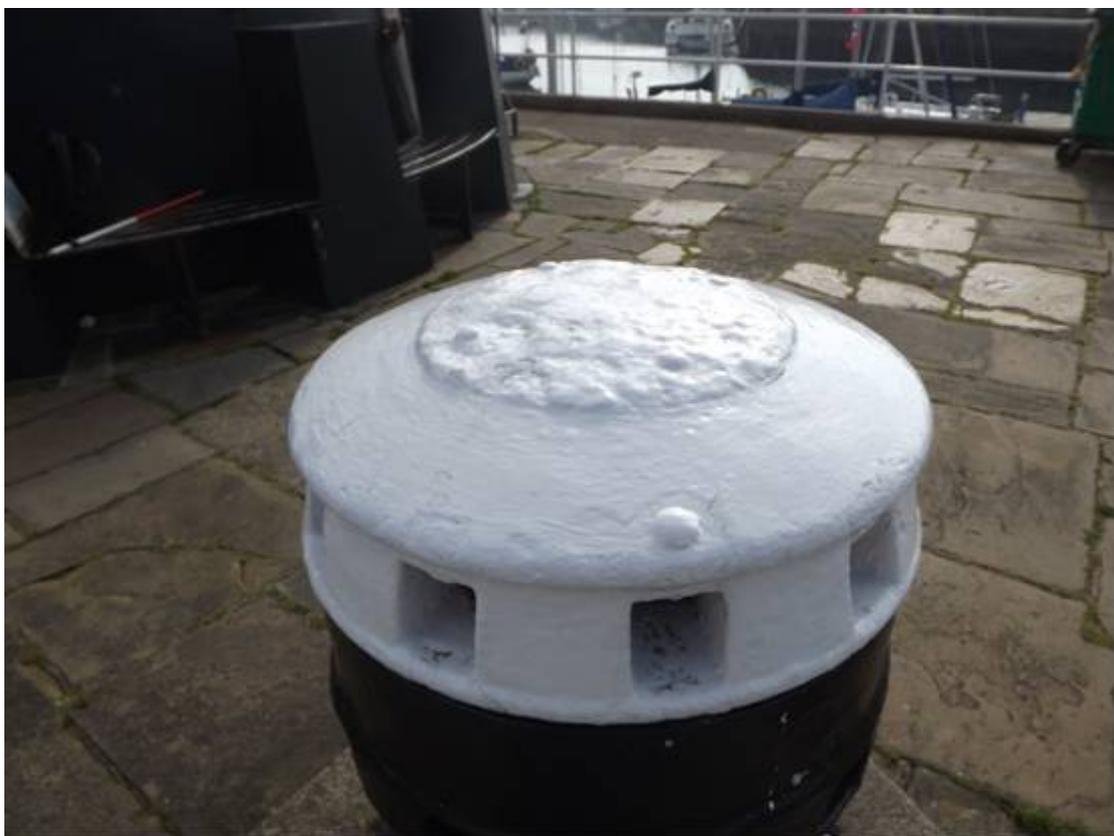
Plate 72 Vincent's Pier, Lighthouse Pier, detail of large capstan head, showing upper row of sockets for capstan bars and corrosion on cap
