Rapid Coastal Zone Assessment Survey

Yorkshire and Lincolnshire: Phase 3

Historical Audit

Scarborough Harbour

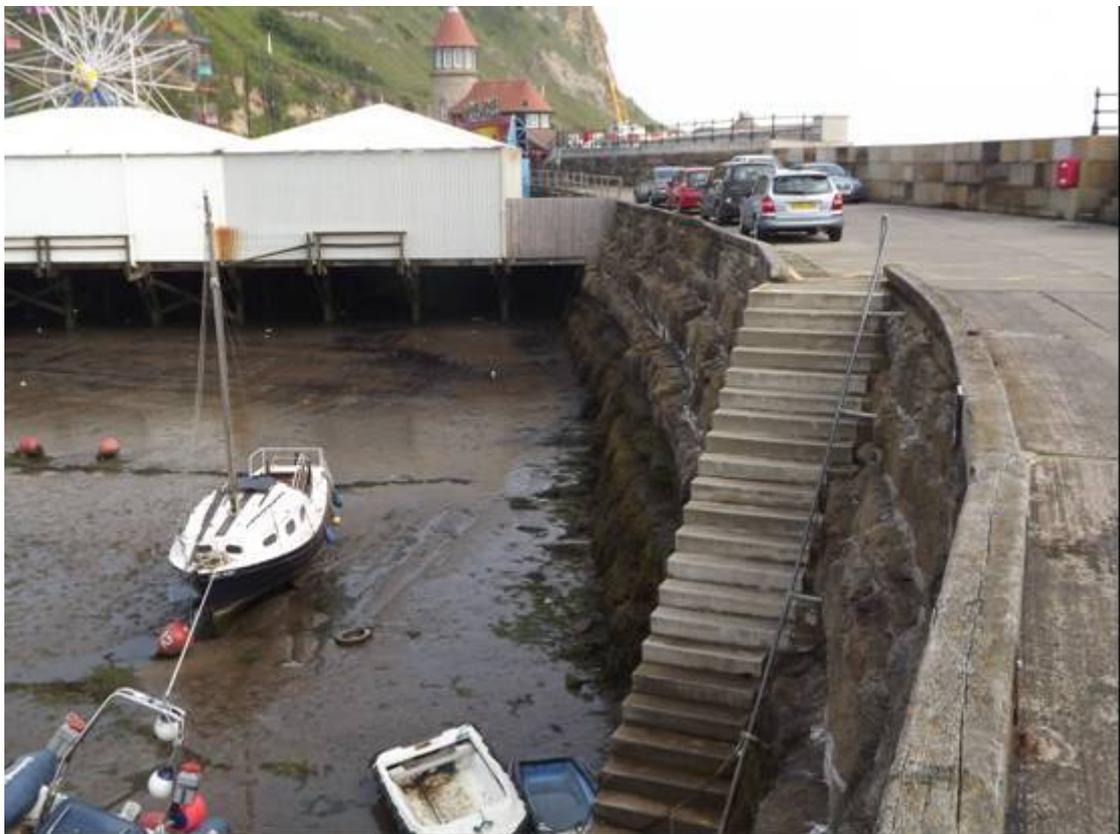
The pier was built using extremely large blocks of stone quarried from nearby White Nab and transported across the bay on floats; progressively larger blocks were used towards the base; this was a deliberate attempt to try and counter the exceptional force of the waves against this very exposed pier (Plates 3–8). The surface of the pier was originally also of stone, which still survives at the south end with more recent repairs (Plates 18–25). The original surfacing blocks here still show narrow rectangular lifting holes characteristic of the use of three-legged lewis clamps (Plate 19): two triangular wedges were put in place at either end of the lifting hole with a rectangular wedge driven between to lock them in place. A few others contain small circular holes which are also present on a number of modern replacement blocks (Plate 20); these reflect the use of a split-pin lewis, consisting, as the name suggests, of a circular pin divided into two. The blocks have been replaced by concrete surfacing in the central and northern sections of the pier, possibly to prevent rain and seawater entering the pier structure (Plates 10–12). The facing of these sections of the pier is badly eroded, with many joints widened and plugged with brick, concrete and modern stone (Plates 5–7). As this face of the pier is protected from direct wave action, this is likely to have been caused by water penetration from the outer face and top of the pier, dissolving the mortar and causing the joints to spall. There are three original stone landing stairs, centrally and at the north and south ends (Plates 4, 5, 8, 9).

Plate 4 East Pier, overhead view of rebuilt northern landing stair, looking north-east

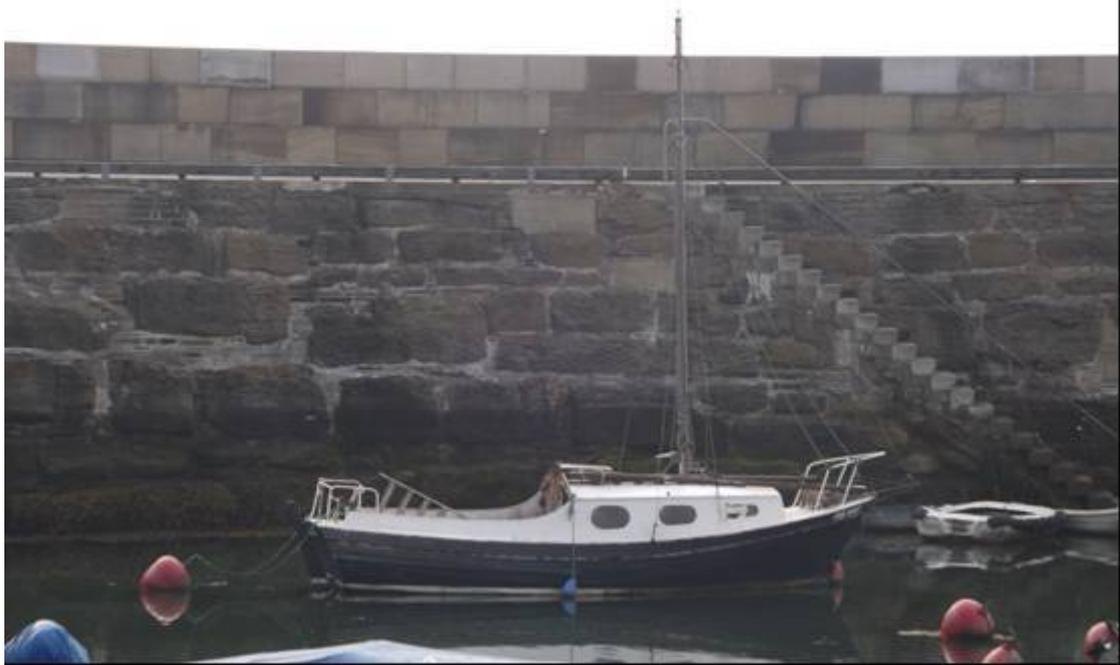
Plate 5 East Pier, detail of rebuilt northern landing stair on east side, with new parapet, looking east

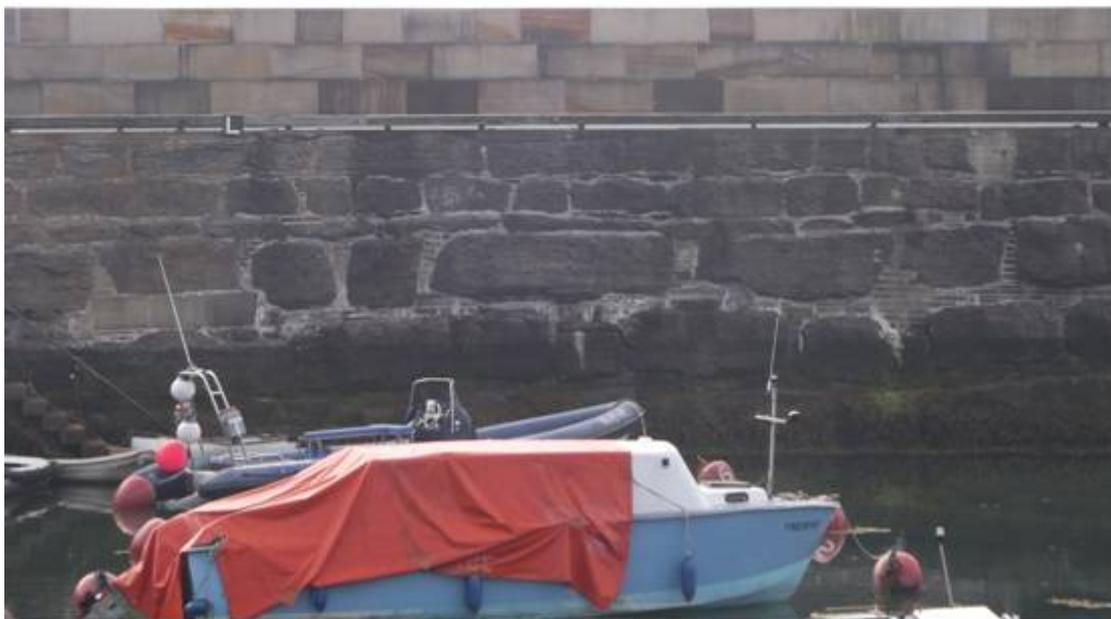
Plate 7 East Pier, detail of inner face, showing extensive patching between original blocks and new parapet, looking south-east

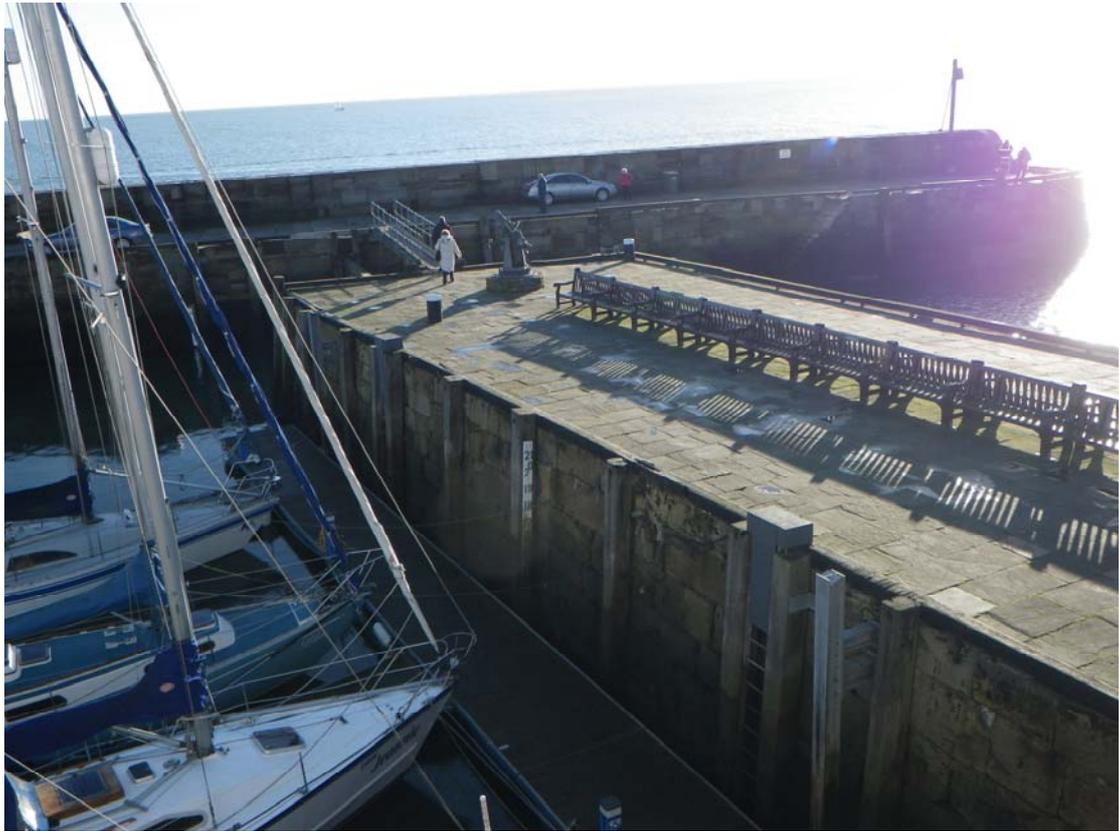
Plate 9 East Pier, south end, showing southern landing stair and temporary footbridge, looking south-east across end of Vincent's Pier

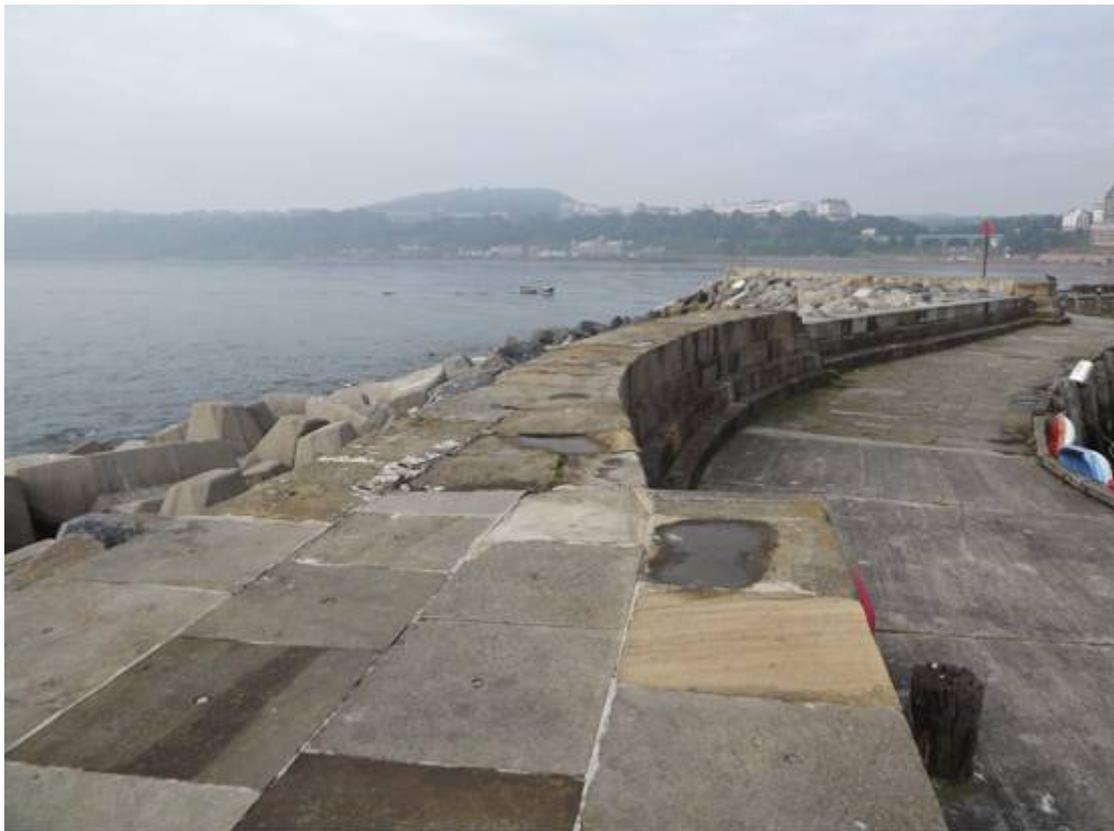
section (Plate 12) consists of three courses of large blocks with a vertical inner face; at the top is a concrete coping and surface supporting a decorative cast iron railing which originally continued along the Marine Drive before a modern parapet was added to improve wave protection. The two sections of original parapet towards the south end of the pier (Plates 14, 15, 23–6) consist of three to four stepped course ending in a shaped terminal (Plate 24). There are two sections of modern parapet consisting of new ashlar blocks which may eventually weather to match the old parapet. These were put in place when the rock armour was added to support the top of the armouring and create continuous wave protection for the outer harbour; the northernmost of these new sections is lengthy (Plates 3–5, 7, 8, 10) and is keyed in at both ends (Plates 13, 26), with steps and railings added at intervals (Plates 3, 8). The southern section is much shorter (Plate 16) and was put in place between existing parapets to support the top of the extensive rock armouring which runs the full length of the pier and Marine Drive (Plates 14, 15).

Plate 15 East Pier, southern section, junction of new and old parapets, with rock armour against east face

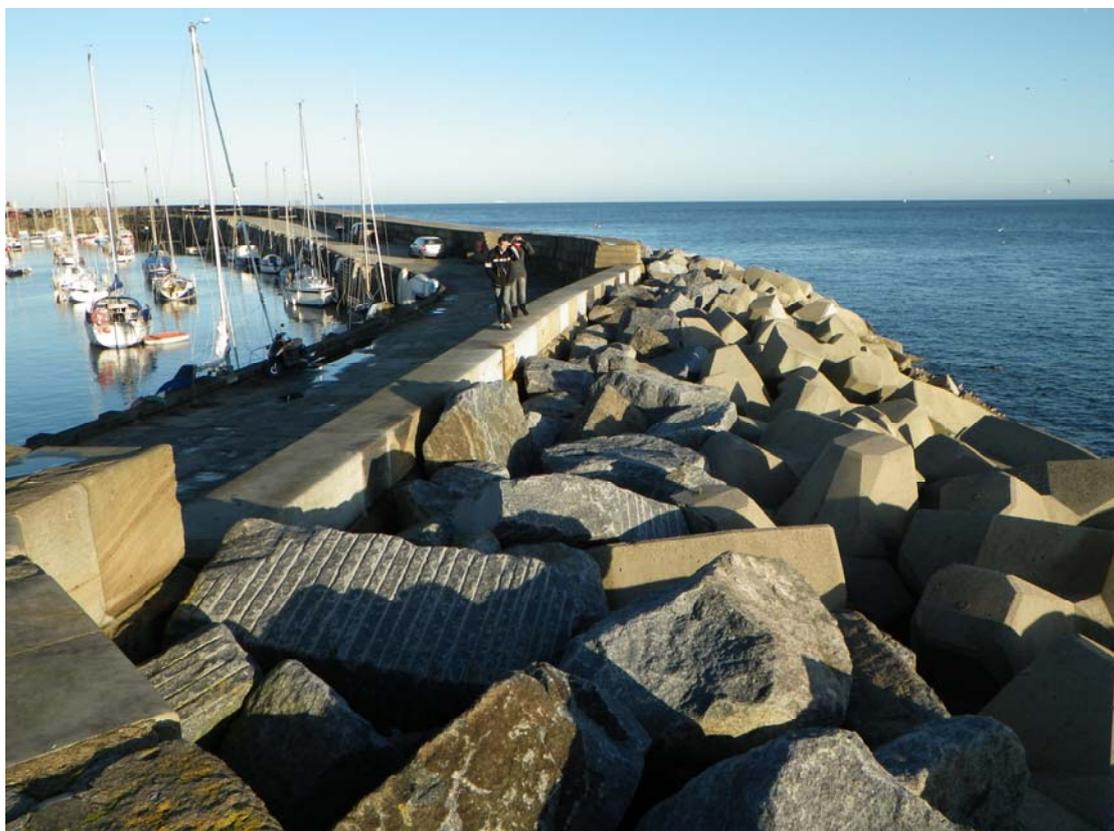
Plate 16 East Pier, southern section, modern rock armour laid against east face, showing short new section of parapet with older sections to north and south

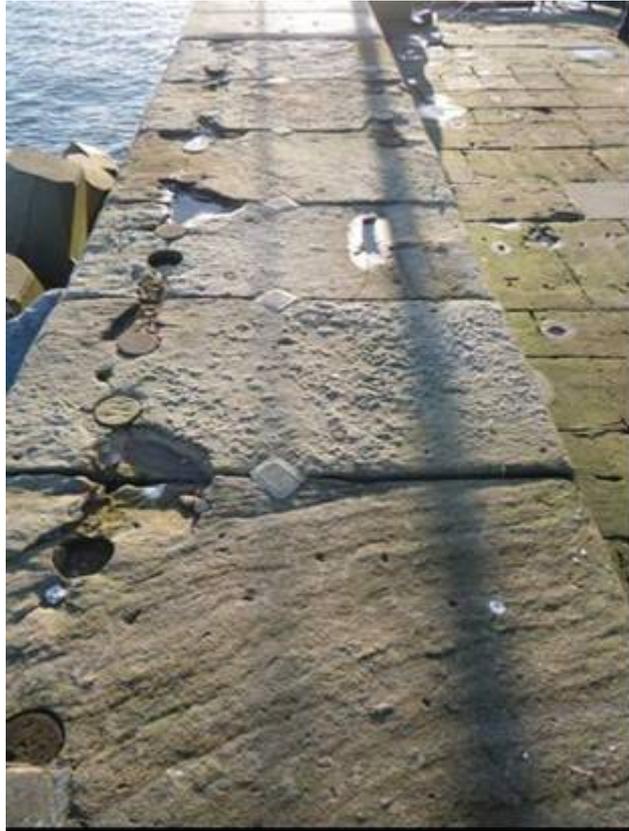
Plate 17 East Pier, southern section, detail of top of original parapet, showing blocked circular sockets for removed cast iron railings

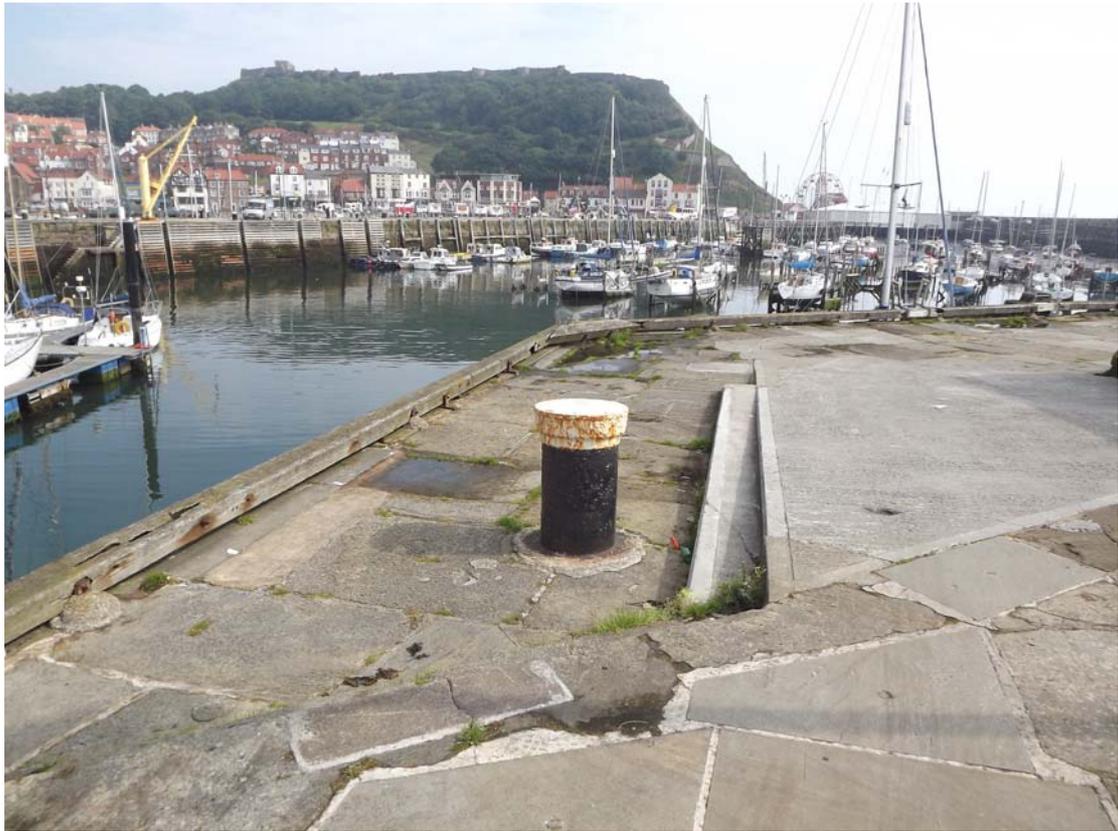
On the western side of the pier at the corner of a substantial bend in the pier near the south end is a Type C bollard with its distinctive flat-topped circular cap (Fig 6c: Plate 25).

Plate 25 East Pier, Type C bollard near south end, looking north-east

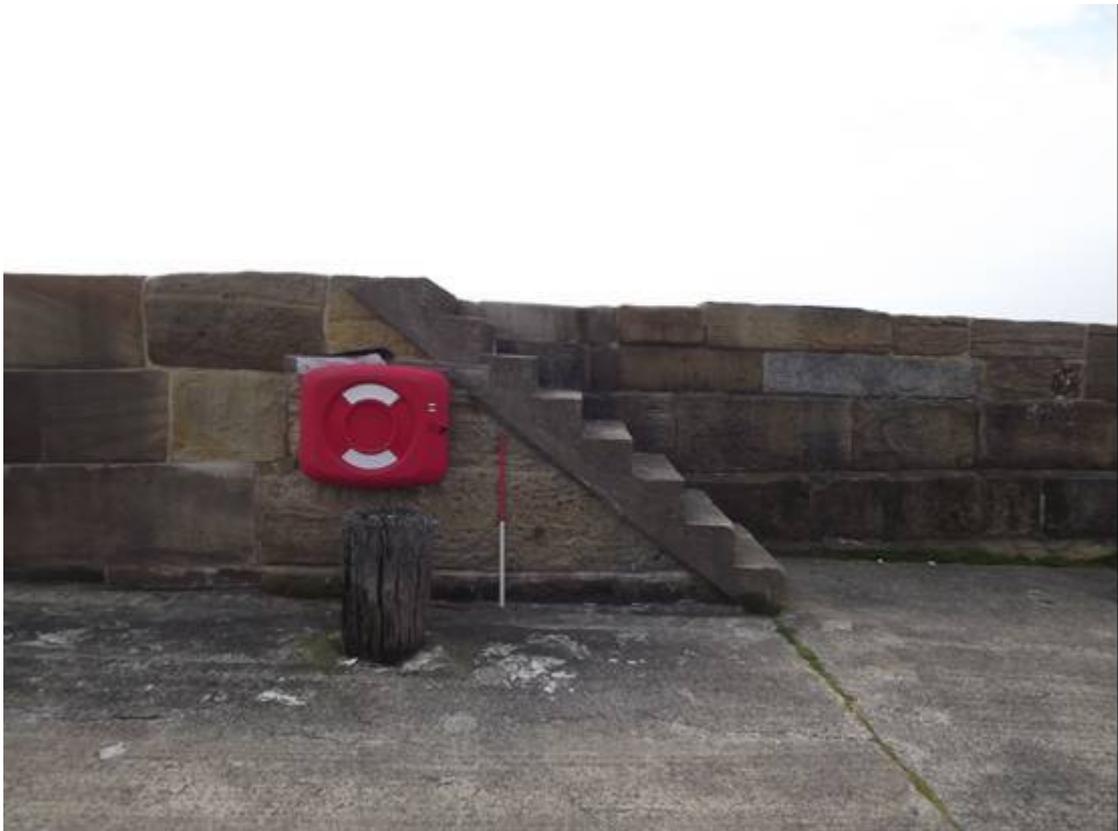
Two wooden bollards were recorded on the East Pier. The first of these (Type E) had iron strap supports (80 x 2340mm) but in this instance was square with a distinctive taper from 500mm to 420mm at the base and stood 700mm tall (Fig 6e: Plates 26, 27).

Plate 26 East Pier, Type E wooden bollard next to rebuilt steps to original parapet (1m scale)

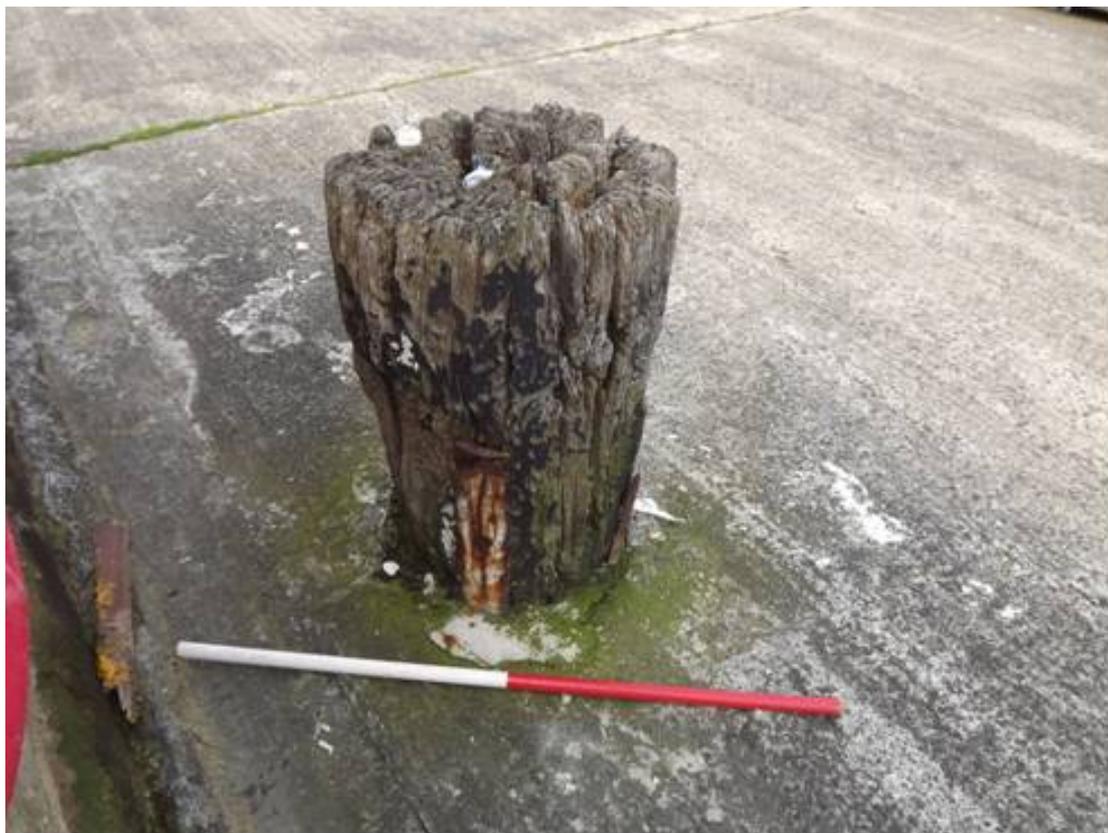
Plate 27 Scarborough Harbour 2012, Type E wooden bollard on East Pier (1m scale)

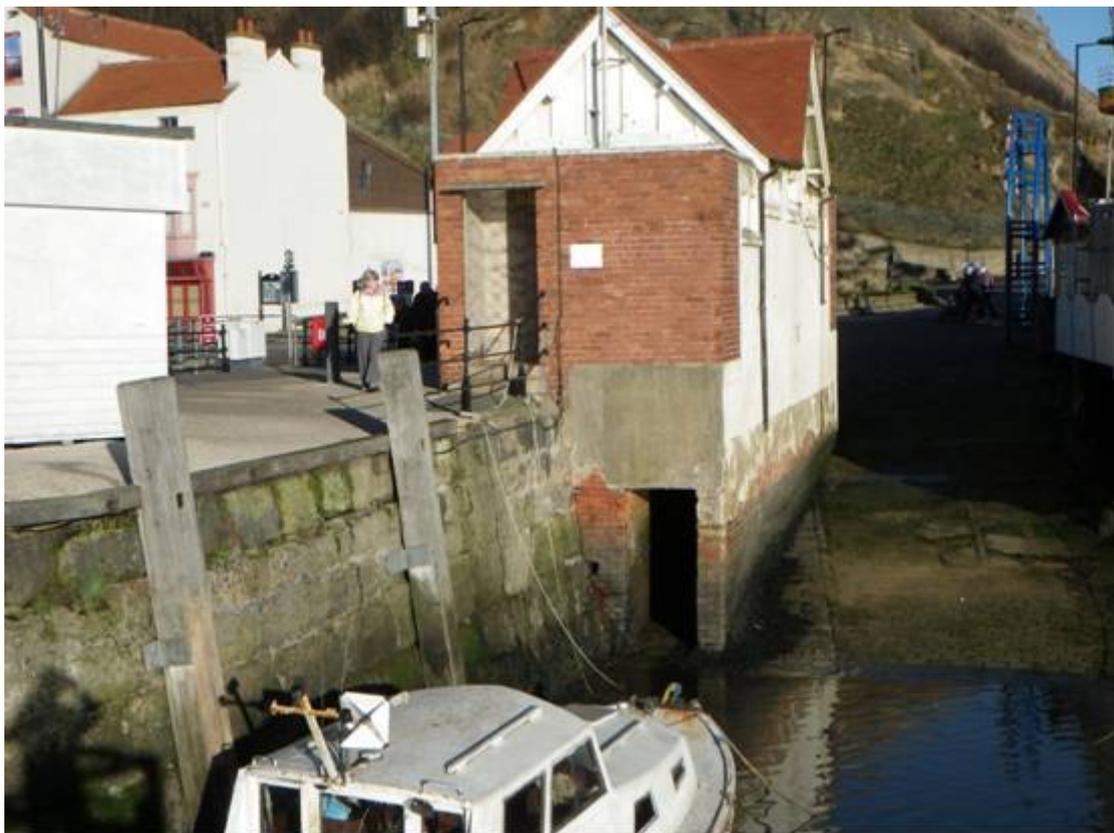
Plate 31 Sandside, public conveniences at north end of Vincent's Pier, showing construction of 'Old Pier' (left), looking north

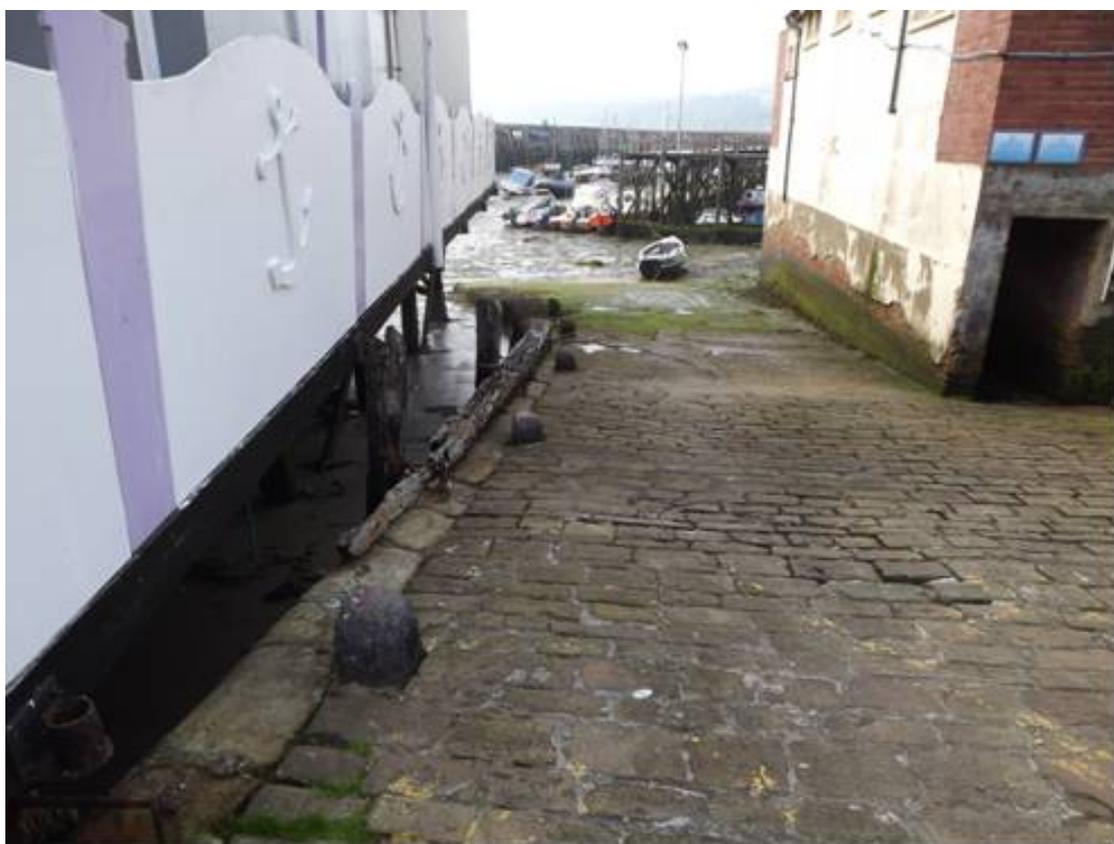
Plate 32 Sandside, slipway east of Vincent's Pier, showing stone posts marking edge, looking south

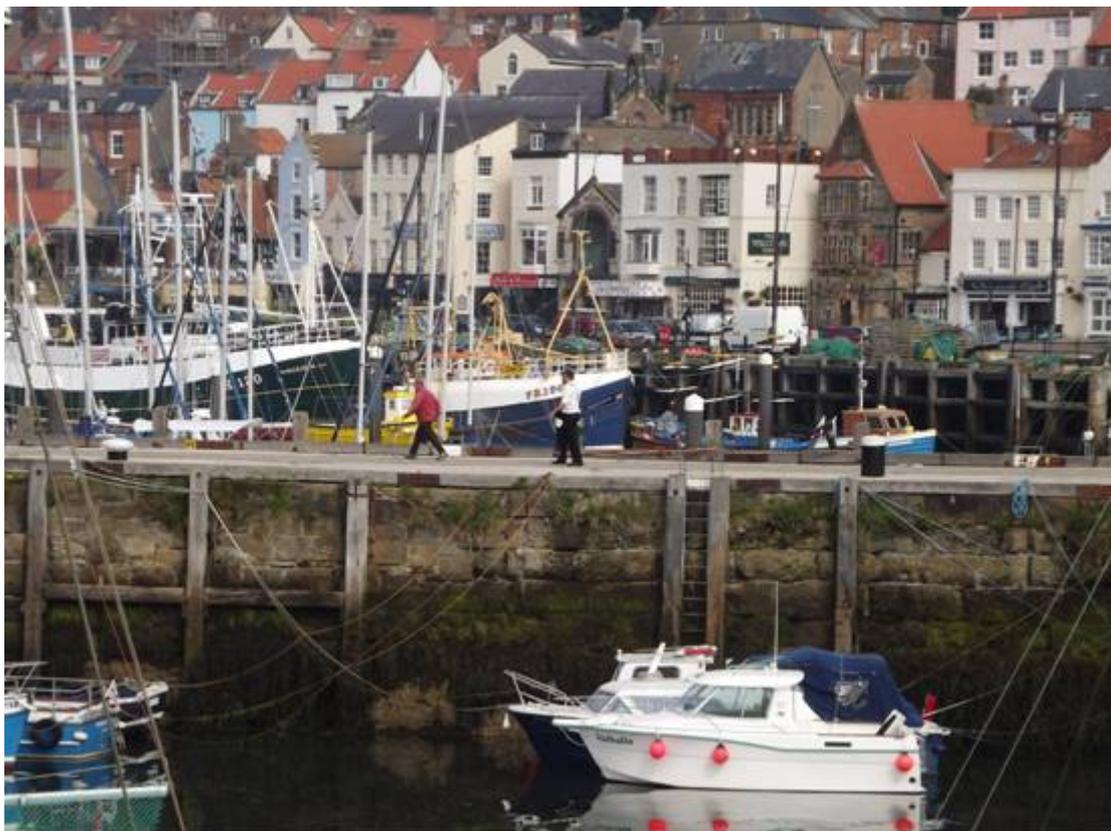
is apparent part way along the pier and this may have been at the junction of Vincent's work and that of his immediate predecessor, or simply reflect a temporary stopping point (Plate 35).

Plate 35 Vincent's Pier, detail of east side of 'Old Pier' showing change in construction between Vincent's work (left) and an existing section, looking north-west

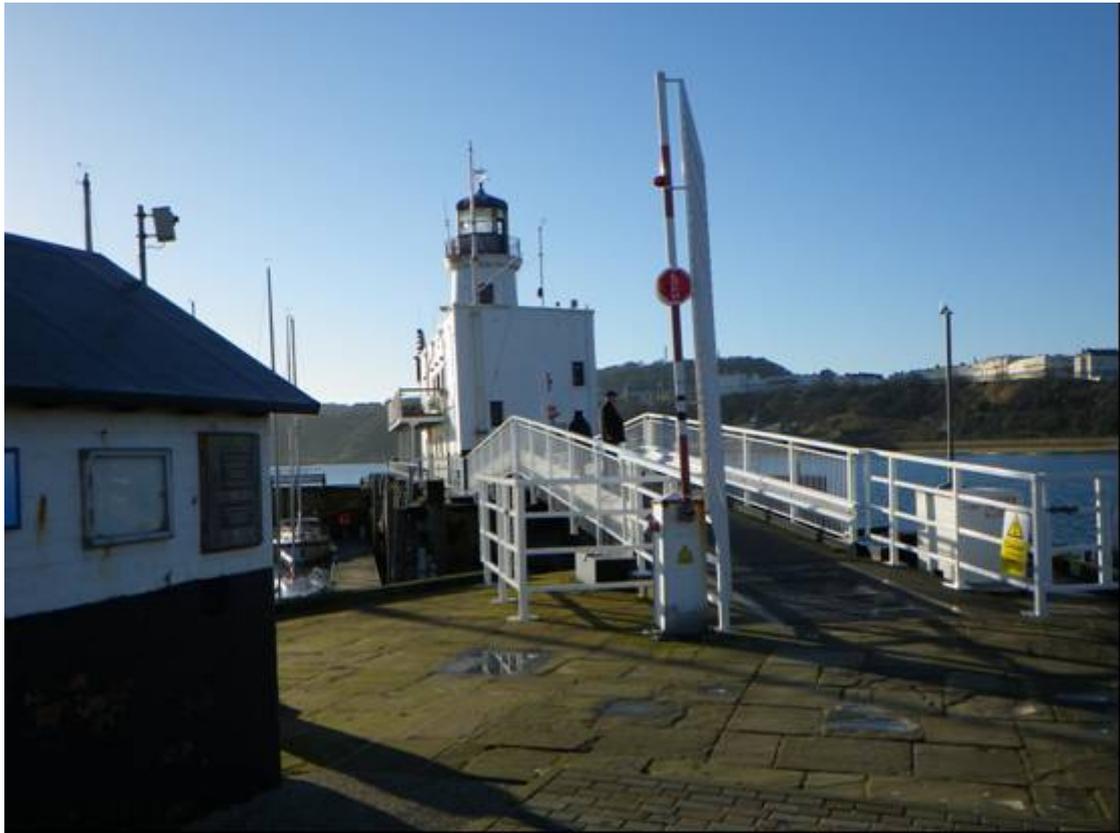
Plate 37 Vincent's Pier, 'Captain Sydney Smith Bridge' linking 'Old Pier' to island pier, looking south

It is to be hoped that the results of the field survey carried out as part of this project will be used as a conservation management tool in advance of any schemes likely to affect the harbour or its setting. There is always a danger that areas are 'tidied up' either for aesthetic reasons or on real or perceived health and safety grounds, but such changes rarely contain the same 'grain' as the original, or have the capacity to weather, depending on materials. Resurfacing can be done more imaginatively to blend in over time using new or relaid materials: cf the modern surfaces on North Wharf (Plates 82, 83) with the nearby slipway (Plates 84, 85), or the original surfaces on East Pier (Plates 19–25) and possible relaid slabs on Vincent's Pier (Plates 37, 38, 56, 58) with modern replacement materials (Plates 27, 28 and Plates 42–7 respectively).

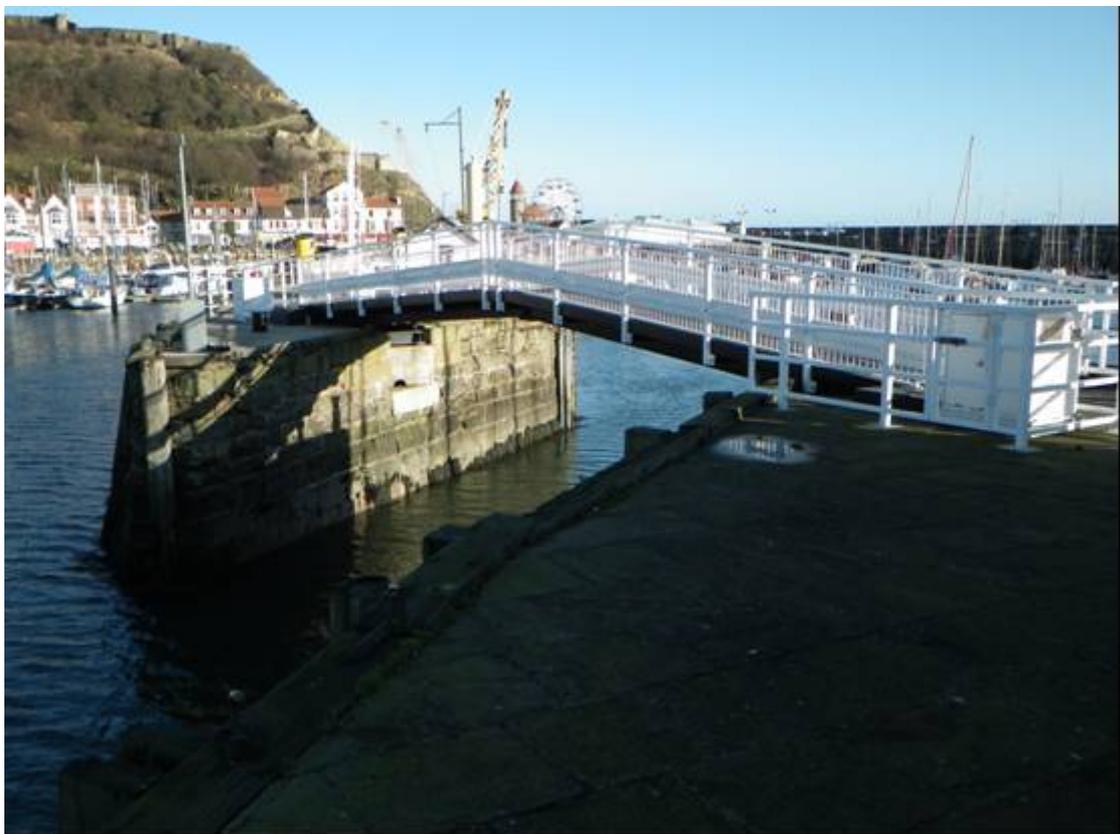
Plate 38 Vincent's Pier, 'Captain Sydney Smith Bridge', looking north-east towards 'Old Pier', position of north end of earlier drawbridge visible directly beneath

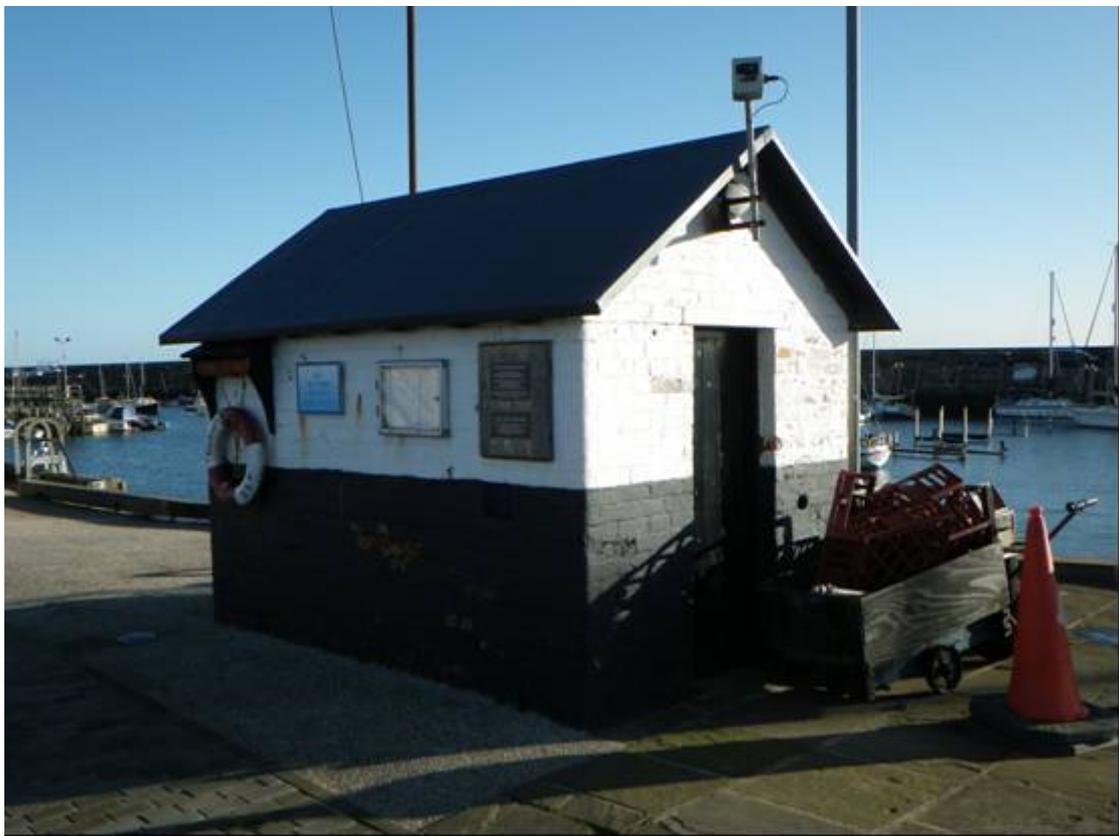
In the harbour itself, the 19th-century Grade II listed lighthouse (Plates 58, 59) and the late 19th-century former fishsellers' offices and lavatories on West Pier (Plates 100–02) are important elements of the harbour, and the interwar office block to the south of the latter is also of historic interest (Plate 103); though unlisted, it does fall within the conservation area. On Vincent's Pier, the small 19th-century Water House is of historic interest (Plate 40).

Plate 40 Vincent's Pier, 19th-century water house at south end of 'Old Pier' section

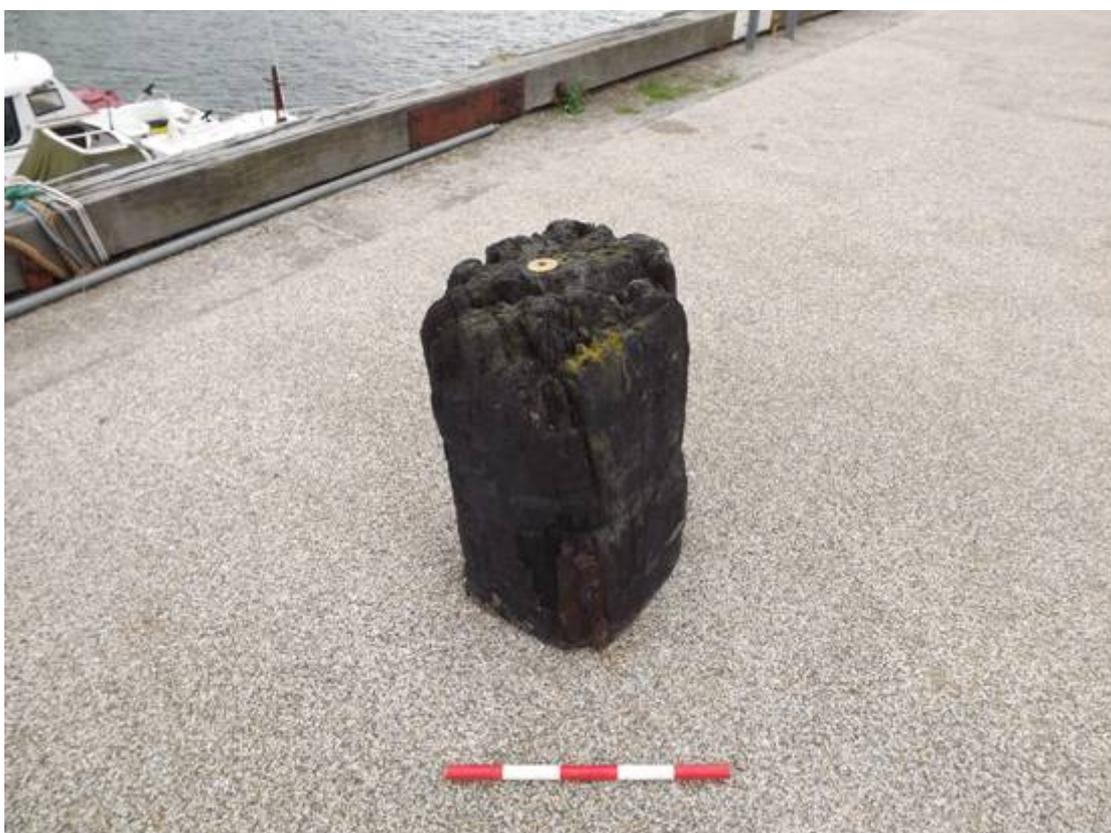
Vincent's Pier retains many bollards of two principal types, but also has two wooden examples (Plate 46). The most important structures, though are on the Lighthouse Pier section, including a decorative bollard with a head cast in the form of a compass rose (Plates 66, 67), and two capstans. The smaller of the two has a single row of bar sockets and a small compass rose on the cap (Plates 68, 69), the larger capstan has a double row of sockets, indicating that it was a reused ships' capstan (Plates 70–2). The upper row would have been used to raise an anchor, the lower row for general deck use. A capstan is shown in virtually the same location as the smaller version on the 1852 1:1056 Ordnance Survey, with a second positioned to the west of the lighthouse, but the present version looks more recent. The larger capstan appears to have been moved to its present location after 1892, and it may be one of three originally located at the end of the East Pier.

Plate 46 Vincent's Pier, wooden Type D bollard on 'Old Pier' (0.5m scale)

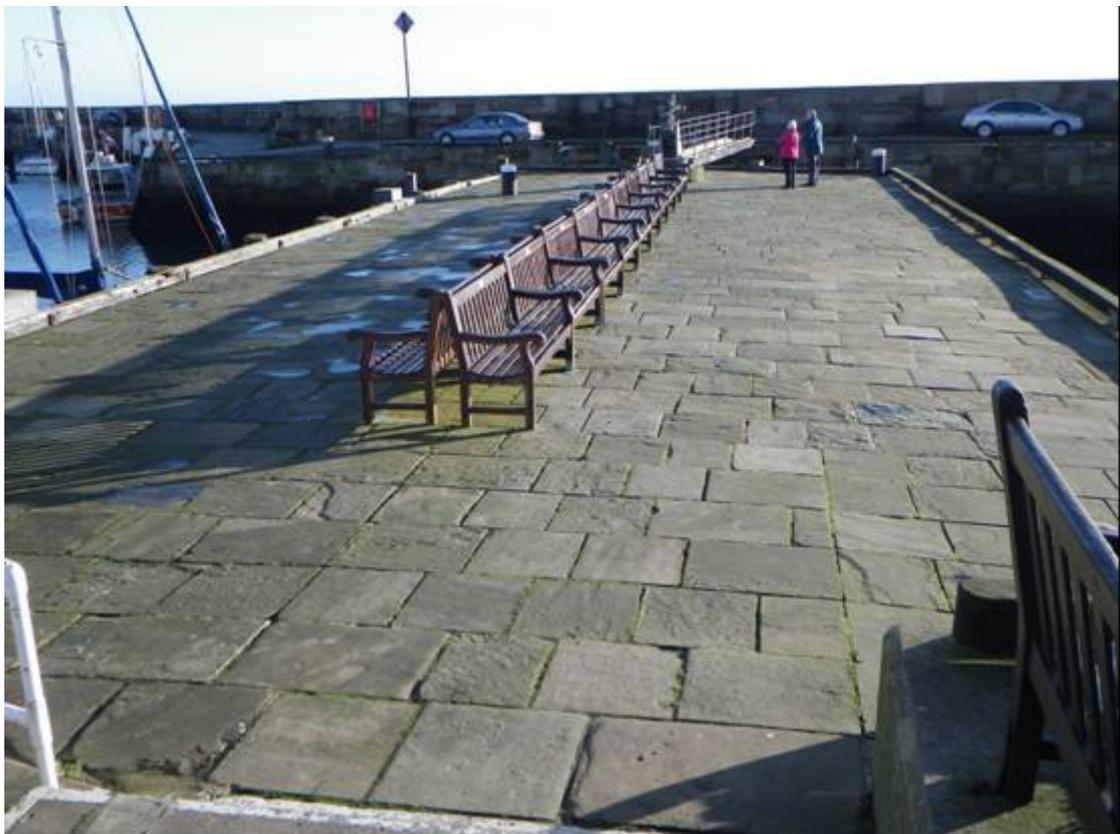
Plate 56 Vincent's Pier, general view of south section of Lighthouse Pier showing stone surface, looking east

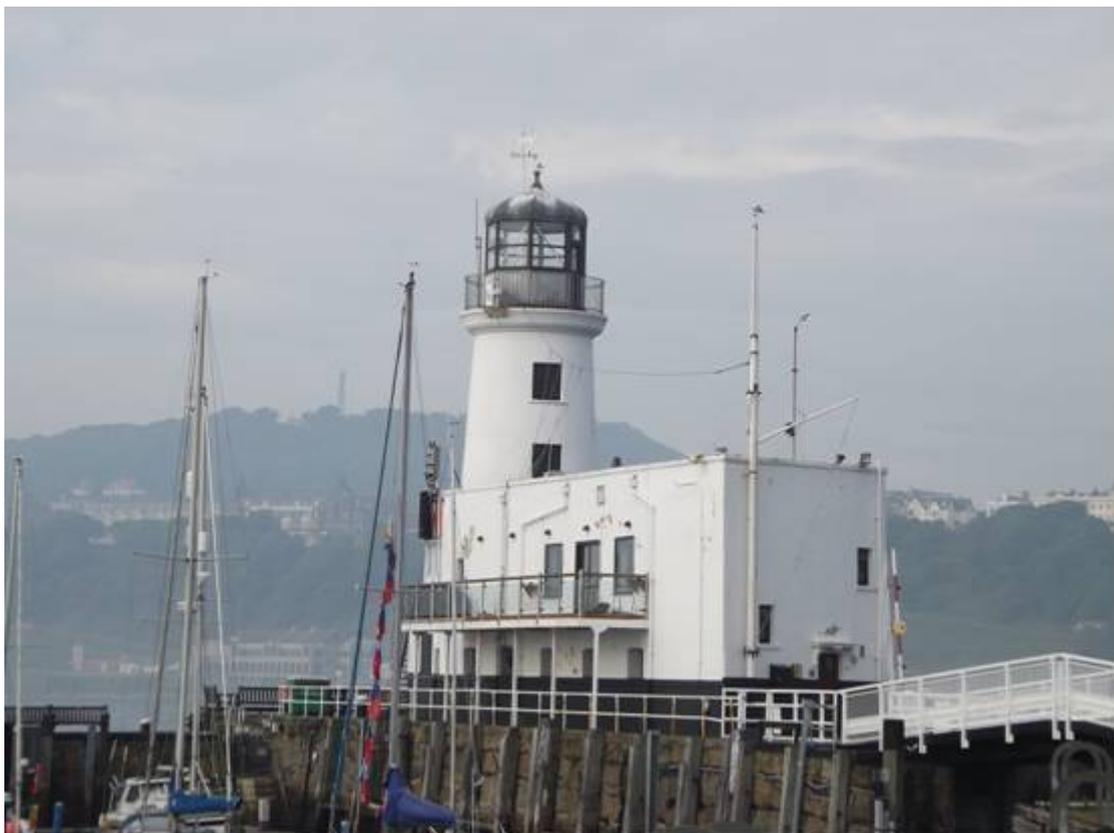
An important building specifically related to the development of the harbour is the Grade 2 listed lighthouse itself (LBS 443958: Plates 58–60). The present tower replaced the original 1801–06 version destroyed in 1914 by German shelling, and was completed in 1931, with a more recent lantern the light is now fully automated. The harbourmaster's house is the original mid 19th-century structure, with some rebuilding. The structure is in apparent good condition.

Plate 59 Vincent's Pier, the Grade II lighthouse and original pier wall, looking south-west

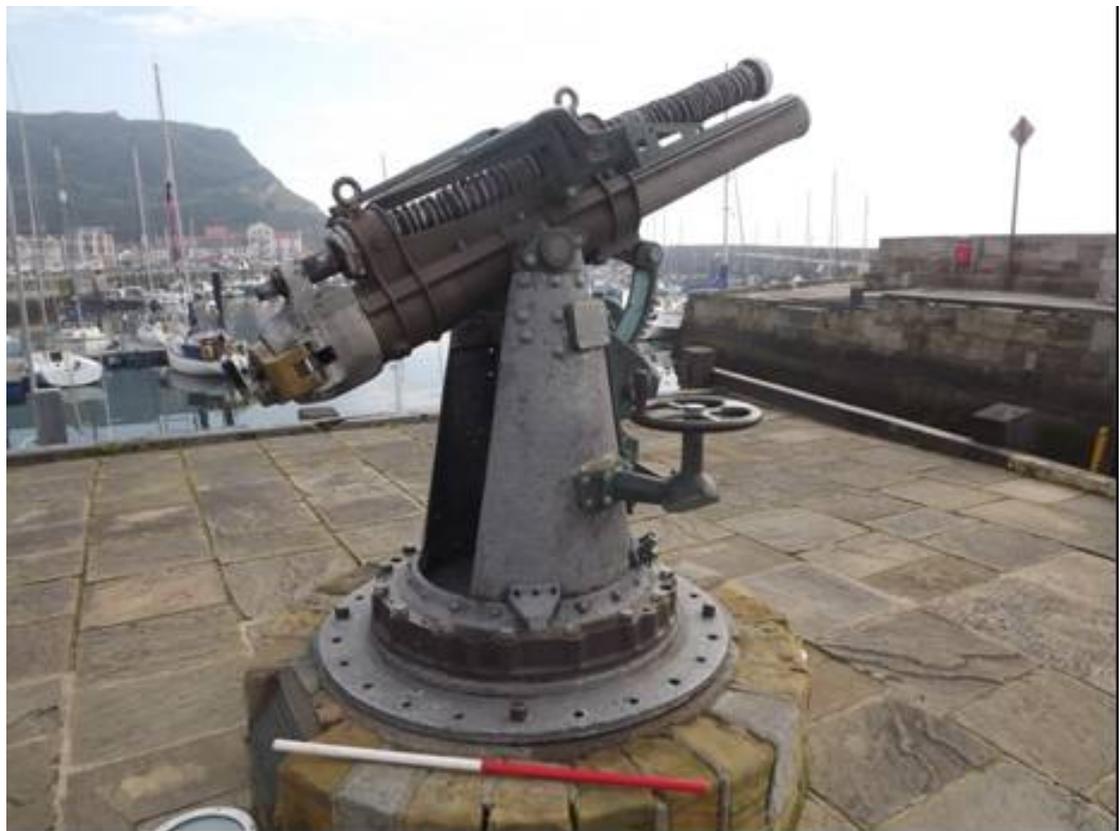
Near the east end of the southern part of the Lighthouse Pier is a navalised 1914 issue 13-pdr Mark V Vickers quick-firing (QF) gun and mounting (Plates 62–4). The gun was recovered in 1982 from the wreck of the *SS Hornsund* which was torpedoed on the 23rd September 1917 (Plate 65).

Plate 62 Vincent's Pier, end of Lighthouse Pier, 13-pounder quick-firing (QF) Mark V Vickers naval gun raised from the wreck of the SS Hornsund in 1982 (1m scale)

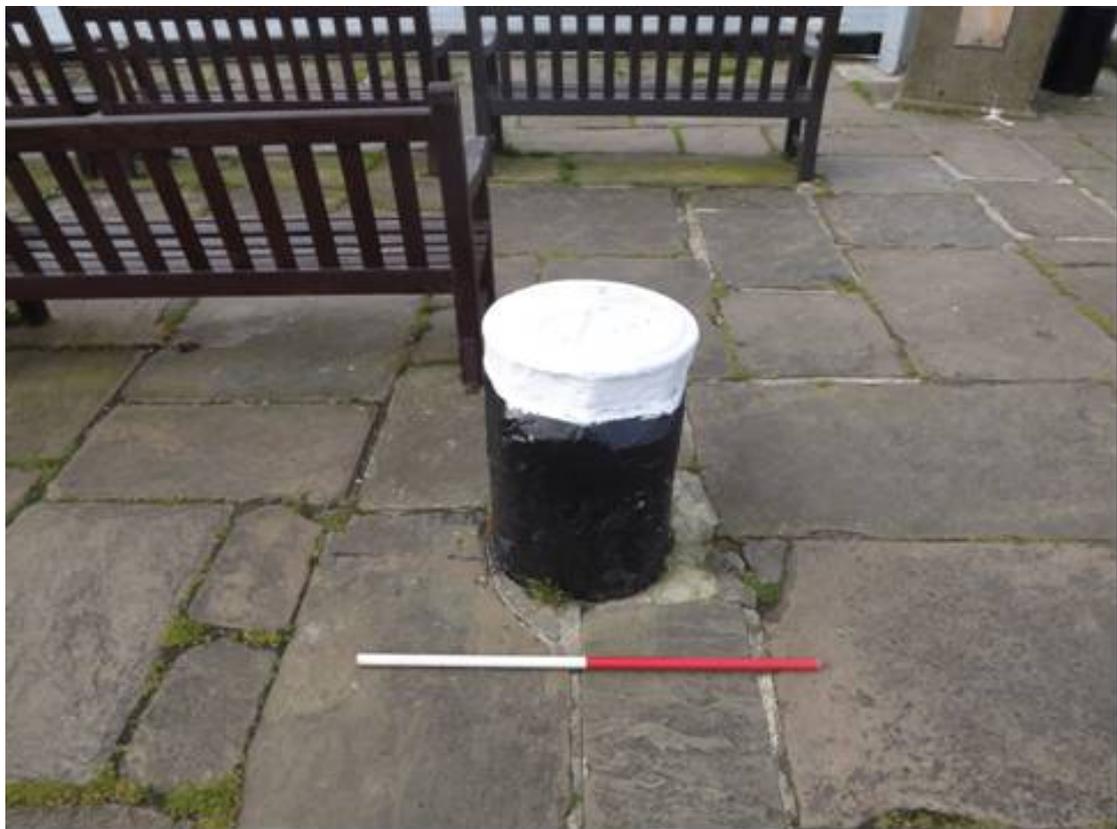
Plate 66 Vincent's Pier, Lighthouse Pier, modified wooden bollard with decorative iron cap (1m scale)

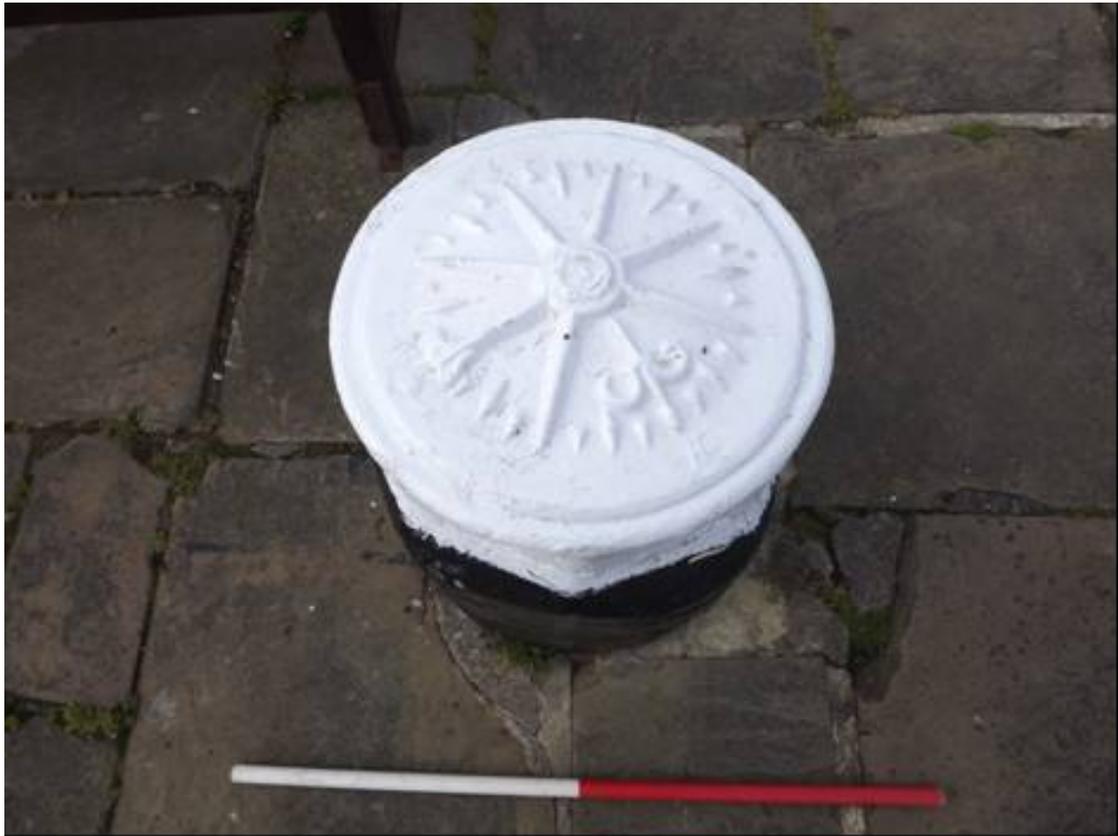
Plate 67 Vincent's Pier, Lighthouse Pier, detail of decorative compass rose on cap of bollard (1m scale)

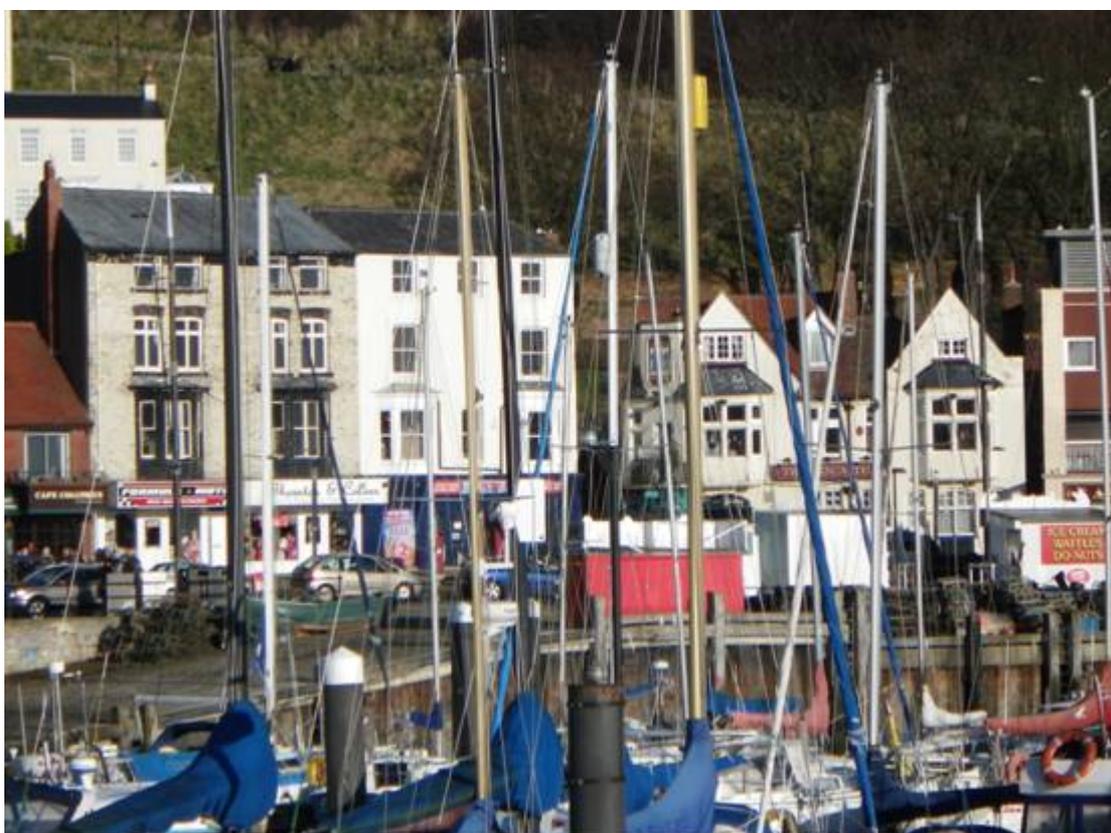
Plate 76 North Wharf, general view of section east of central slipway with modern refacing, looking north
