Rapid Coastal Zone Assessment Survey

Yorkshire and Lincolnshire: Phase 3

Historical Audit

Scarborough Harbour

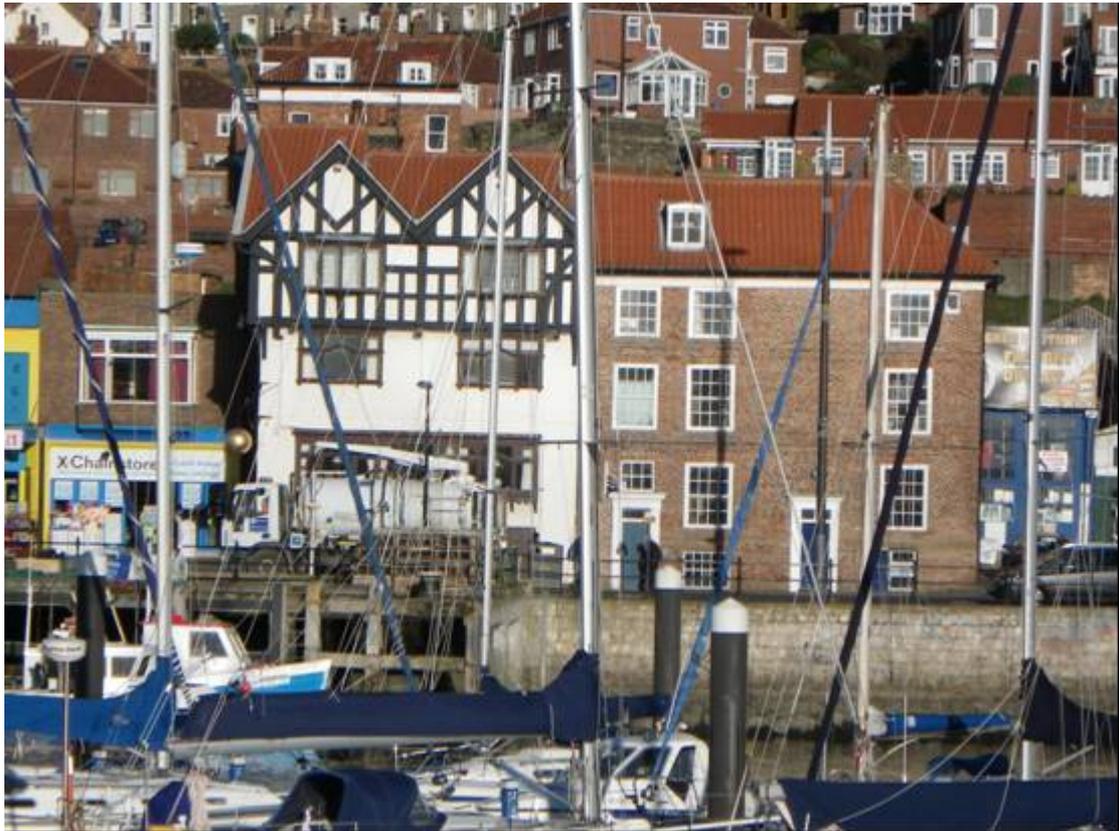
Plate 77 North Wharf, general view of seawall (right) immediately west of central slipway and east end of 1928 wharf staging (left), looking north

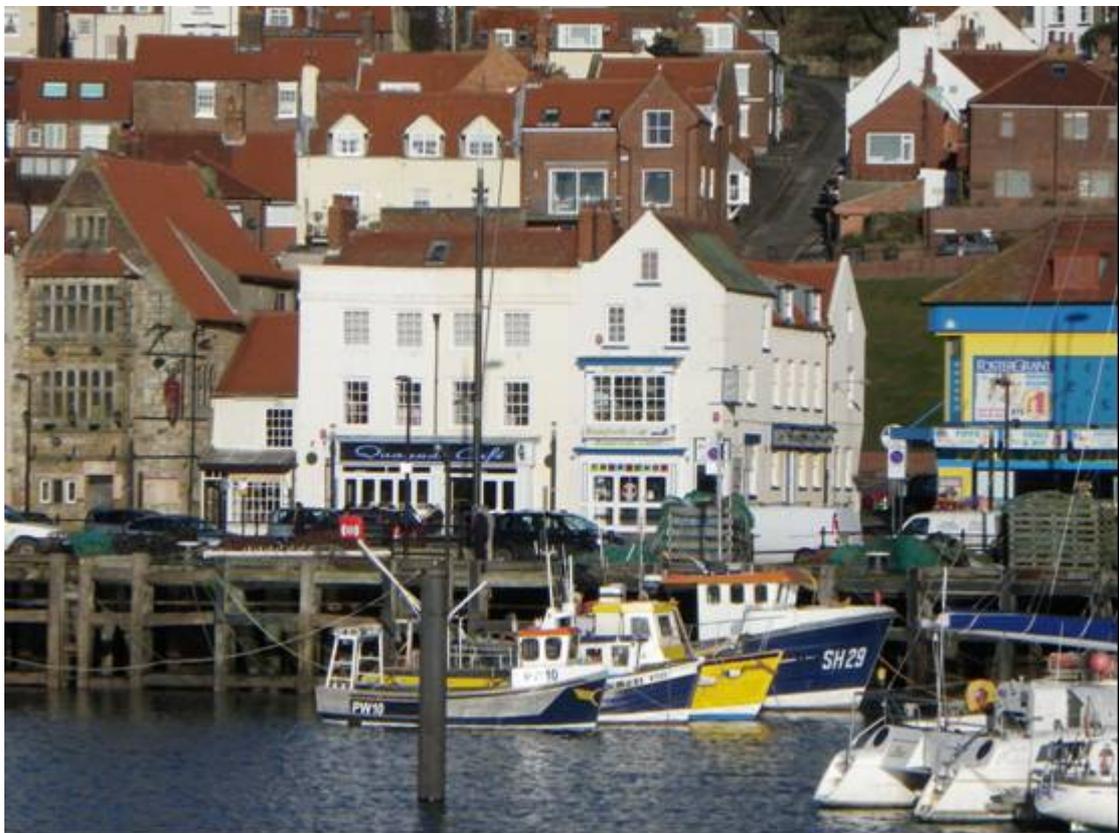
Plate 78 North Wharf, general view of eastern section of 1928 wharf staging, looking north

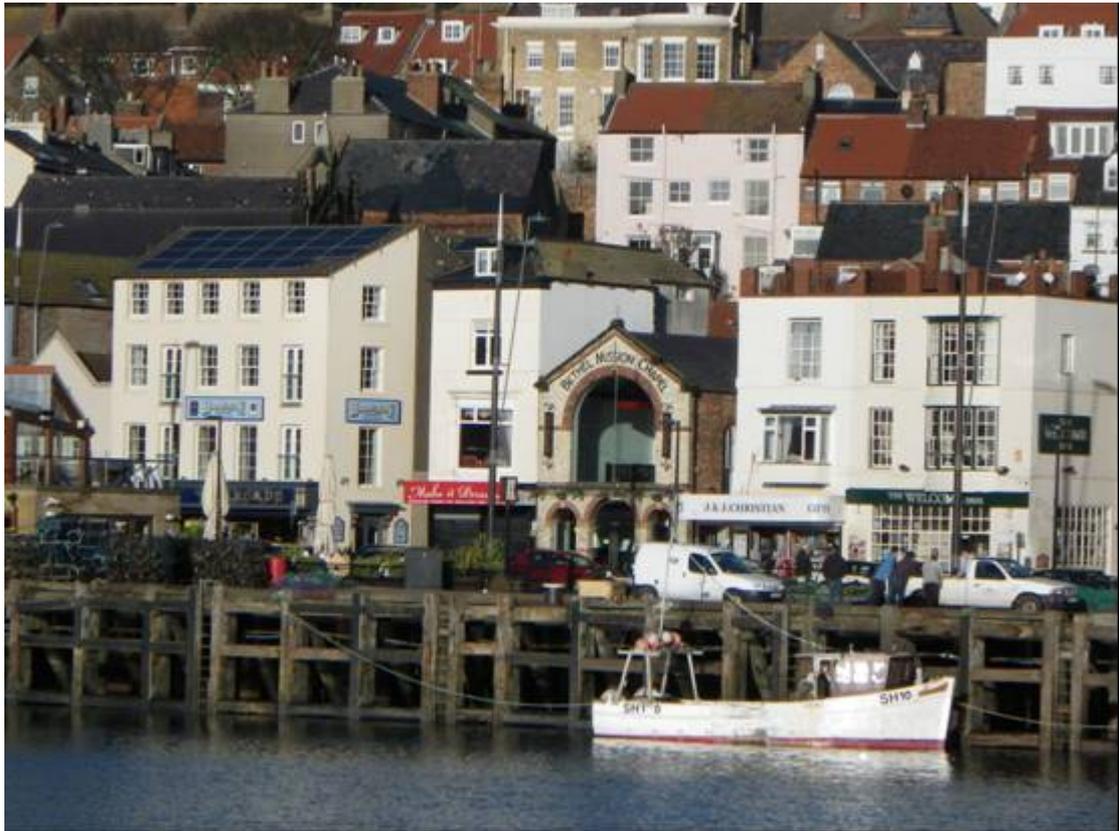
Plate 79 North Wharf, general view of central section of 1928 wharf staging, looking north

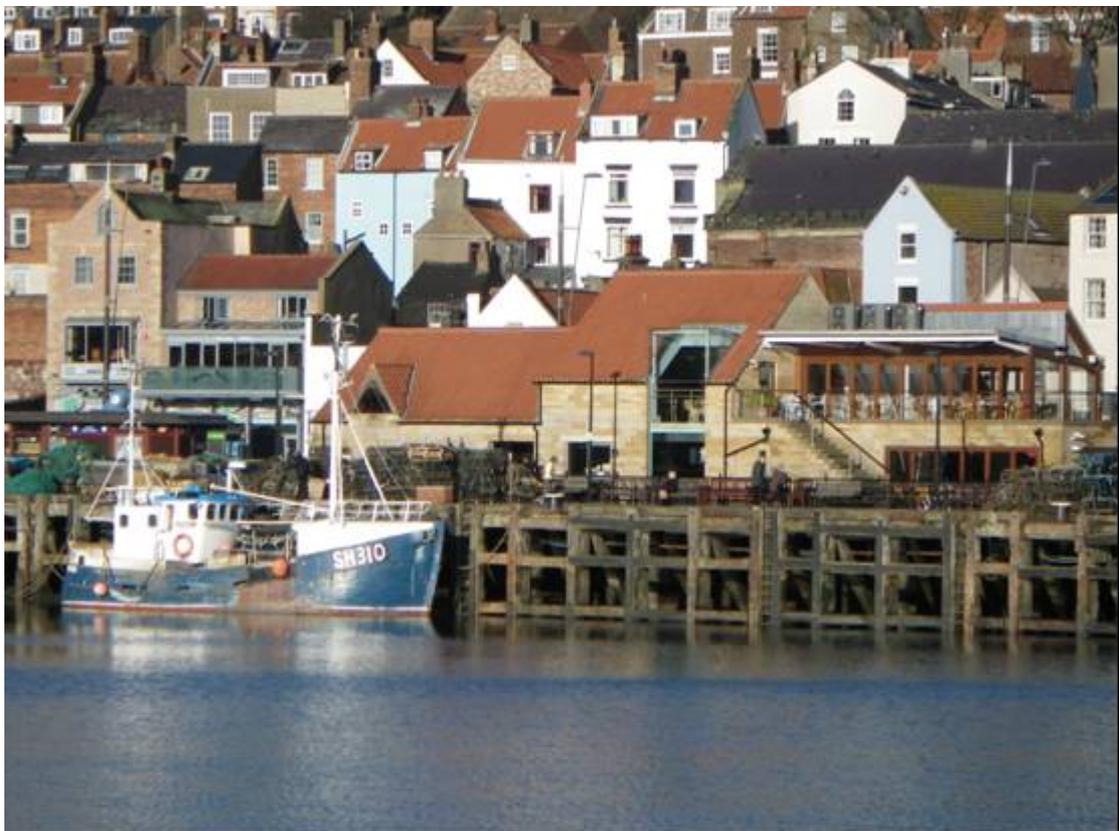
Plate 80 North Wharf, general view of western section of 1928 wharf staging, looking north

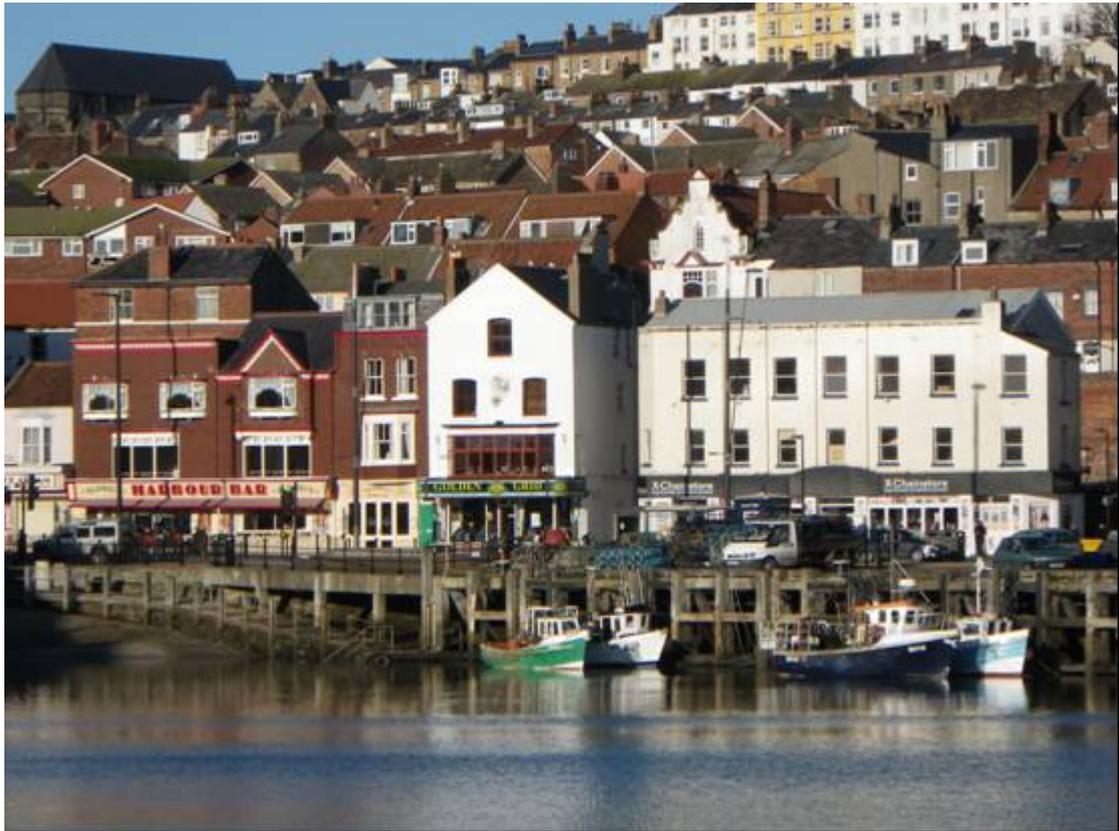
Plate 81 North Wharf, general view of west end of 1928 wharf staging and slipway next to West Pier (left), looking north

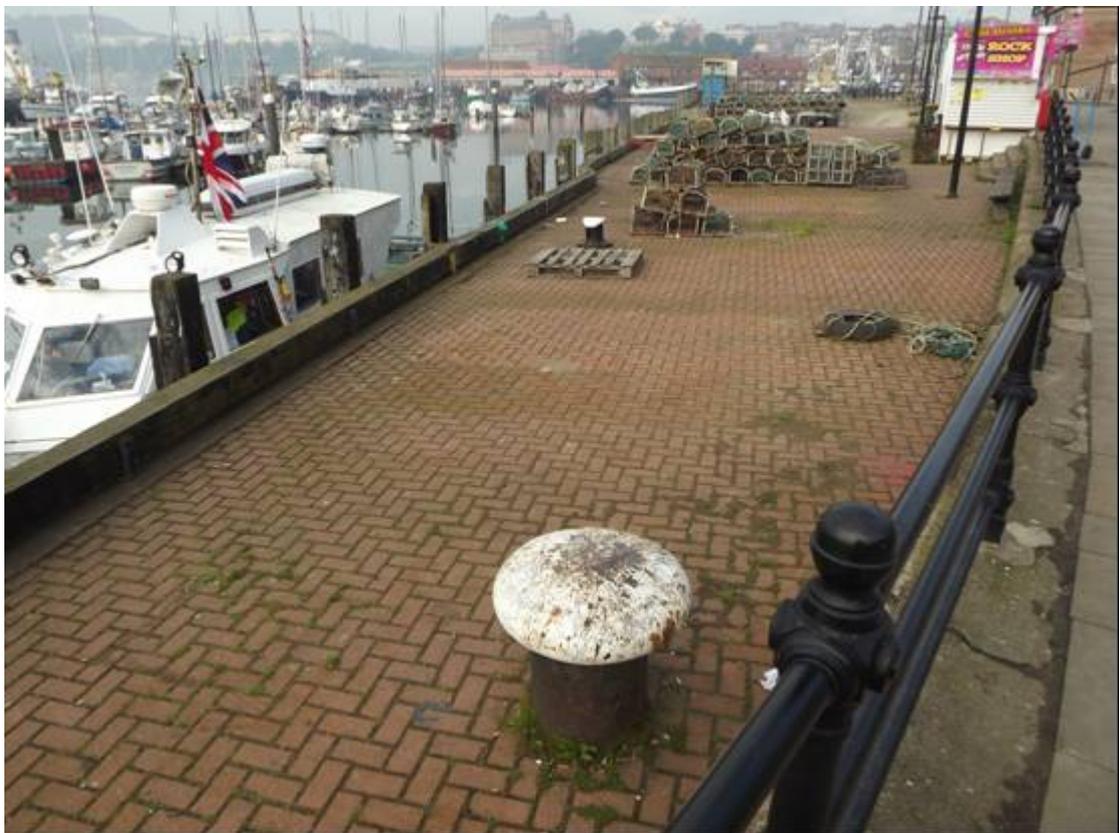
Plate 82 North Wharf, section of rebuilt wharf east of central slipway with Type B bollard and modern setts

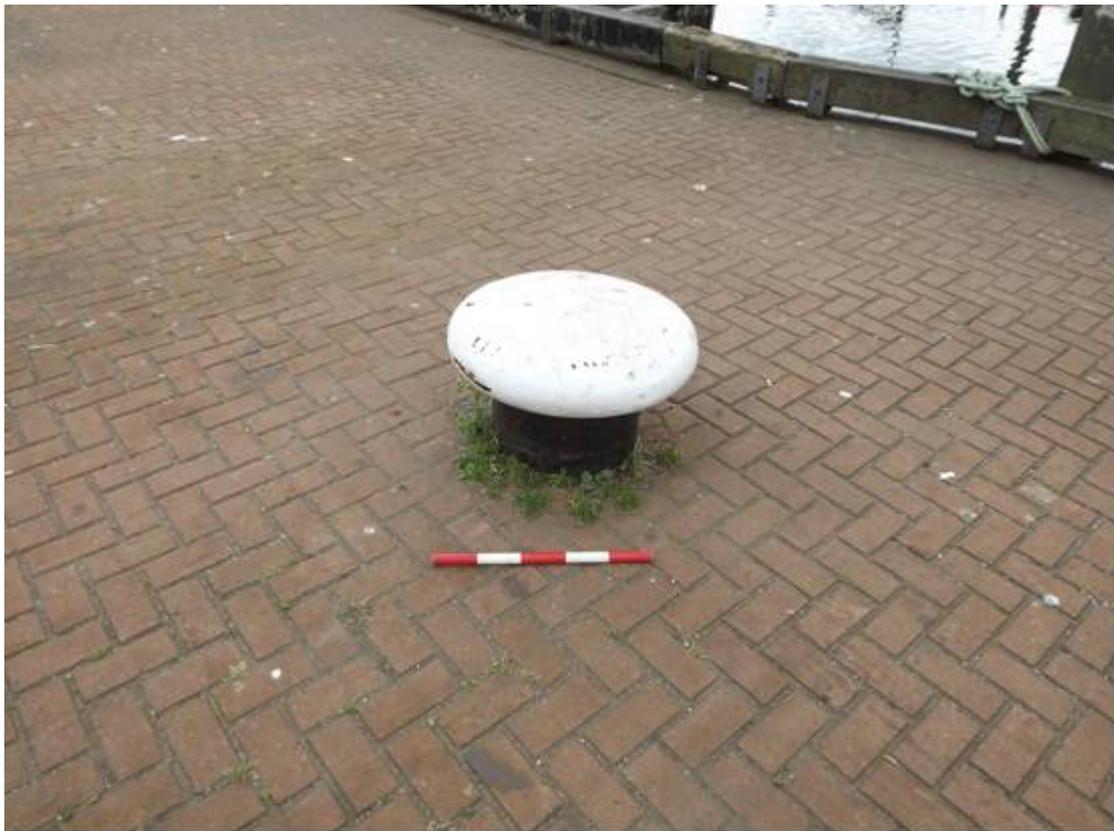
Plate 83 North Wharf, detail of Type B bollard, partly sunk in modern setts (0.5m scale)

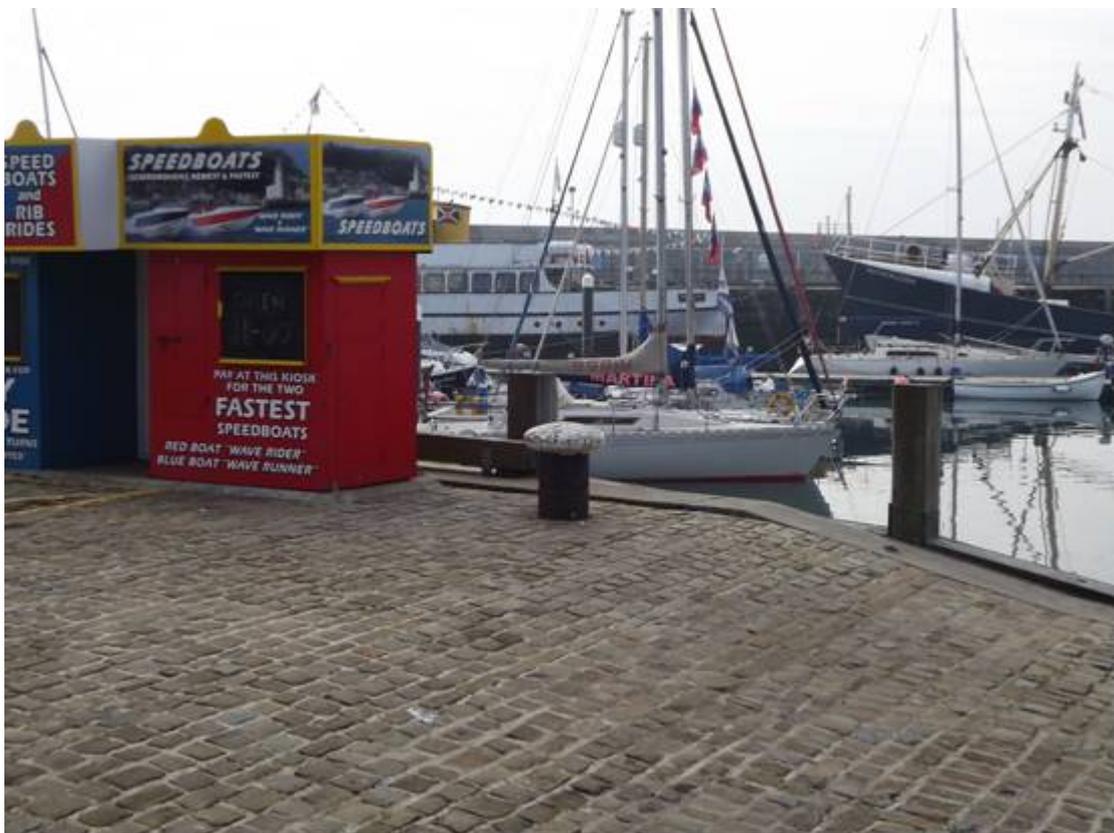
The construction of the Sandside carriageway c 1900 led to changes to the north side of the harbour, with construction of a new harbour wall and slipways (cf Plates 149, 150; also Plates 84, 85), followed in 1928 by the construction of North Wharf (Plate 151) to replace the Corporation Quay of 1826 (Plate 148). Slipways were, however, already in place either side of Vincent's Pier (Plates 30–3) and in the north-west corner of the harbour next to West Pier (Plates 91, 92).

Plate 84 North Wharf, top of central slipway with Type B bollard and speedboat booths, looking south-east towards Vincent's Pier

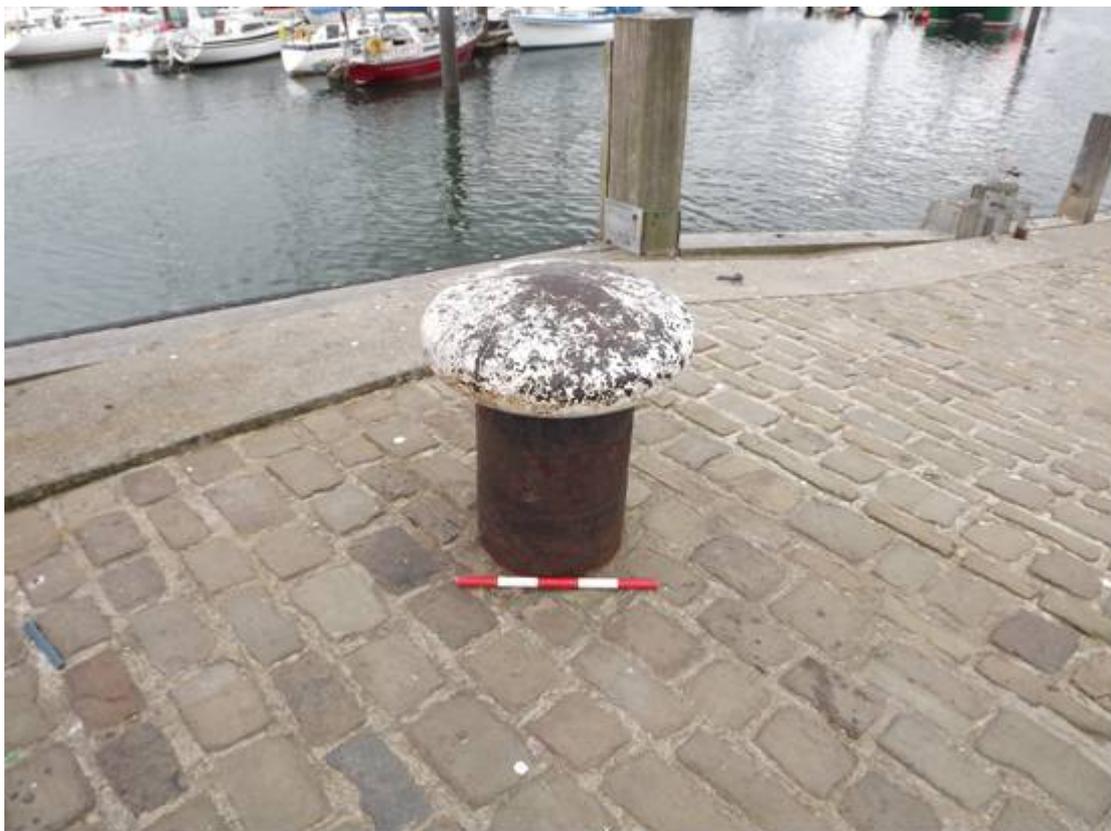
Plate 85 North Wharf, Type B bollard at top of central slipway (0.5m scale)

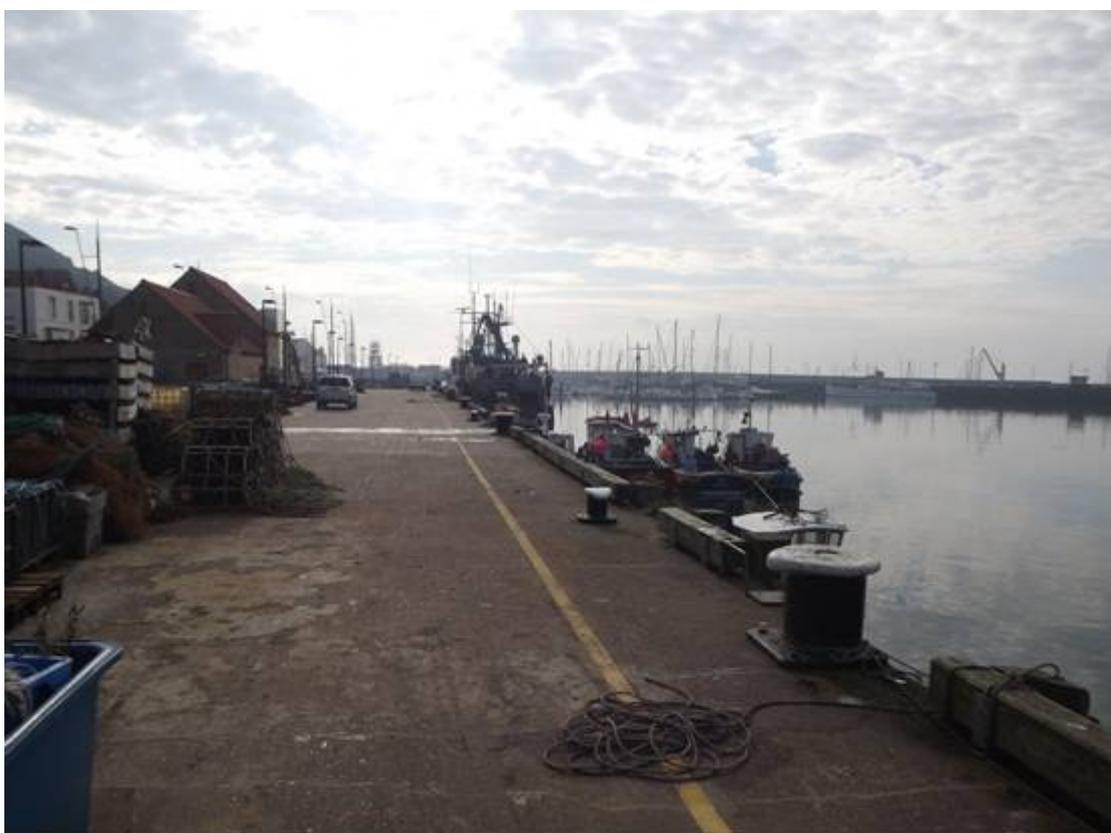
Plate 86 North Wharf, general view along wharf showing range of large and small bollards, looking east

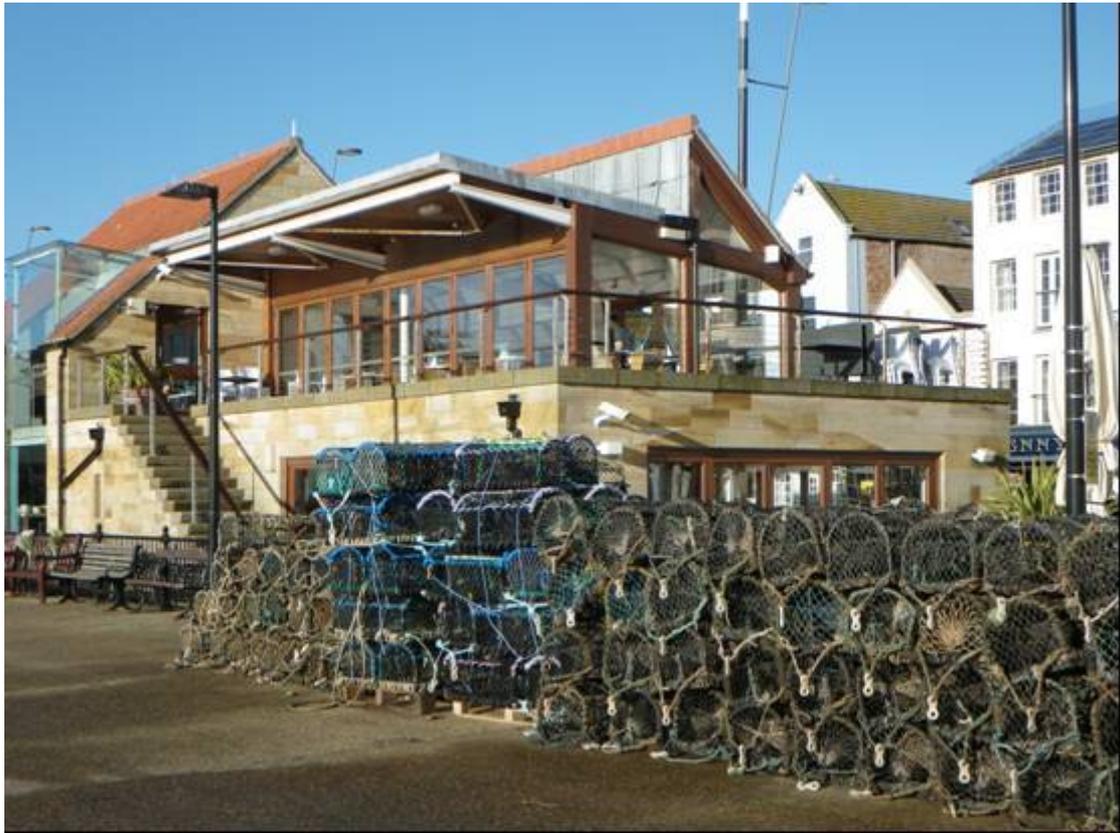
Plate 87 North Wharf, general view of lobster pots and modern restaurant fronting Sandside

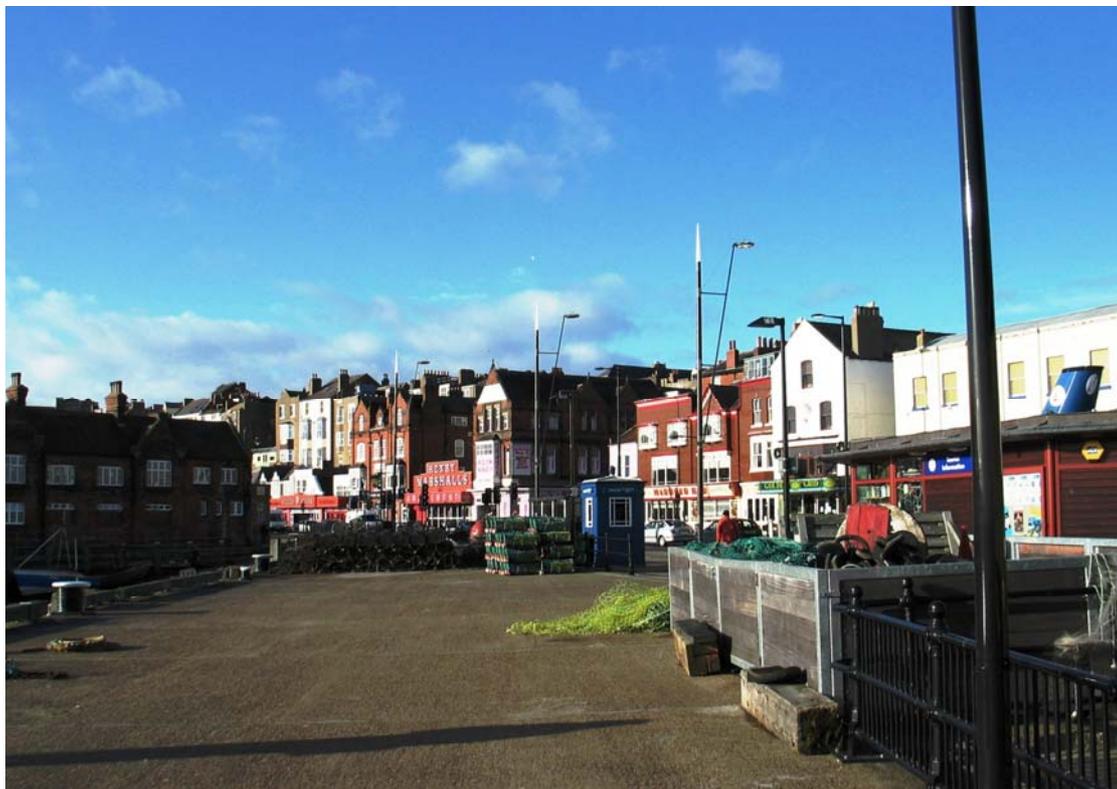
Plate 88 North Wharf, general view towards Sandside and north end of West Pier, looking west

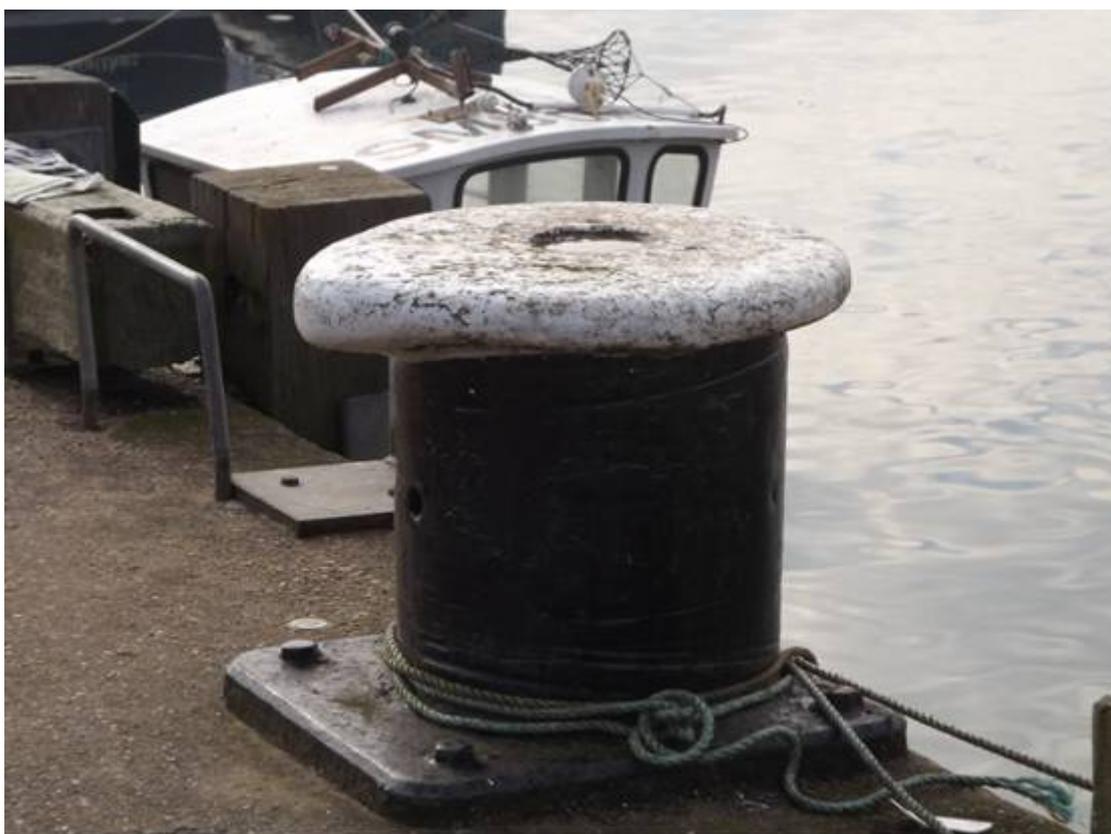
Plate 89 North Wharf, large modern bollard with square baseplate

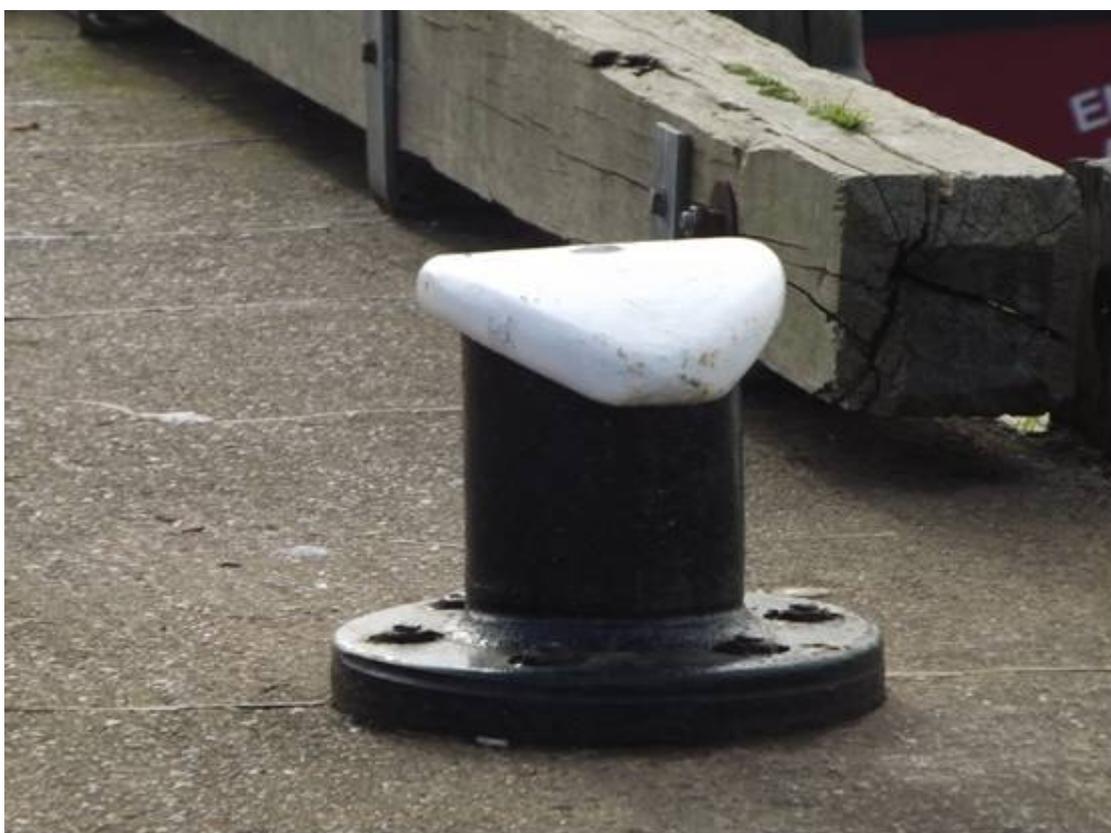
Plate 90 North Wharf, smaller modern bollard with circular baseplate

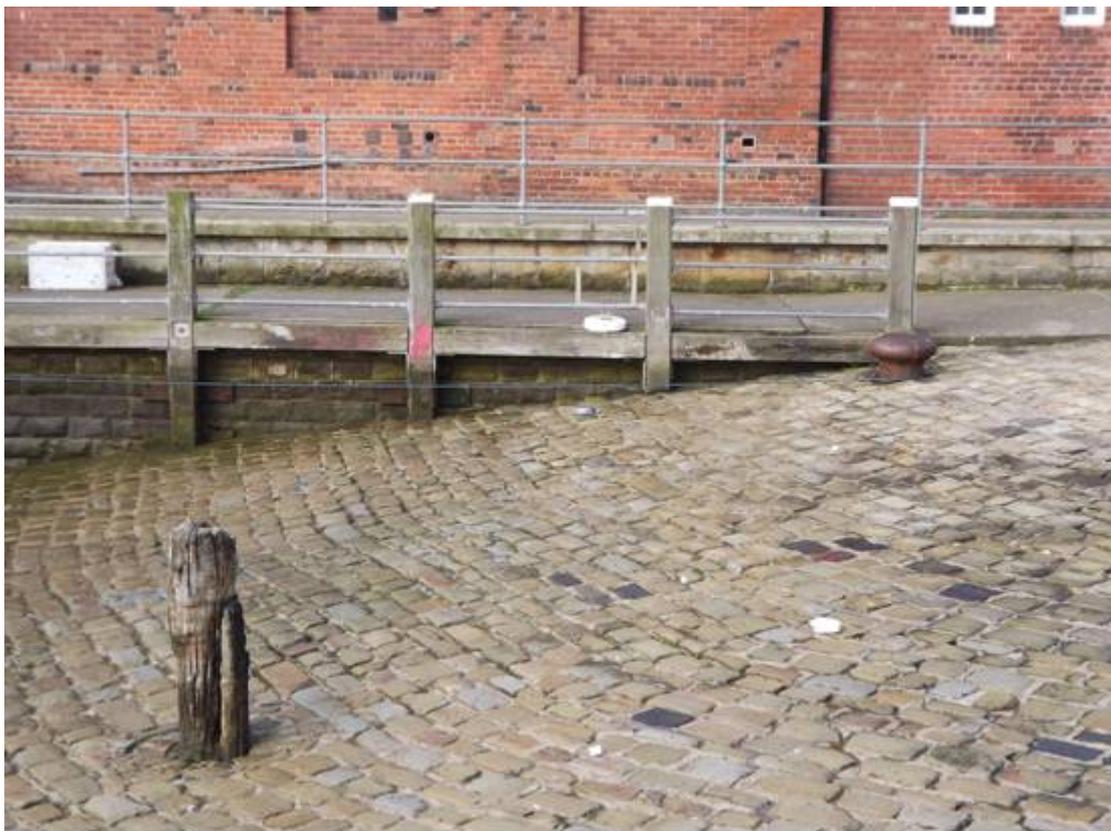
West of the North Wharf, the fan-shaped western slipway retains the original stone setts (Plate 91), with a large timber mooring post set into a circle of smaller stones (Plate 92).

The West Pier was largely rebuilt in the late 19th century and widened along the western edge subsequently, although early 19th-century masonry survives at the landward end of the eastern face (Plate 91). The Pier includes early examples of concrete facing dating to 1877–80 (Plates 93, 94). The wharf surface is a mixture of concrete and tarmac (Plates 102–06 etc).

Plate 91 Sandside, western slipway between North Wharf and West Pier, with wooden post (left) and unpainted Type B bollard (background)

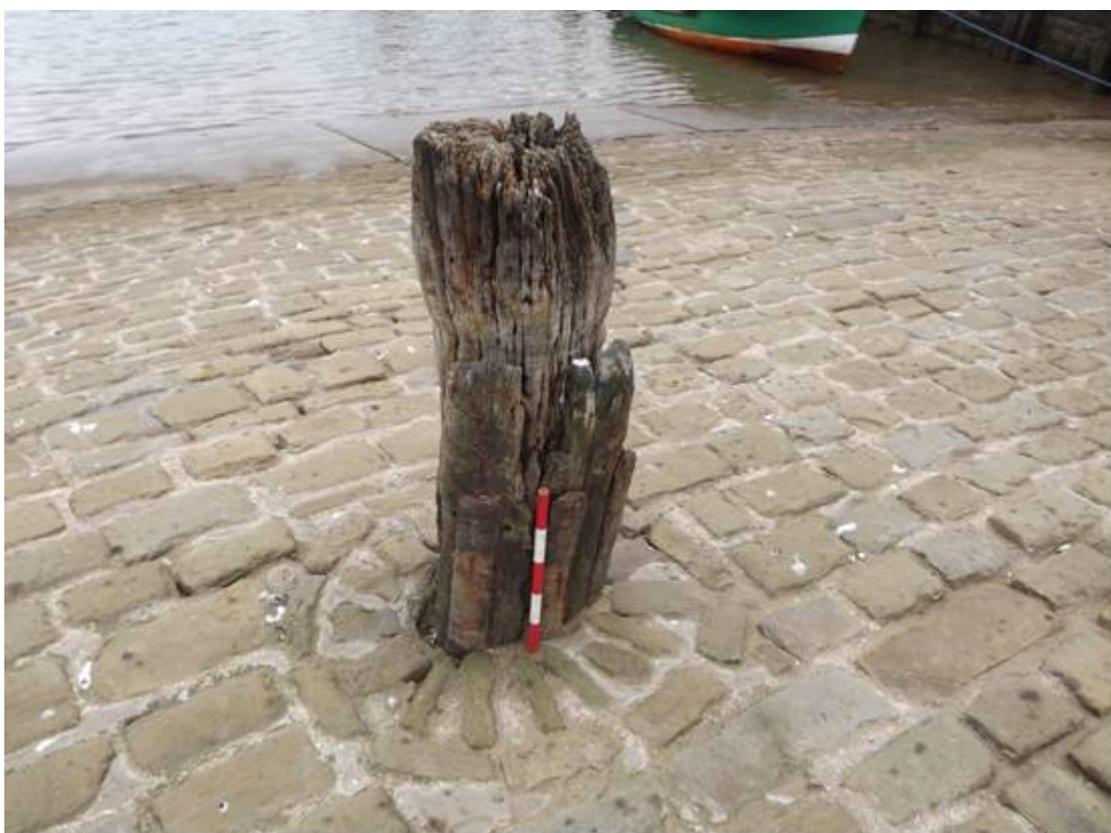
Plate 92 Sandside, wooden post and post setting in western slipway (0.5m scale)

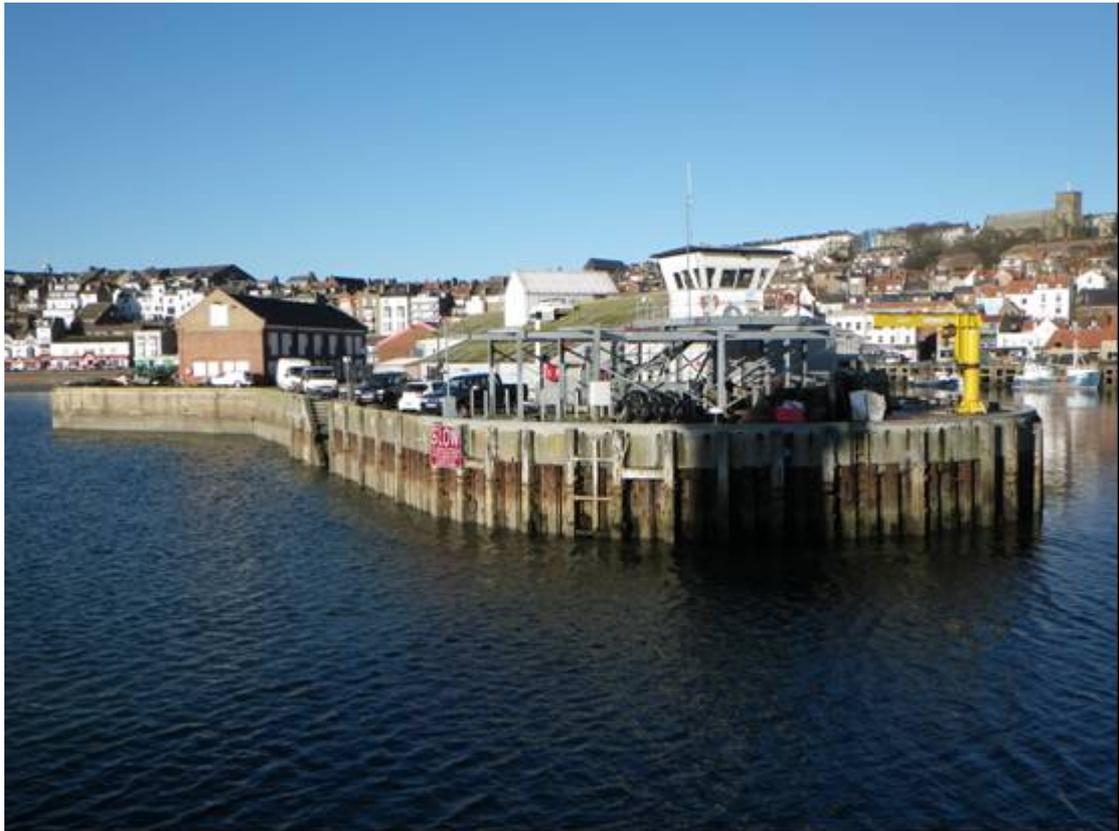
Plate 93 West Pier, south end of 1877–80 pier with c 1900 extension and surviving modern bait shed to left, looking north-west

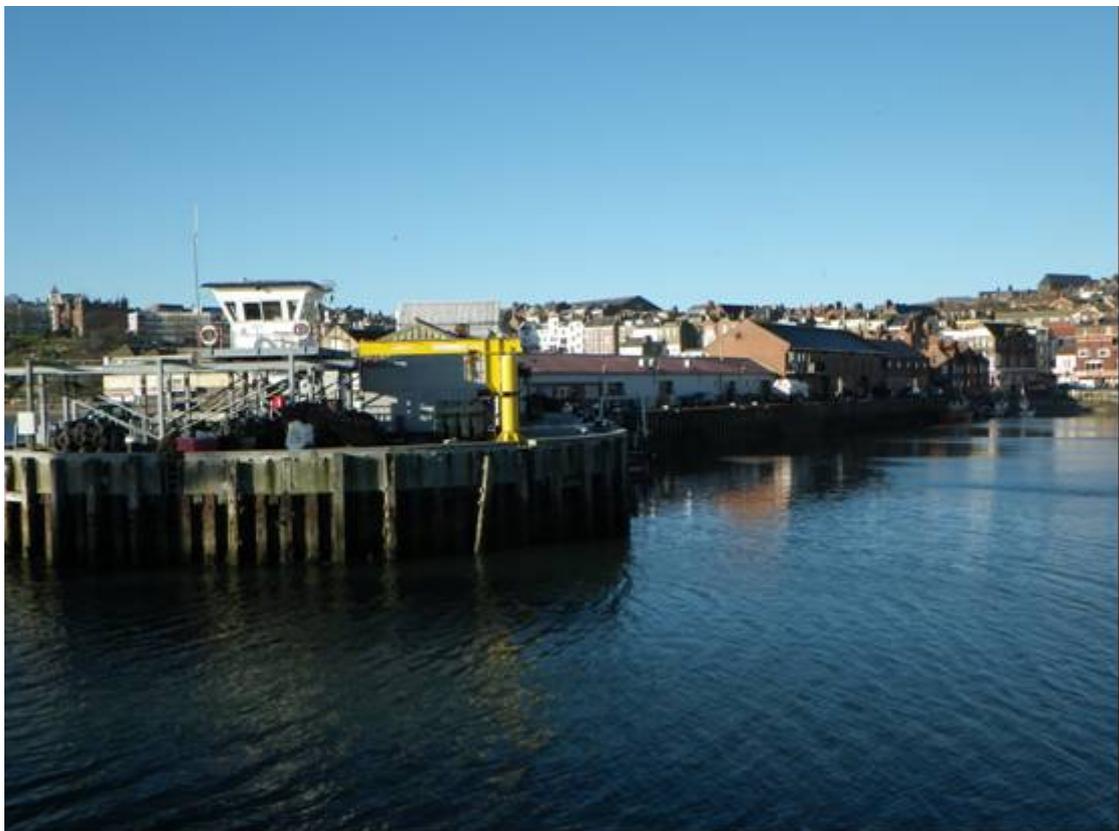
Plate 94 West Pier, general view of south end and east side, looking north-west

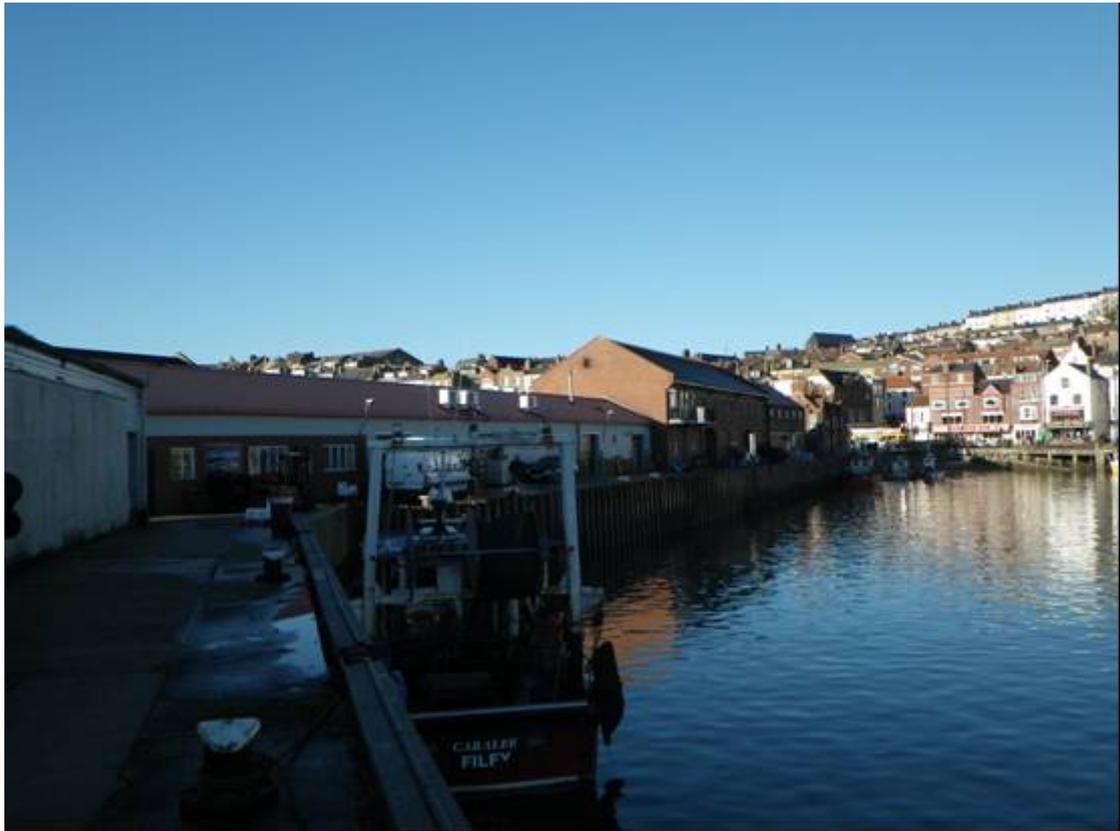
Although the 1892 1:500 OS shows a number of mooring posts along both sides of the West Pier, none of these now survive. The pier does, however, support a number of modern Type A bollards along the western side (Plates 112, 113, 115), but on the eastern there are also several large ship's bollards similar to those on the North Wharf (Plate 104) including those types recorded as Figs 6g and 6h (Plates 95) as well as a large 'Hammerhead' type (Plates 96, 104, 116).

Plate 95 West Pier, general view of east side of pier with fish market and office buildings, looking north-west

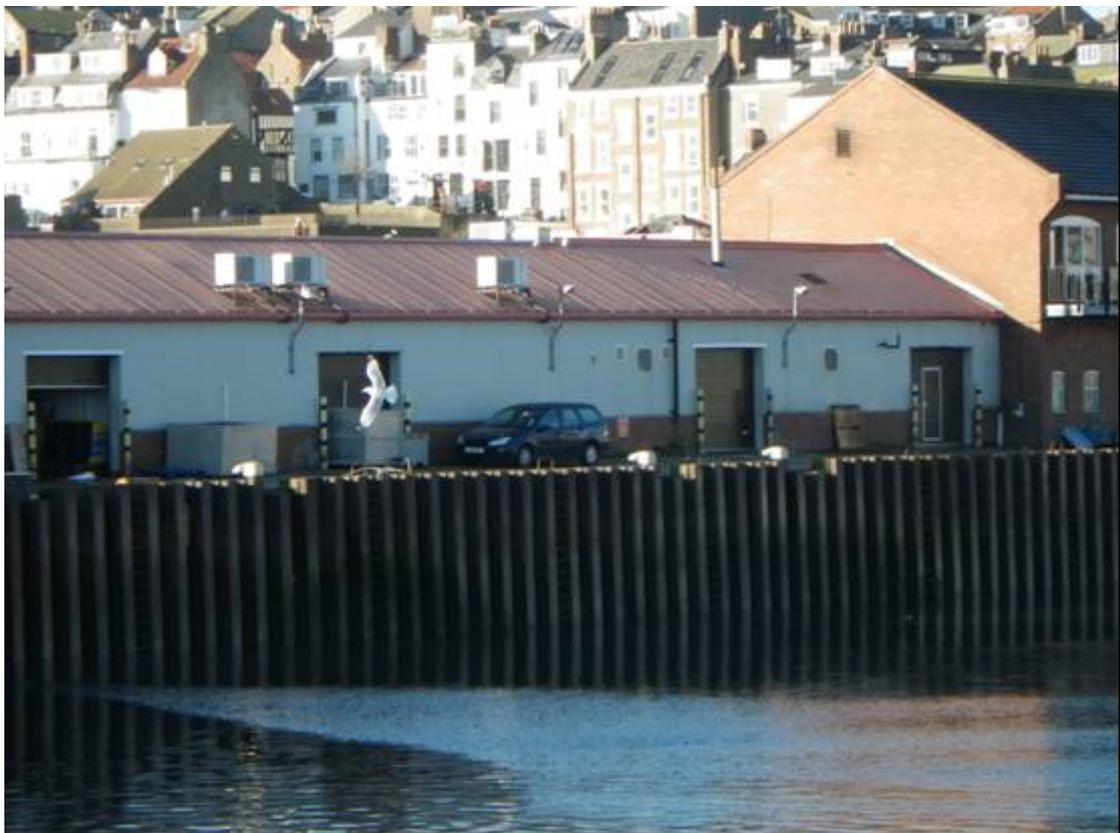
Plate 96 West Pier, general view showing east side of pier and 20th-century fish market buildings, looking west

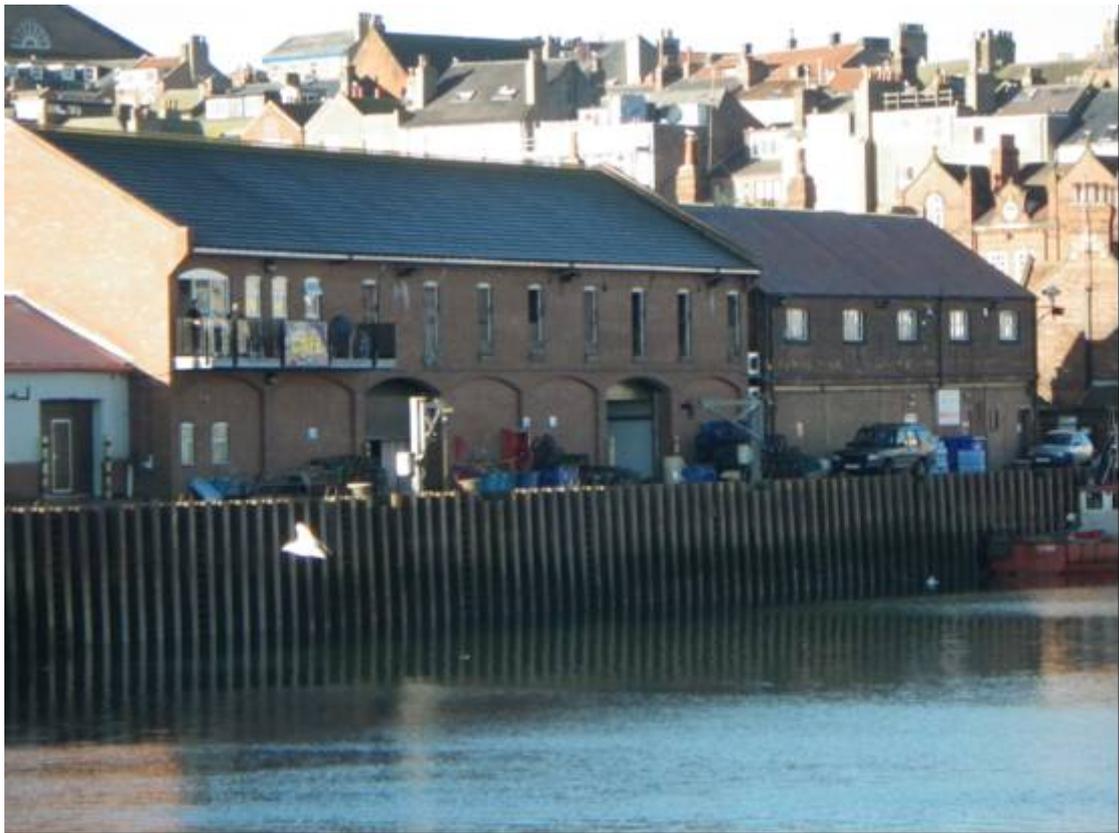
Plate 97 West Pier, general view showing east side of pier, 1990 fish market (left) and inter-war fish sellers' offices (right), looking west

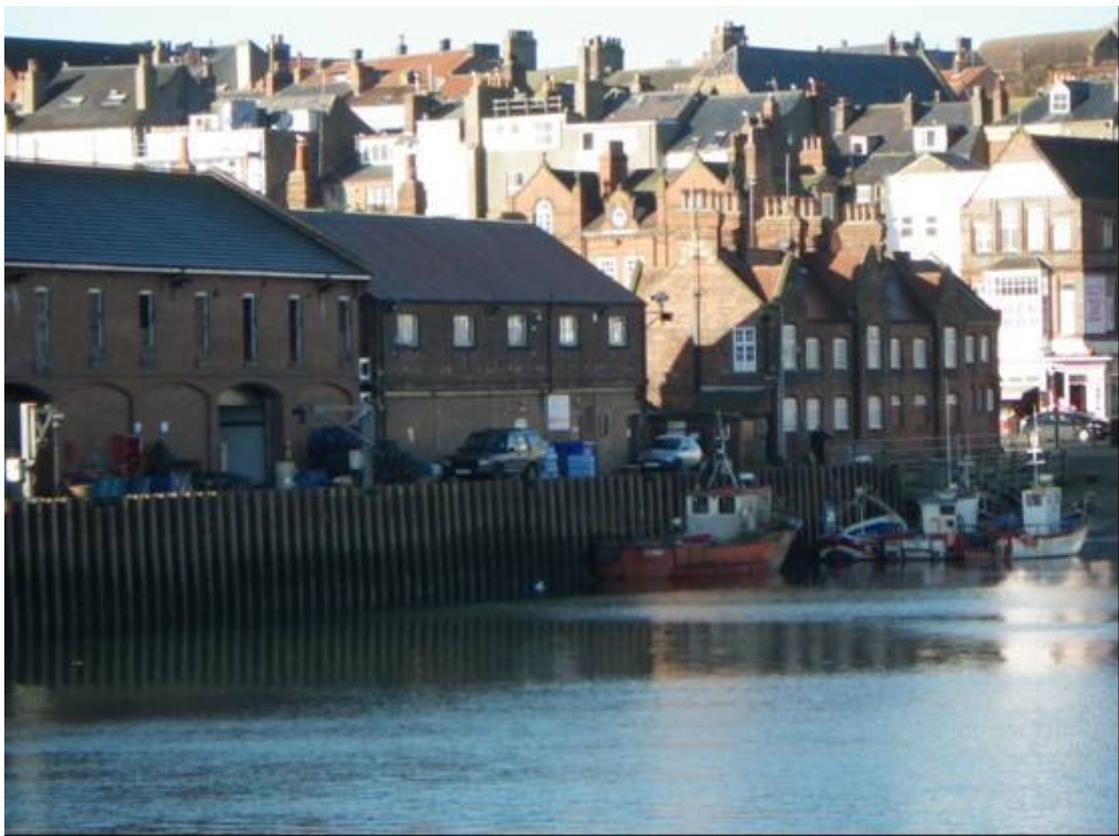
Plate 98 West Pier, north end, showing 1990 fish market (left) and inter-war and late 19th-century fish seller's offices, looking west

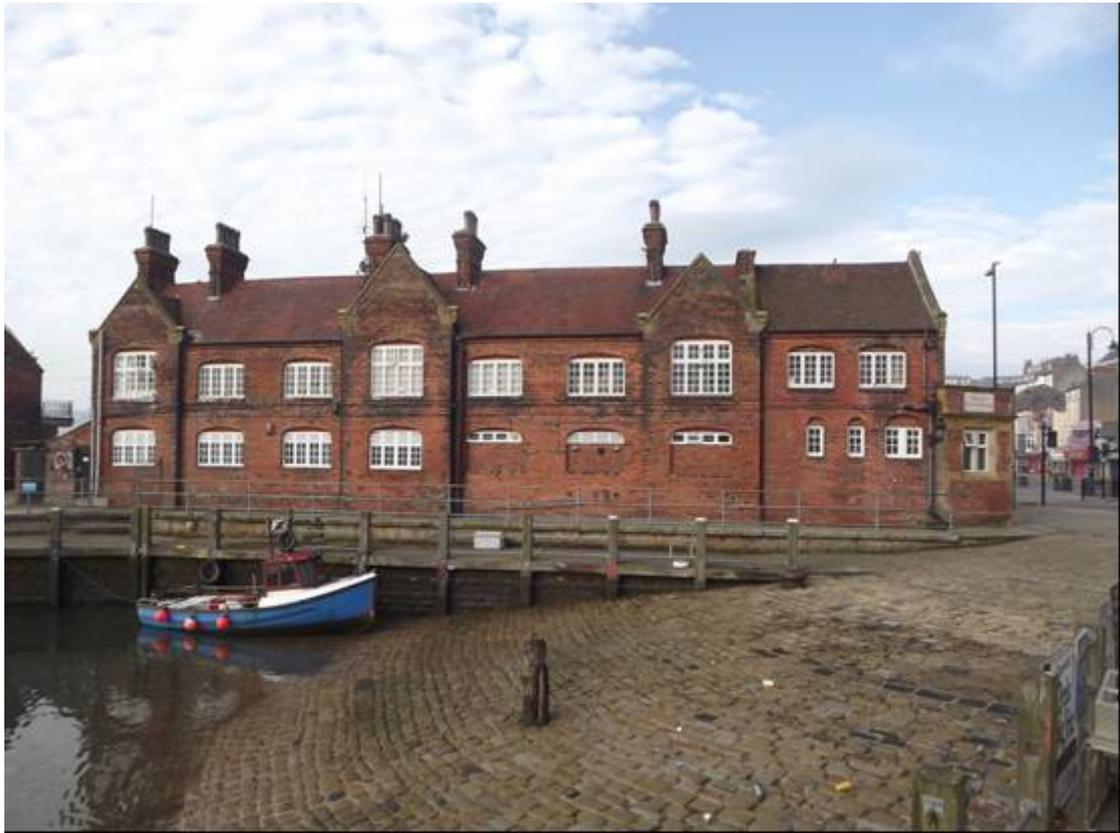
originally built as fish sellers' offices c 1896, the first permanent building on the pier following its rebuilding in 1877–80 (Plates 99–102). The offices are constructed of dark red brick with a cast iron balcony at first floor level. There are rows of large windows and doorways to individual offices at both ground and first floor level with stone surrounds, mullions and transoms, and with five-centred arched doorways, also with stone jambs and lintels, and it is particularly these elements which give the appearance of almshouses. The steeply-pitched tiled roof supports several large brick chimney stacks characteristic of the style. South of the 1896 building is an interwar set of offices in stripped-down Queen Anne style (Plates 103–05), with a substantial two-storey fish market building dated 1990 to the south of that (Plates 106–08). Despite the differing dates and architectural styles, all three show similar features, a clear reflection of function defining form. Further single-storey market buildings and sheds of various materials and 20th-century dates extend to the end of the pier along the east side (Plates 109, 110).

Plate 99 West Pier, east wall of pier at north end and rear elevation of late 19th-century former fish sellers' offices, with slipway (foreground), looking south
