Rapid Coastal Zone Assessment Survey

Yorkshire and Lincolnshire: Phase 3

Historical Audit

Scarborough Harbour

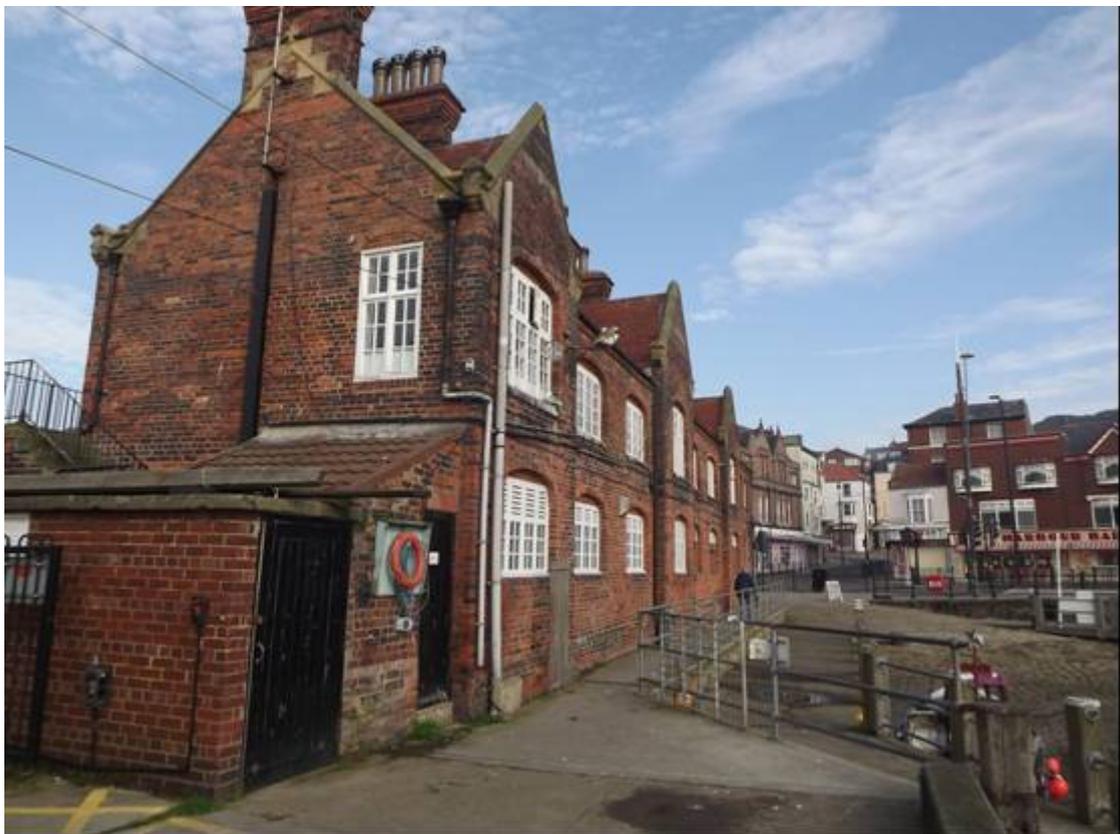
originally built as fish sellers' offices c 1896, the first permanent building on the pier following its rebuilding in 1877–80 (Plates 99–102). The offices are constructed of dark red brick with a cast iron balcony at first floor level. There are rows of large windows and doorways to individual offices at both ground and first floor level with stone surrounds, mullions and transoms, and with five-centred arched doorways, also with stone jambs and lintels, and it is particularly these elements which give the appearance of almshouses. The steeply-pitched tiled roof supports several large brick chimney stacks characteristic of the style. South of the 1896 building is an interwar set of offices in stripped-down Queen Anne style (Plates 103–05), with a substantial two-storey fish market building dated 1990 to the south of that (Plates 106–08). Despite the differing dates and architectural styles, all three show similar features, a clear reflection of function defining form. Further single-storey market buildings and sheds of various materials and 20th-century dates extend to the end of the pier along the east side (Plates 109, 110).

In the harbour itself, the 19th-century Grade II listed lighthouse (Plates 58, 59) and the late 19th-century former fishsellers' offices and lavatories on West Pier (Plates 100–02) are important elements of the harbour, and the interwar office block to the south of the latter is also of historic interest (Plate 103); though unlisted, it does fall within the conservation area. On Vincent's Pier, the small 19th-century Water House is of historic interest (Plate 40).

Plate 100 West Pier, rear and east end of late 19th-century former fish sellers' offices, looking west

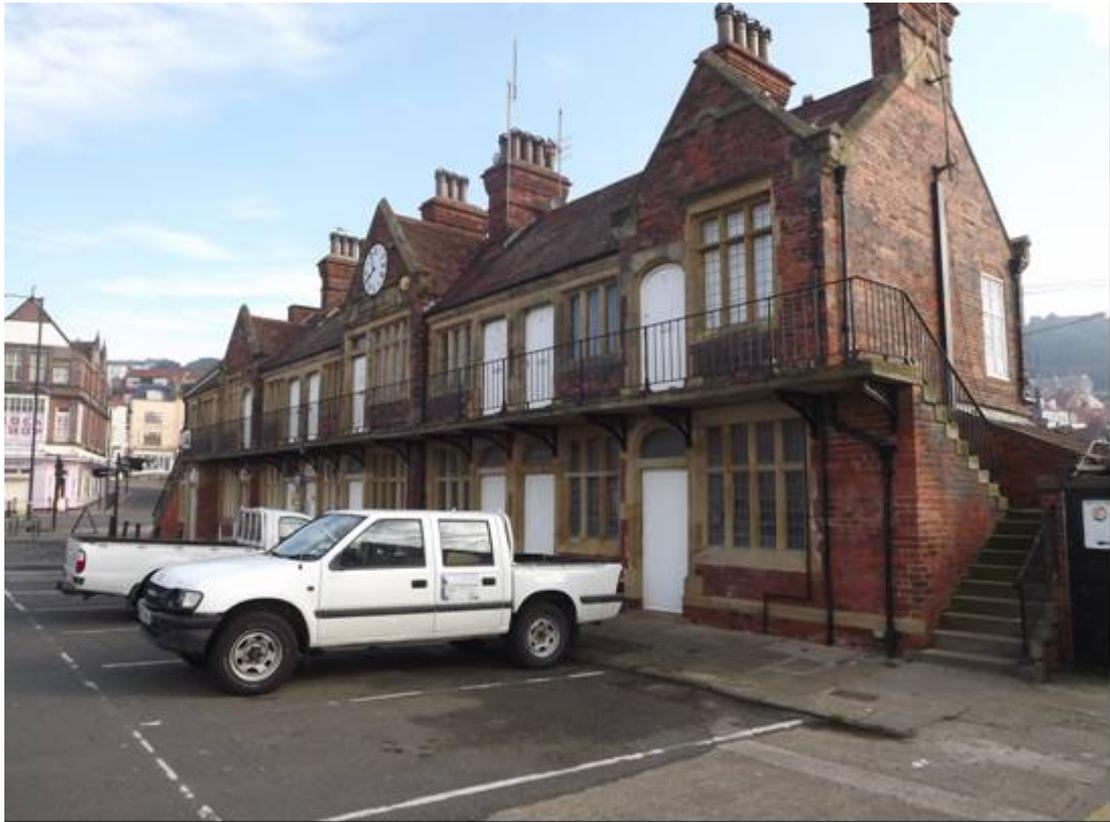
Plate 101 West Pier, late 19th-century former fish sellers' offices showing two level 'almshouse' design, looking north

This historical audit has confirmed that the principal structures of interest are the East Pier and Vincent's Piers, and the more recent West Pier and North Wharf, together with a number of slipways; these are already protected by Grade II listing of the harbour as a whole. However, itemising the more significant features such as the two capstans (Plates 68–72) and Water House (Plate 40) on Vincent's Pier, and the earlier fishsellers' offices on West Pier (Plates 101, 103) would assist in protecting them and possibly attract restoration grants.

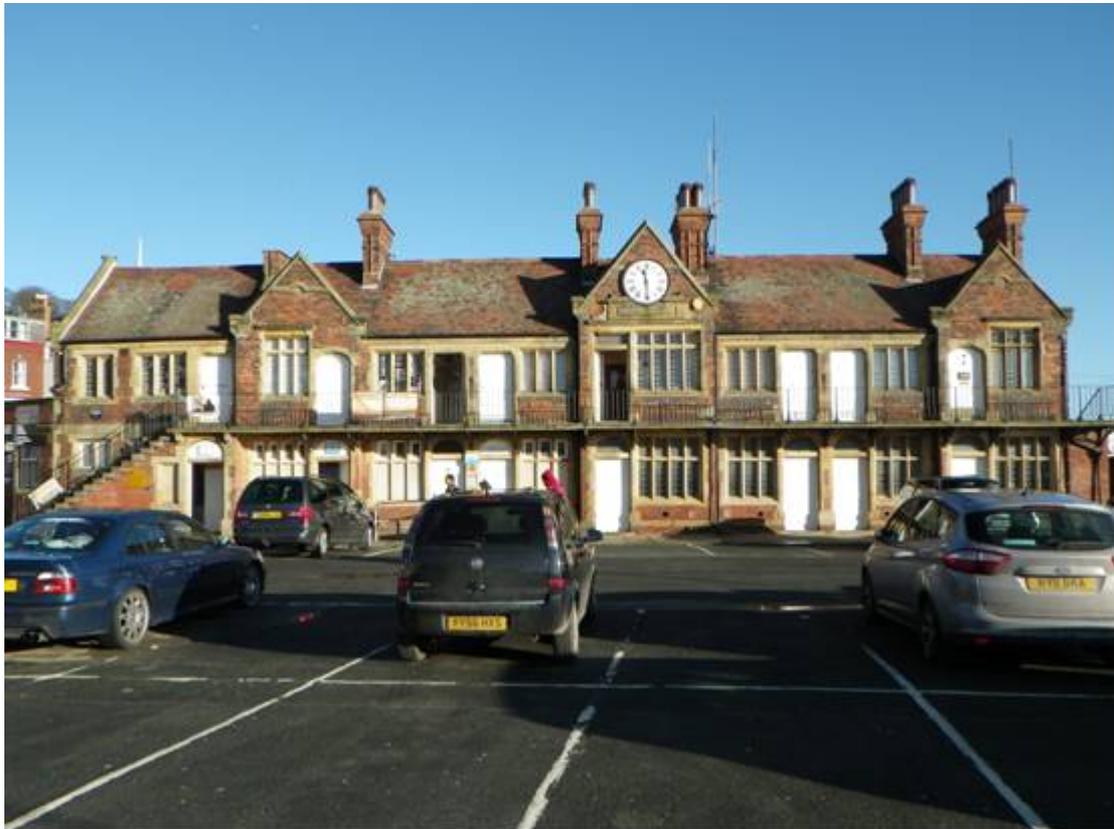
Plate 102 West Pier, front elevation of late 19th-century former fish sellers' offices, looking north-east

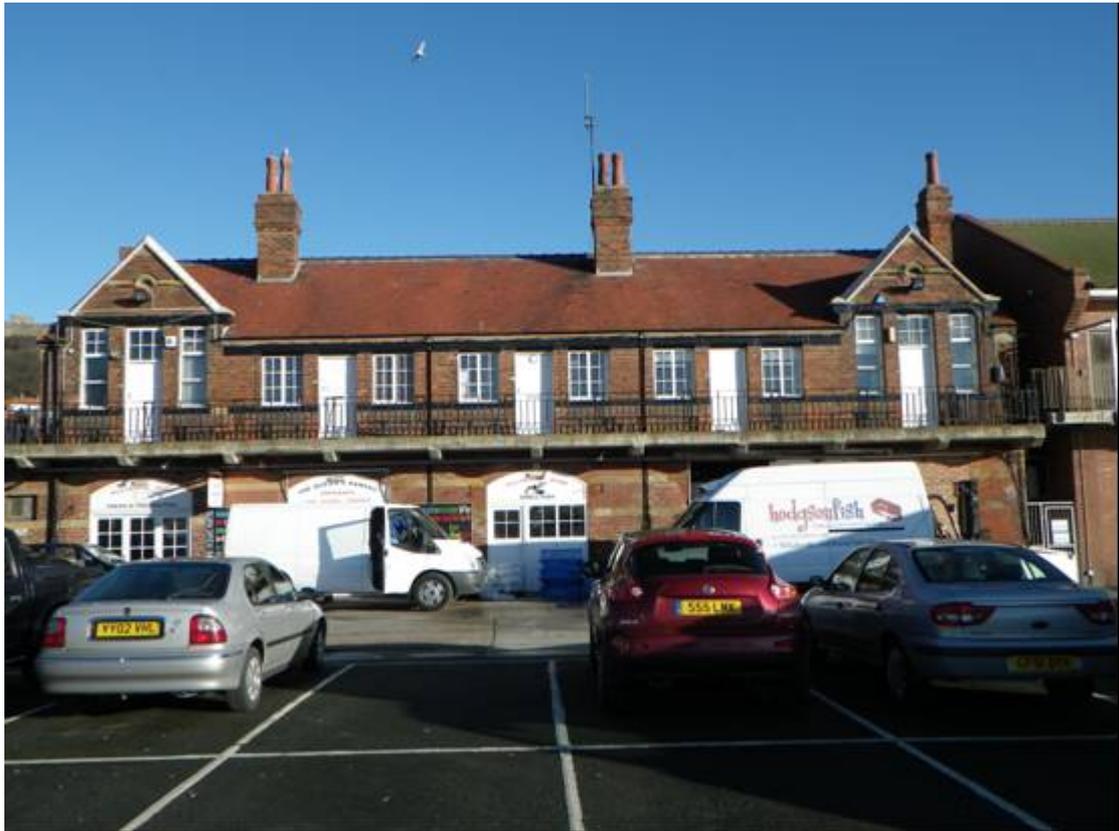
Plate 103 West Pier, front elevation of inter-war fish sellers' offices, showing general similarity to earlier building, looking north-east

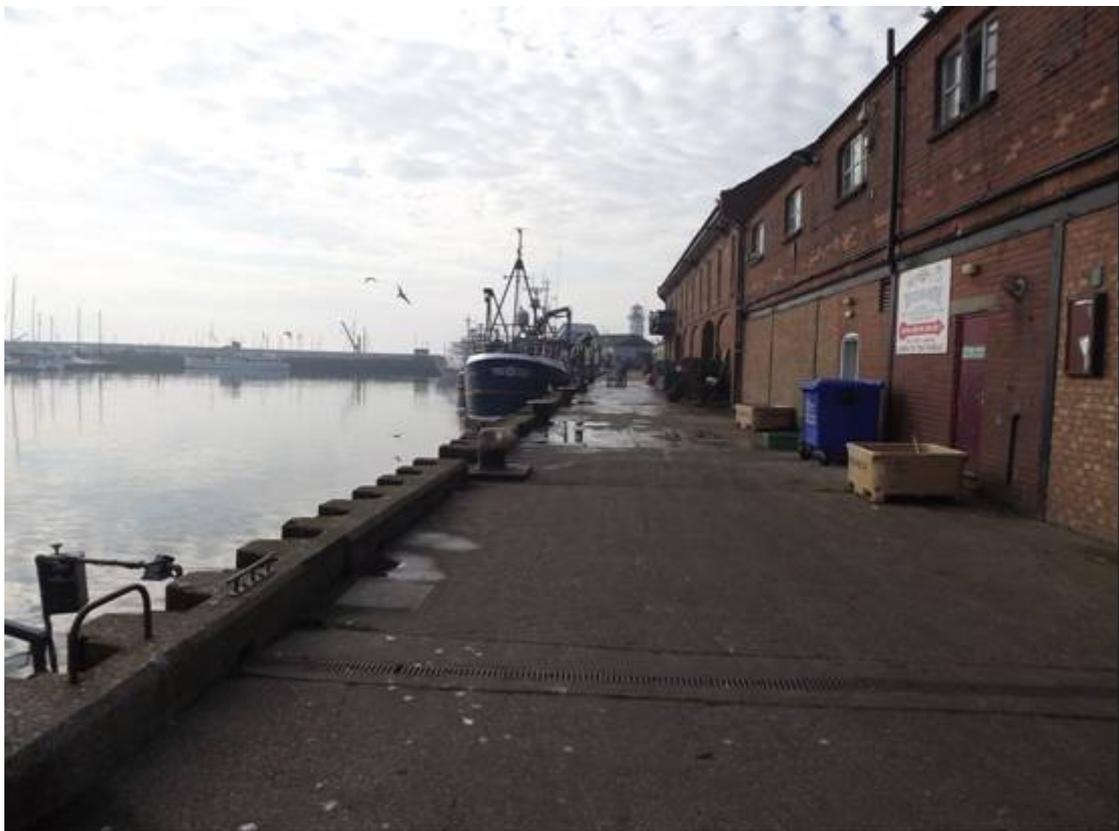
Although the 1892 1:500 OS shows a number of mooring posts along both sides of the West Pier, none of these now survive. The pier does, however, support a number of modern Type A bollards along the western side (Plates 112, 113, 115), but on the eastern there are also several large ship's bollards similar to those on the North Wharf (Plate 104) including those types recorded as Figs 6g and 6h (Plates 95) as well as a large 'Hammerhead' type (Plates 96, 104, 116).

Plate 104 West Pier, general view along east side of pier, with inter-war offices and 1980 fish market (right), looking south-east

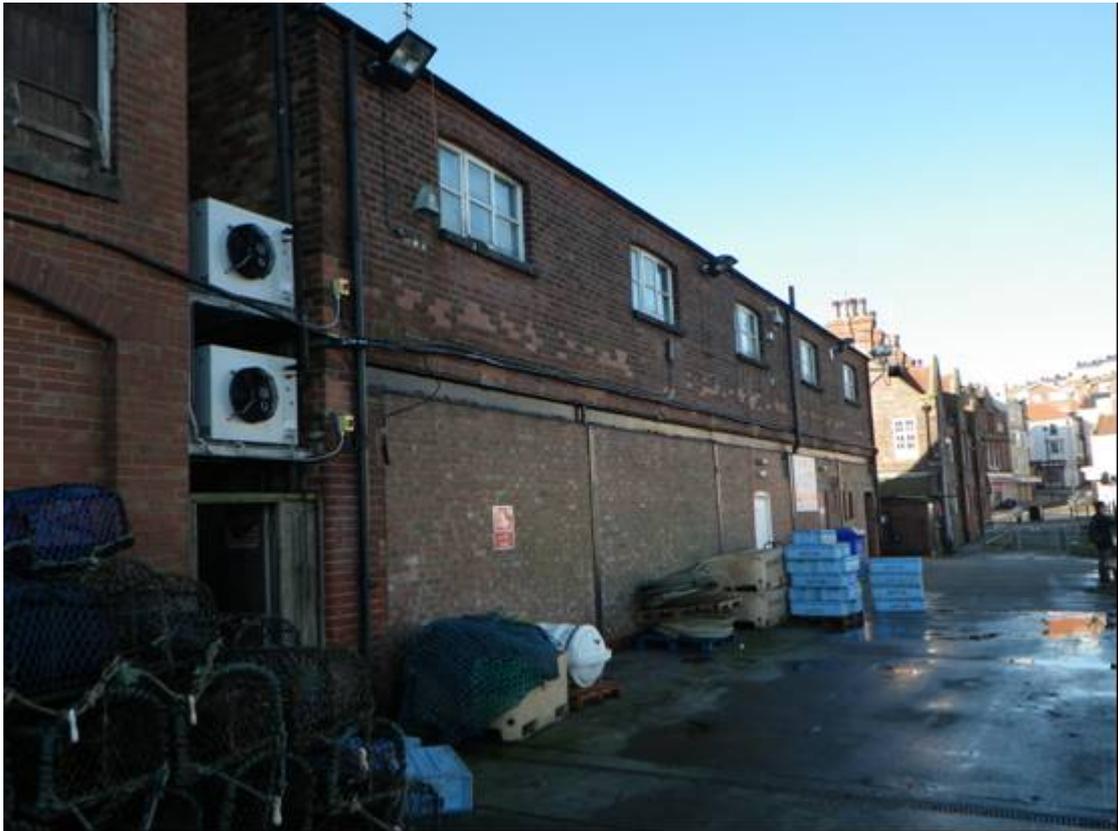
Plate 105 West Pier, rear of inter-war fish-sellers' offices, looking north-west

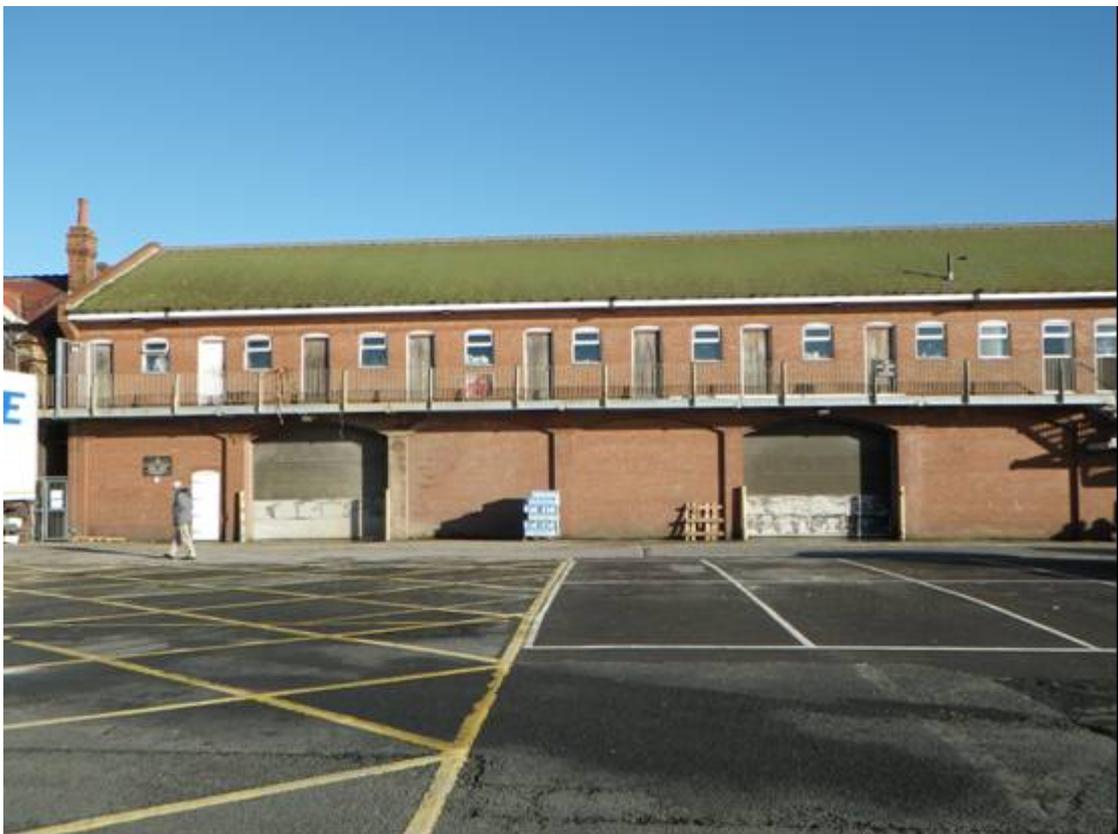
Plate 106 West Pier, front elevation of 1990 fish market, looking south-east

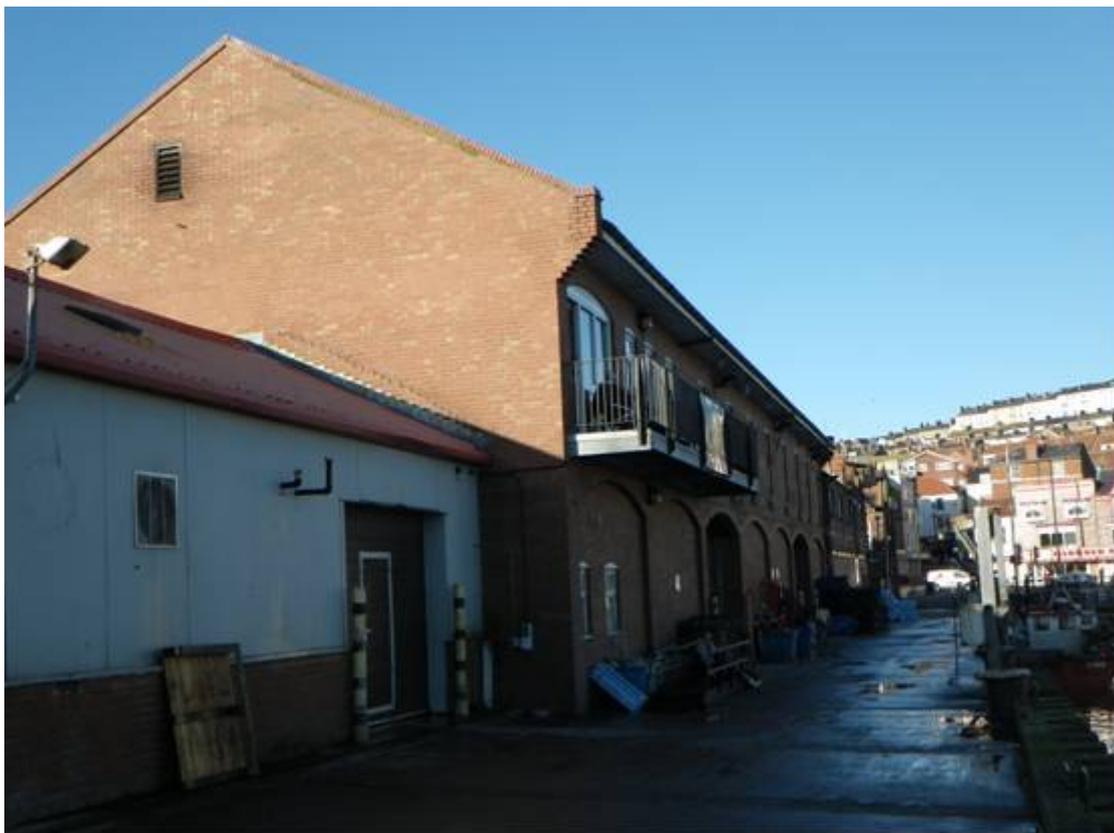
Plate 107 West Pier, rear of 1990 fish market adjoined by north end of remodelled single-storey building (left), looking north-west

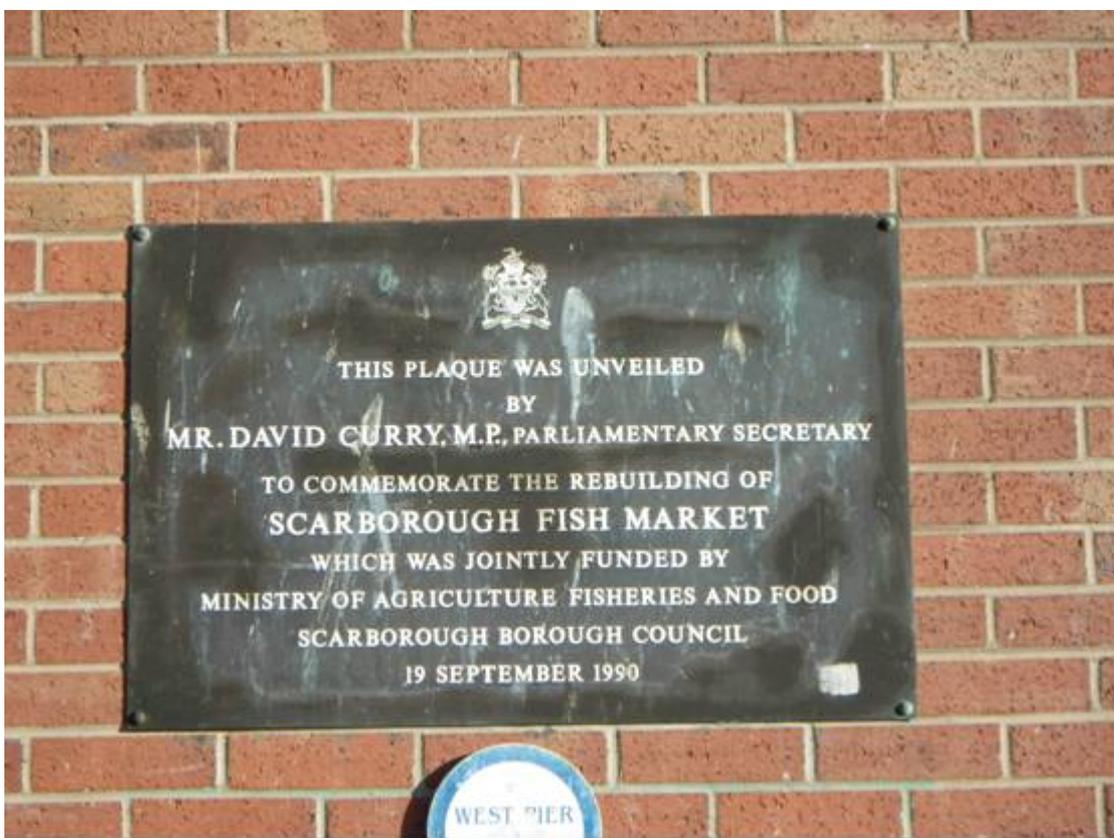
Plate 108 West Pier, foundation plaque on 1990 fish market

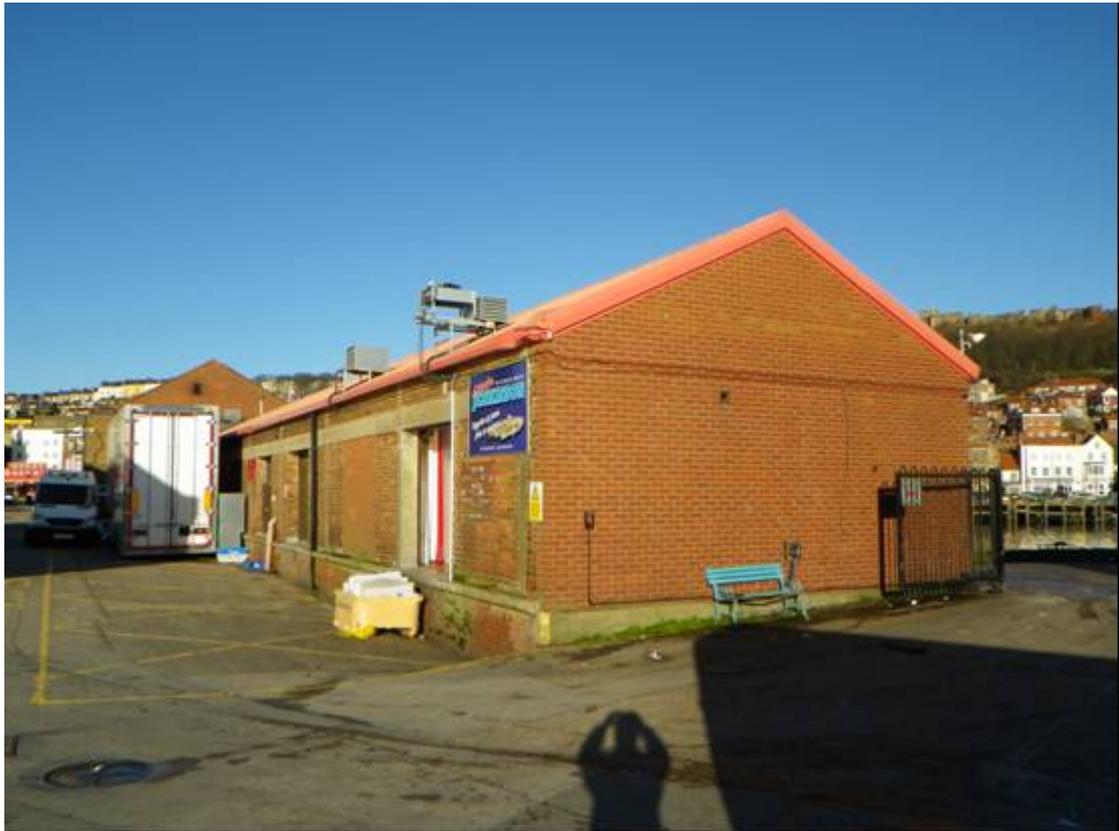
Plate 109 West Pier, south end of remodelled single-storey 20th-century fish market building, looking north

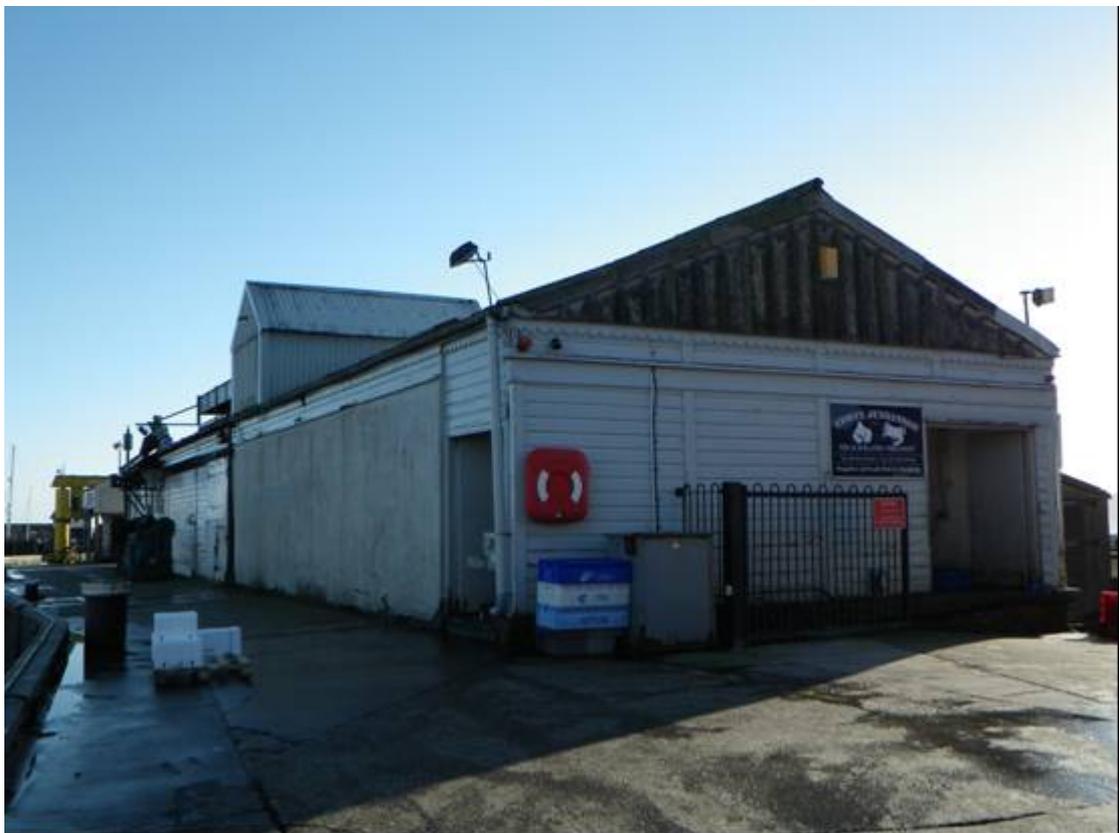
Plate 110 West Pier, fish processing building, south end of pier, looking south-east

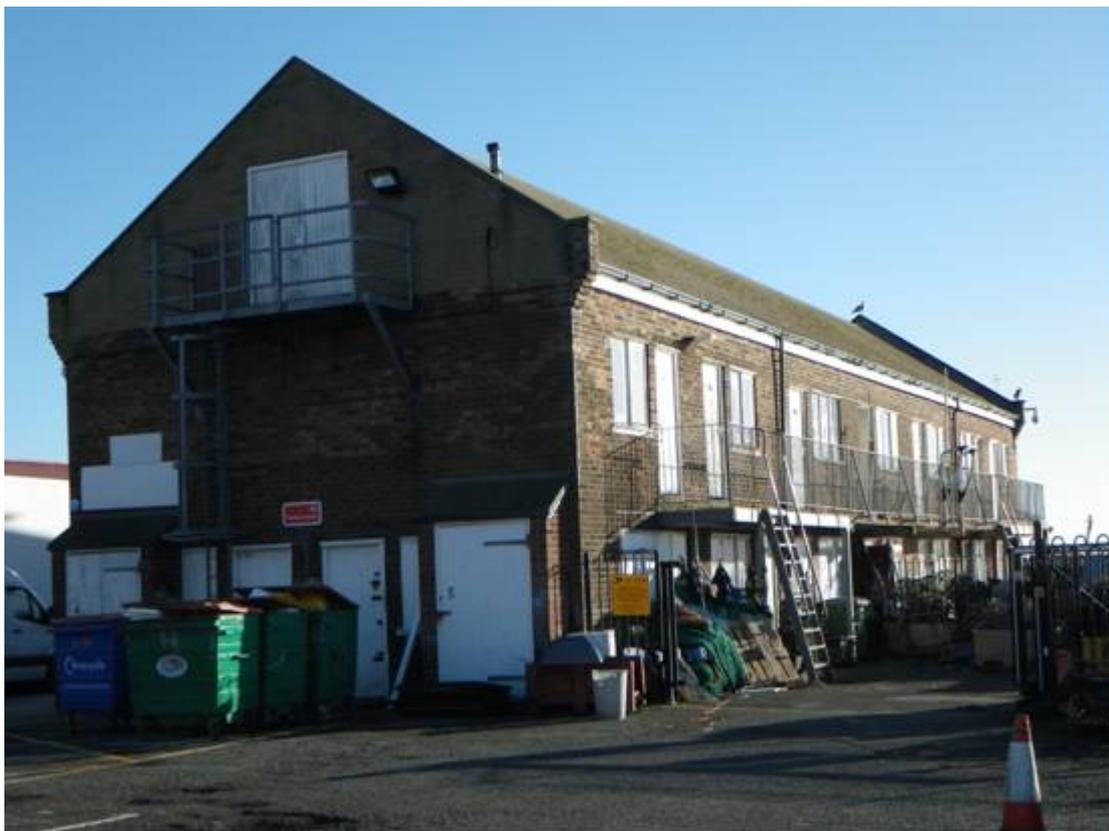
At the south-west corner of the pier at the time of the visit was a surviving two-storey brick 'bait shed', one of two (Plates 111, 112); one was demolished by January 2011 and the second was due to follow, to be replaced by temporary car parking. Much of the remaining west side of the pier is already a car park (Plates 113, 114).

Plate 111 West Pier, surviving 1973 'bait shed' awaiting demolition at south-west corner of pier, looking south-east

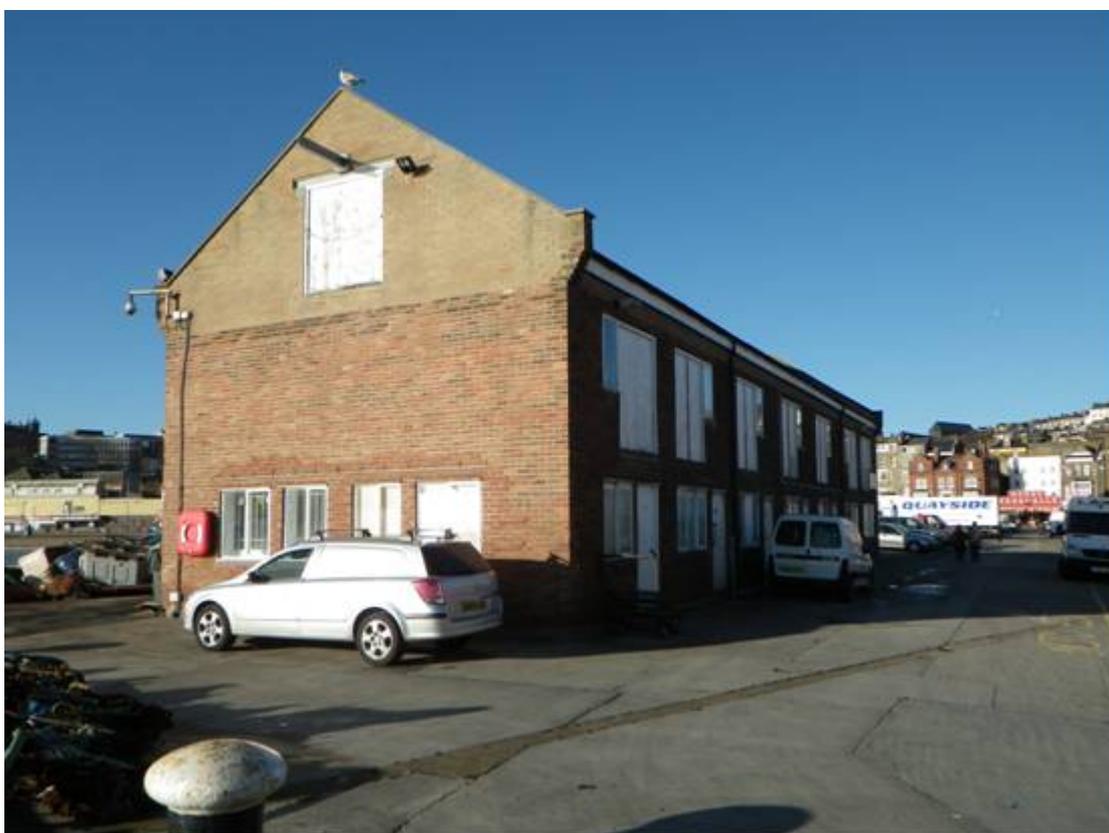
Plate 112 West Pier, surviving 1973 'bait shed' at south-west corner of pier with Type A bollard (foreground), looking north-west

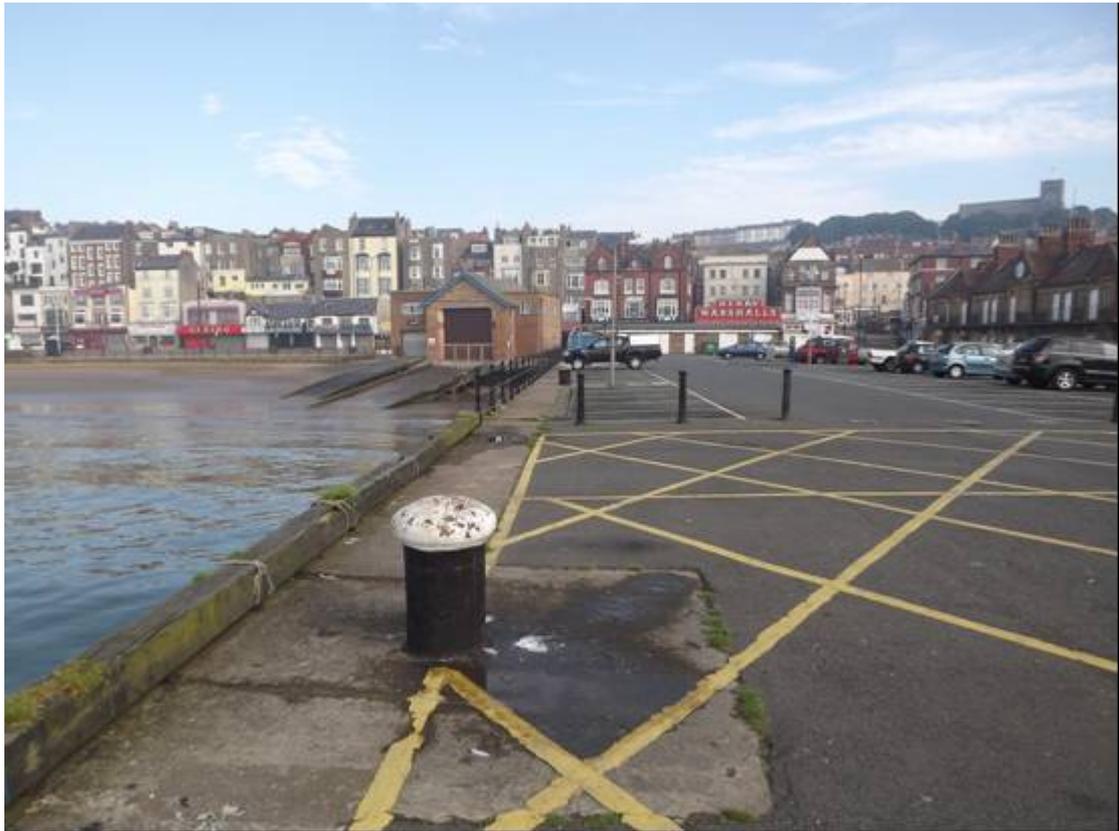
Plate 113 West Pier, view along west side of pier towards lifeboat house, with Type A bollard (foreground), looking north-west

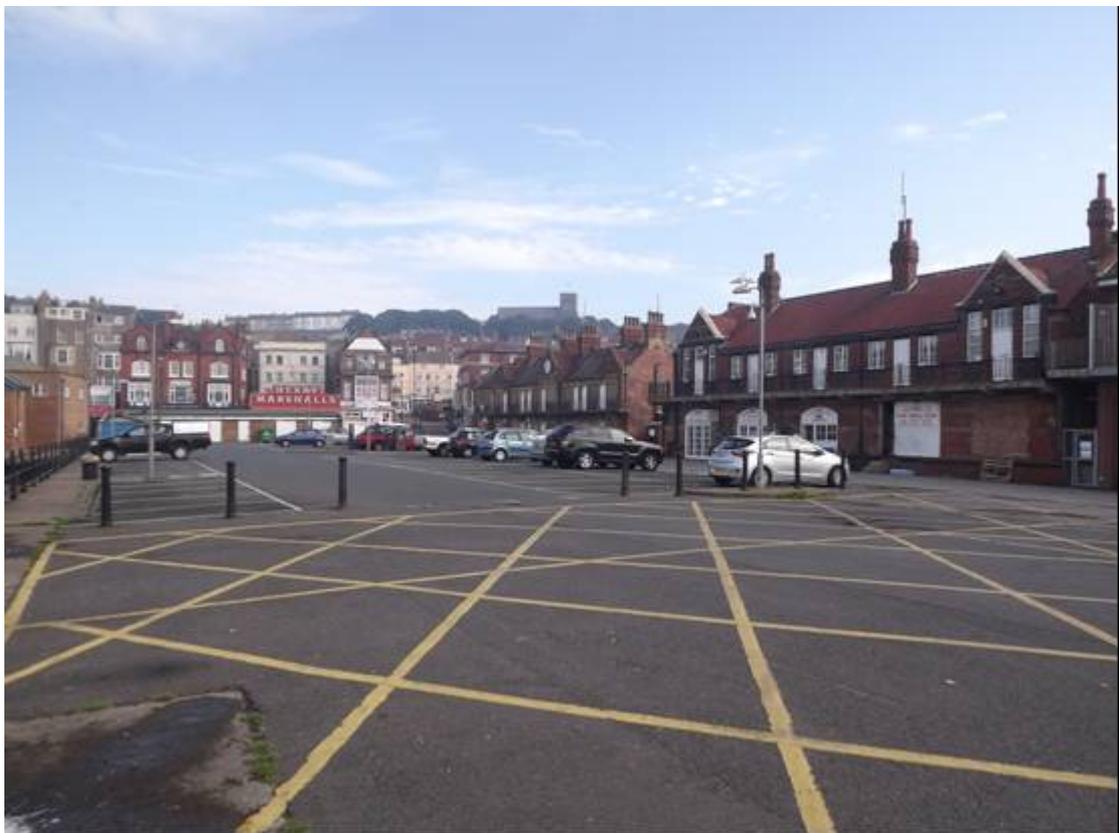
Plate 114 West Pier, view of car park area and offices at north end of pier, looking north

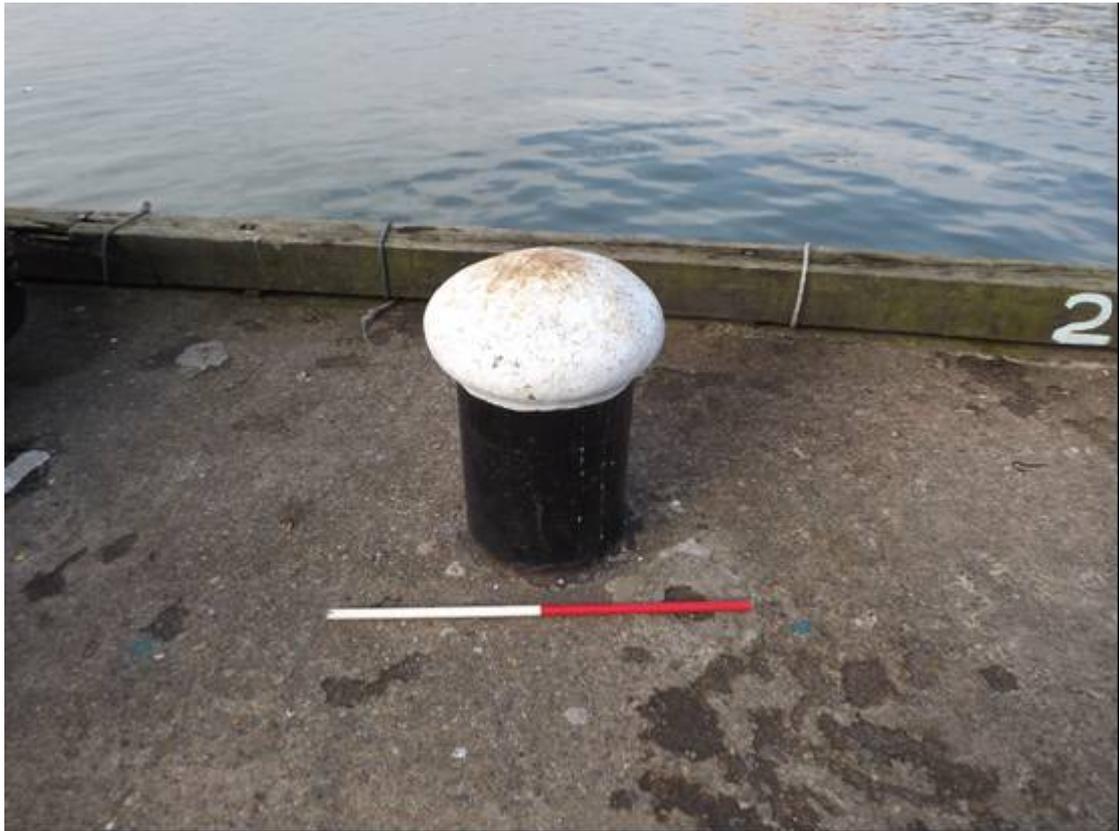
Plate 115 West Pier, Type A bollard on west side of pier (1m scale)

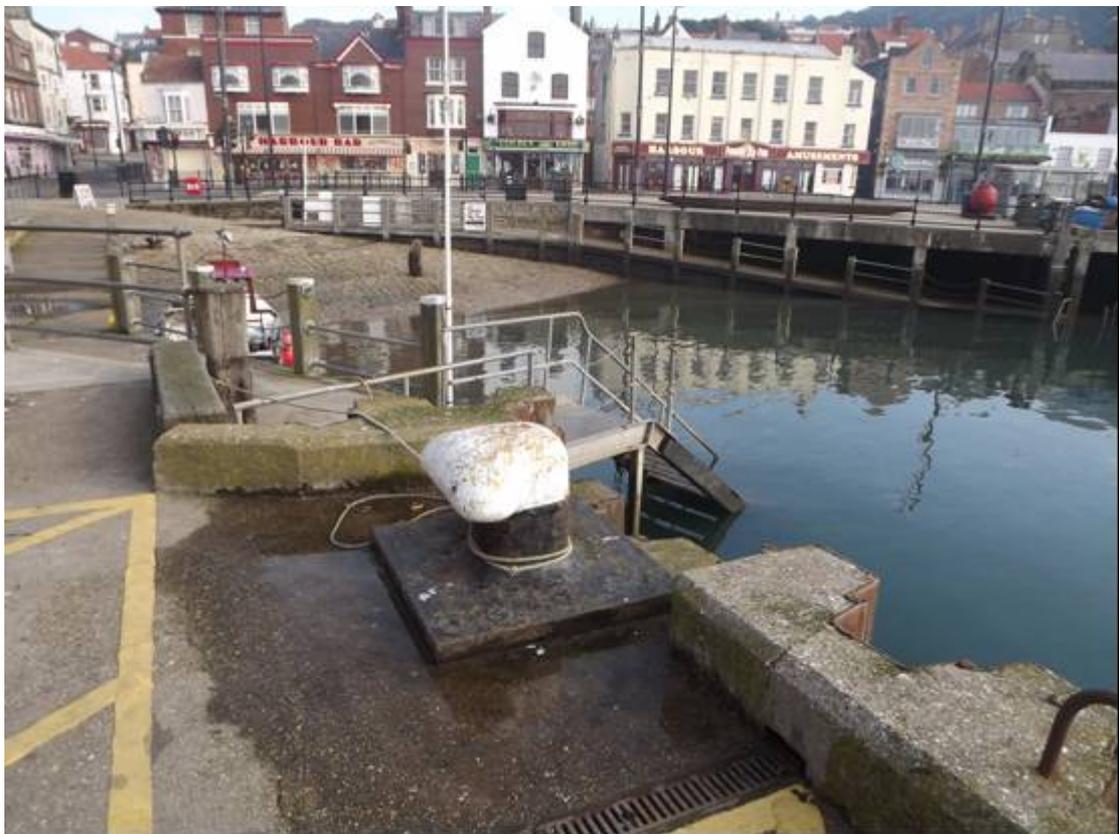
Plate 116 West Pier, modern hammerhead bollard on east side of pier (1m scale), looking north across western slipway to North Wharf

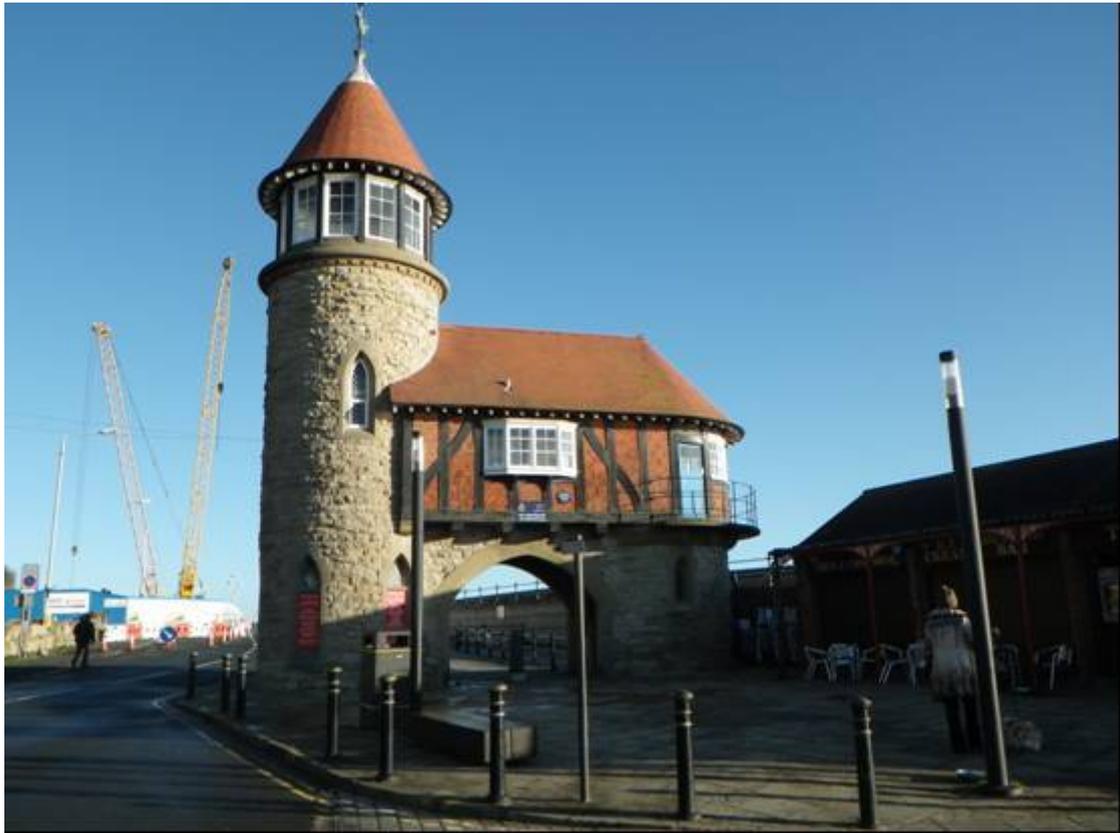
Other structures such as the neo-Gothic South Toll House (also Grade II), built at the same time as the Marine Drive (1897–1907), is now used by HM Coastguard, and forms an important northern gateway to the harbour area (Plate 117).

Plate 117 Marine Drive, the Gothic style South Toll House, now used by HM Coastguard, looking north

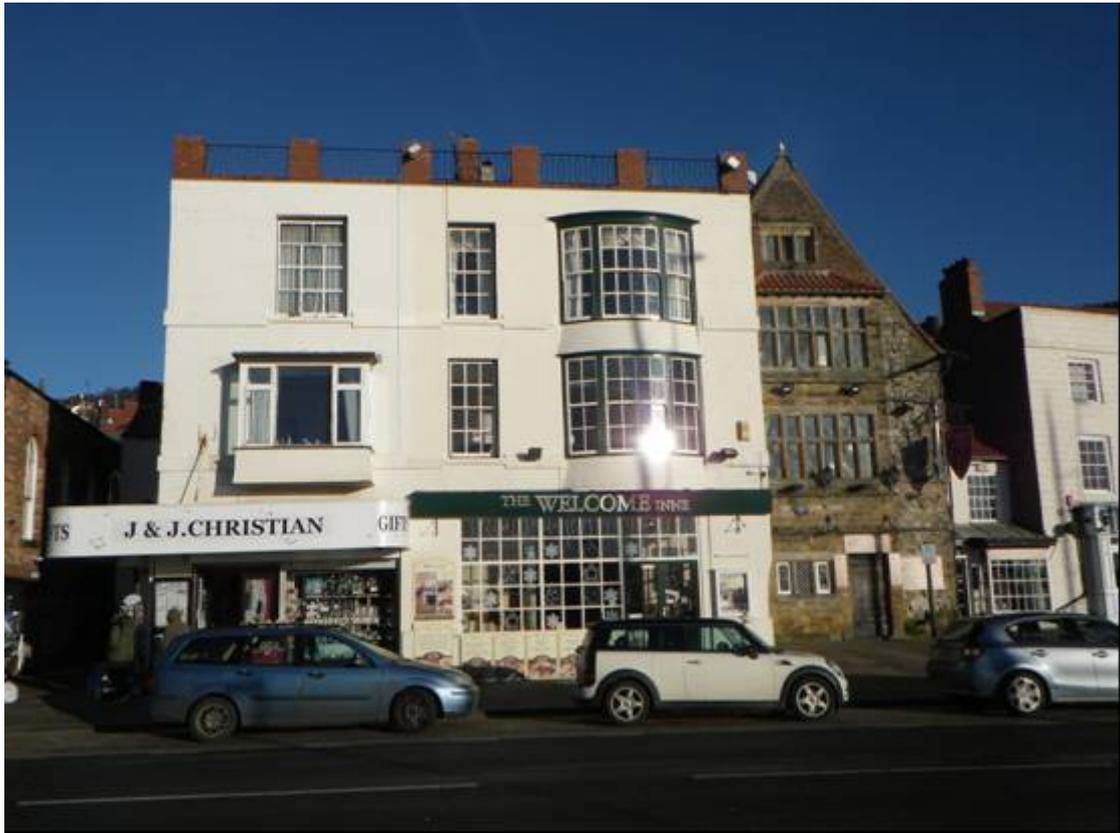
Plate 130 Nos 24 (King Richard III House), 25–26, & 27–28 Sandside, looking north

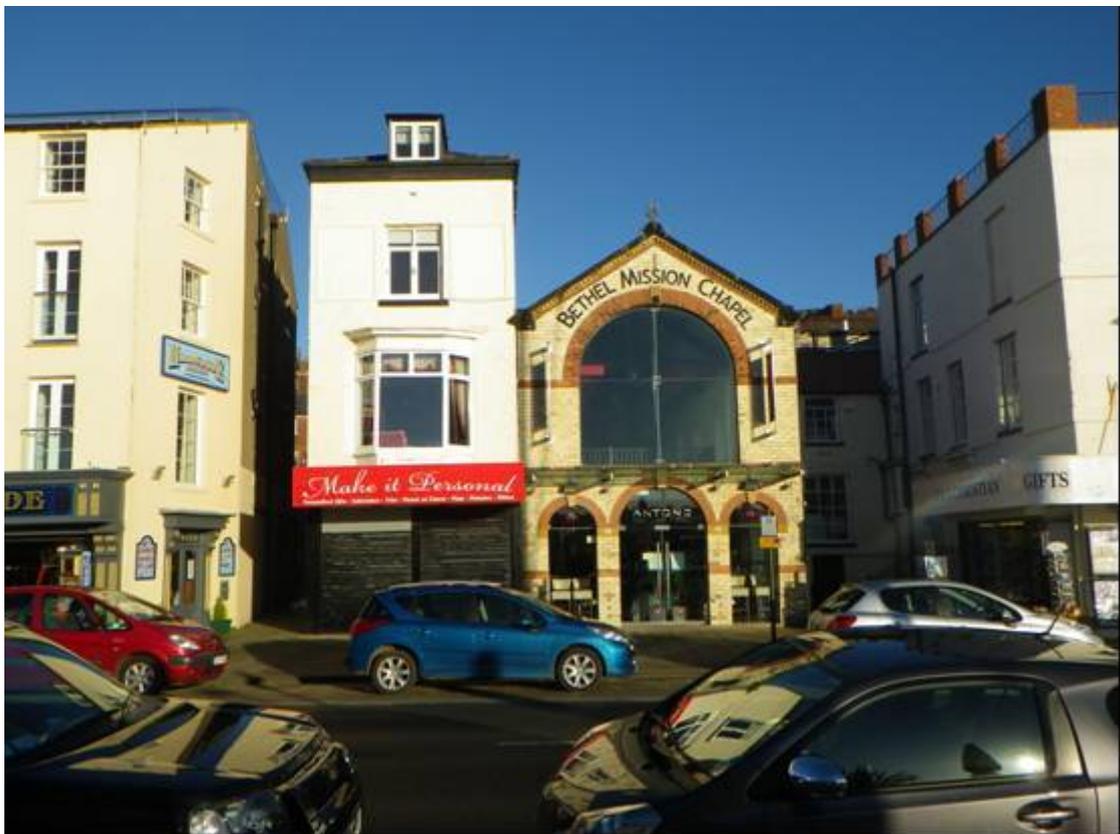
Plate 131 Nos 21, 23, & 24 (King Richard III House) Sandside, looking north; the pre-1900 roadway curved around this projecting block

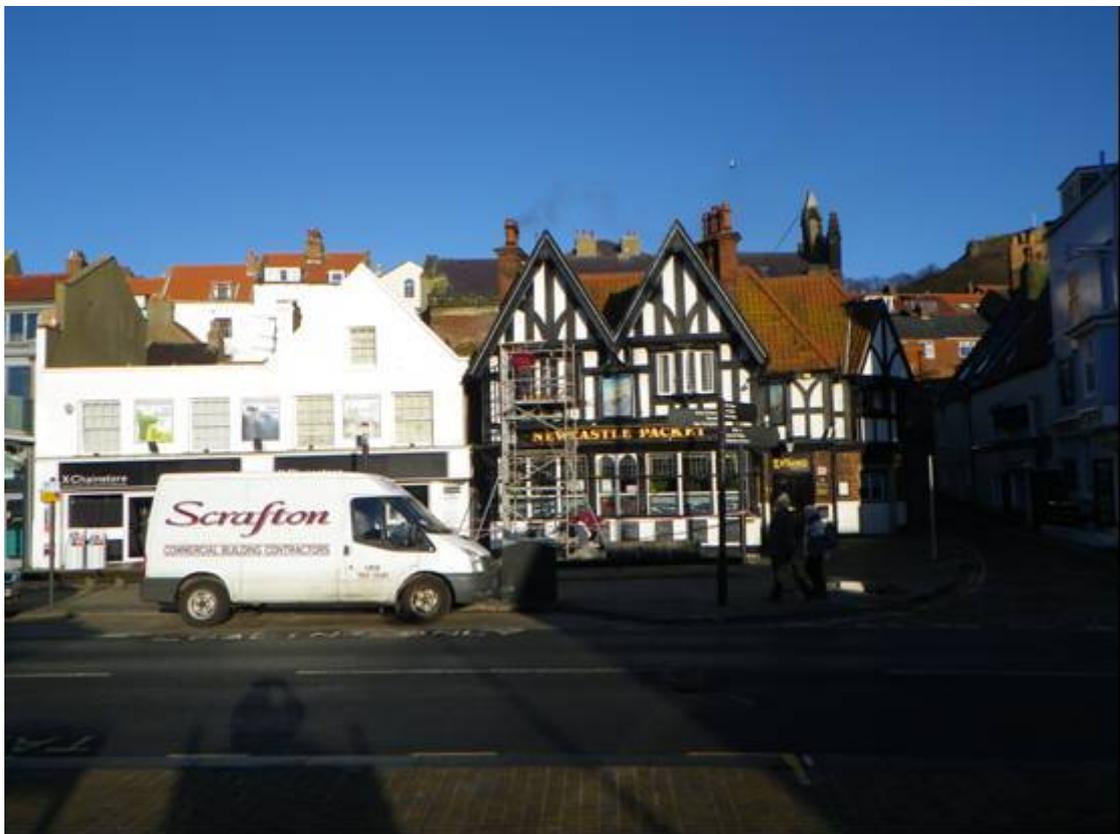
Plate 133 Nos 13 ('Newcastle Packet' public house), 15, 16, & 17-18 Sandside, looking north

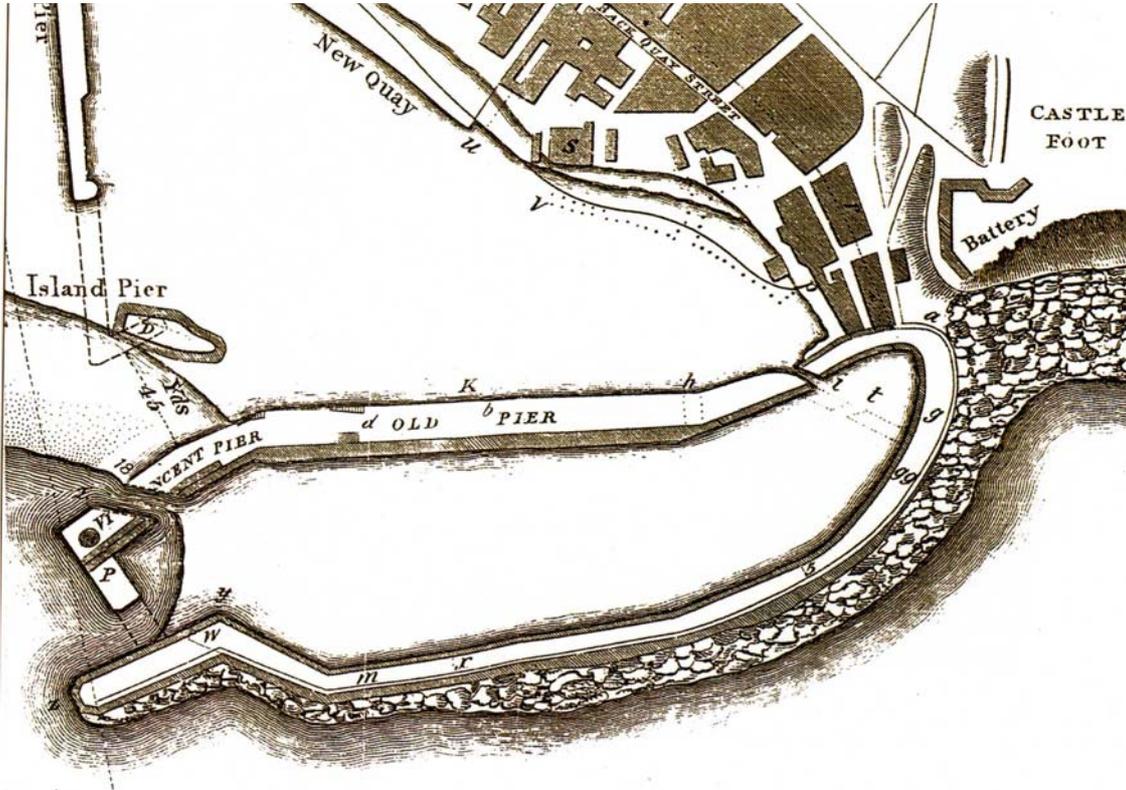
Plate 146 William Chapman's, 'A Plan of Scarborough Harbour Sept 1800'

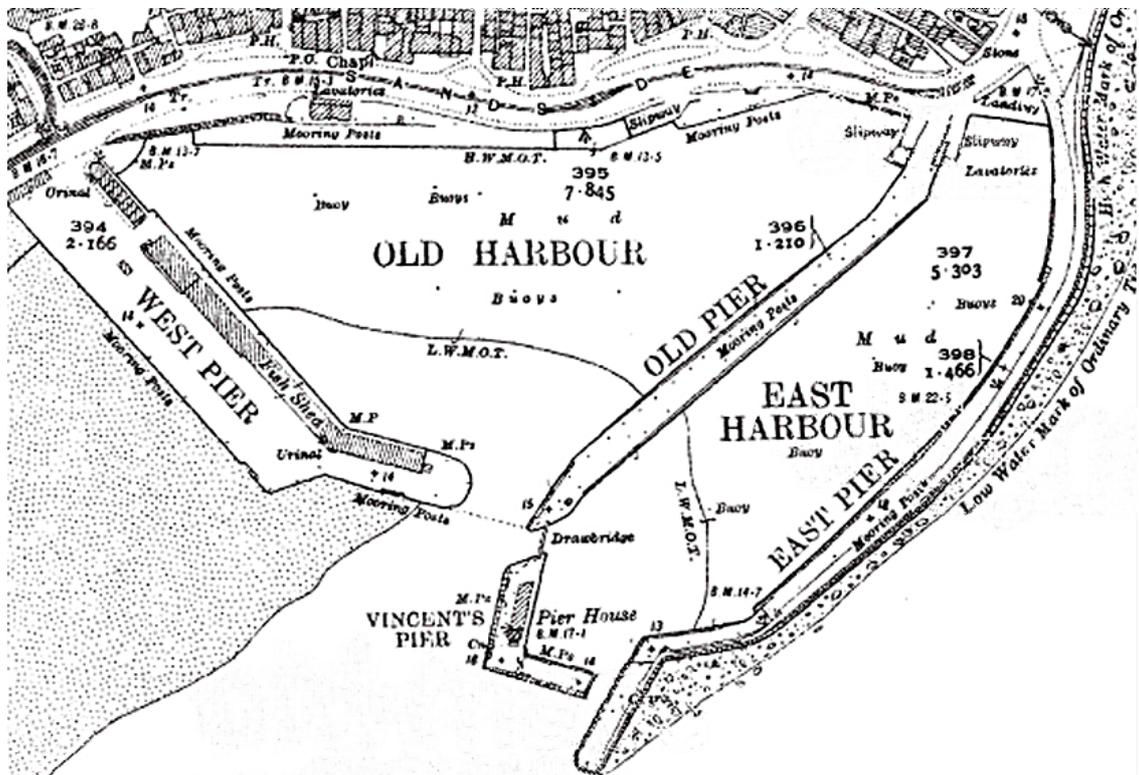
The pier was further widened along the western side c 1900, presumably as part of the scheme of improvements which included the construction of the new Sandside carriageway and the Marine Drive, the last link in a new route through Scarborough and around the seafront to Peasholm (Plate 150).

Plate 150 Scarborough harbour, 1:2500 Ordnance Survey, 1912
