Rapid Coastal Zone Assessment Survey

Yorkshire and Lincolnshire: Phase 3

Historical Audit

Scarborough Harbour

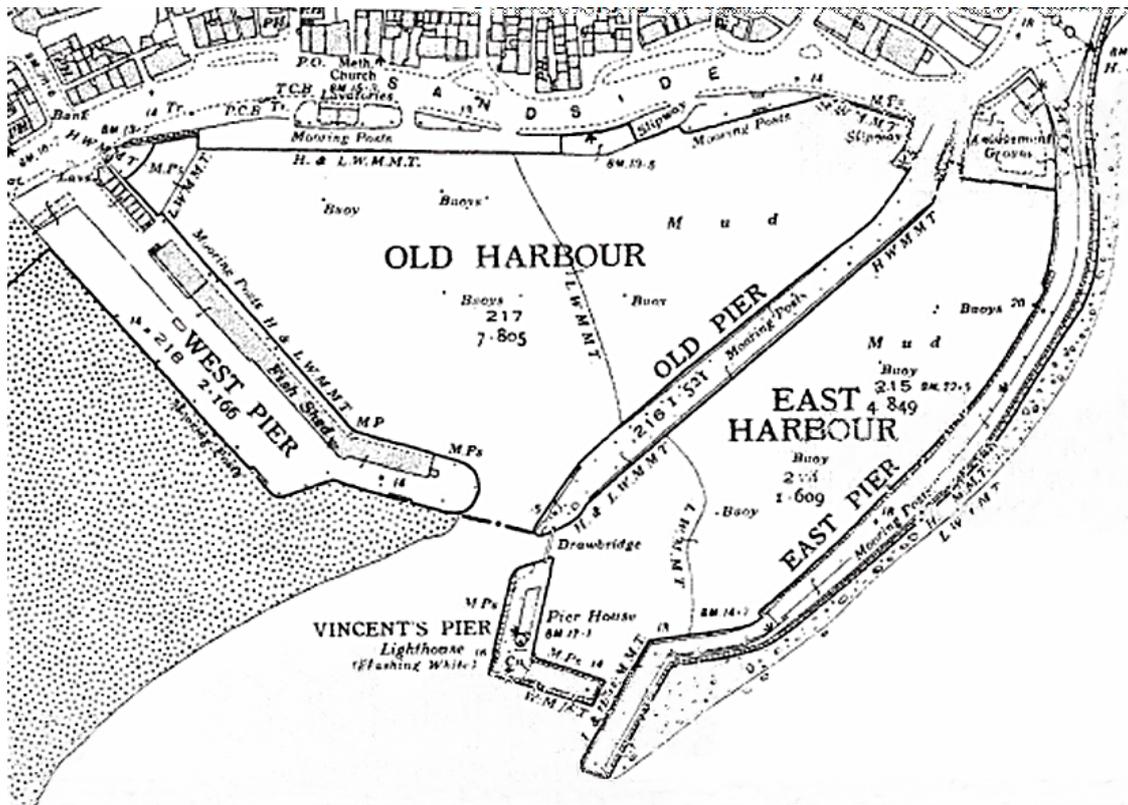
Immediately north of the harbour, the Marine Drive was constructed between 1897 and 1907, opening in 1908 to provide a scenic driveway between the town and Peasholm, where oriental gardens and a boating lake opened in 1912; it linked to an existing promenade in the North Bay, the Royal Albert Drive, completed in 1890 largely to protect the cliff from further catastrophic slippages and erosion (Aytoun 1891). As part of these improvements, the construction of the Sandside carriageway across the front of the harbour to allow access to the Marine Drive entailed the demolition of a swathe of 18th- and 19th-century buildings constructed south of the original Sandside among the former shipyards. A new stone harbour wall was built along the south side of the new road, with several new or improved slipways to the foreshore (cf Plates 149, 150). The loss of much of the area of the old Corporation Quay and the shipyards for the roadway, however, left limited wharfage, although this was remedied by the construction of North Wharf in 1928 (Plate 151).

Plate 151 Scarborough harbour, 1:2500 Ordnance Survey, 1929

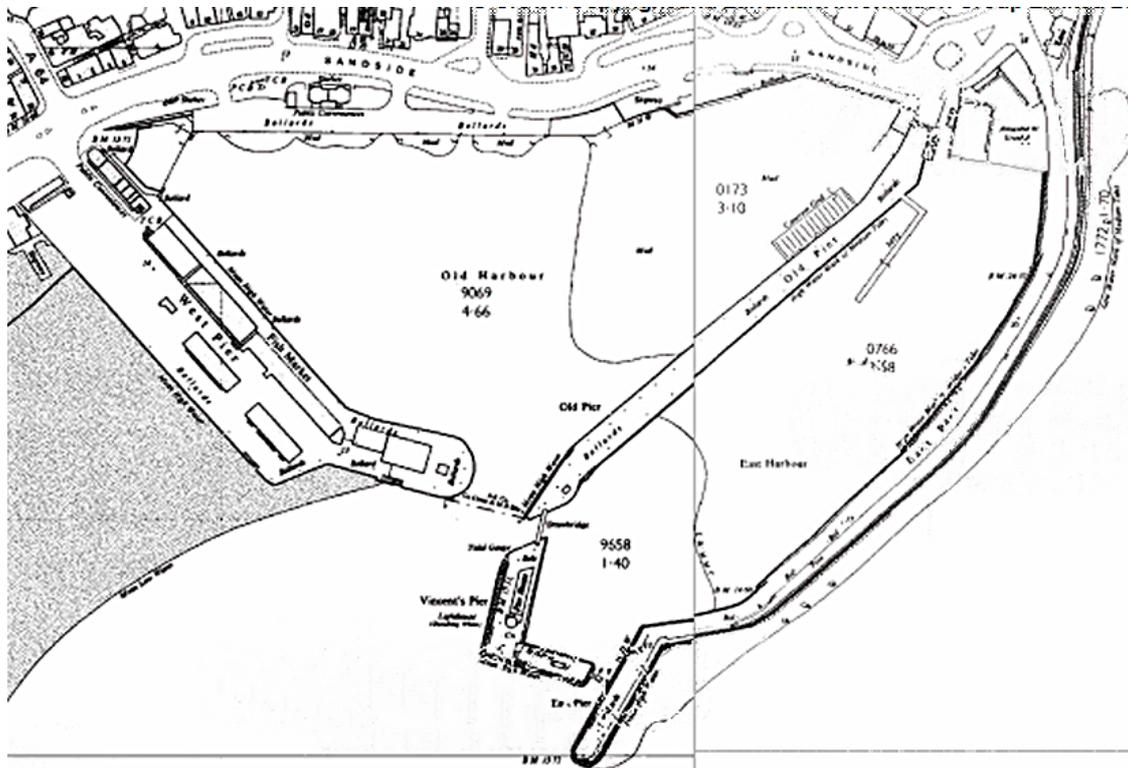
In the north-east corner of the harbour between the two eastern piers, a late pre-war addition was decking for the Gala Land amusements, extending an existing landing (Plate 152).

Plate 152 Scarborough harbour, 1:2500 Ordnance Survey, 1939

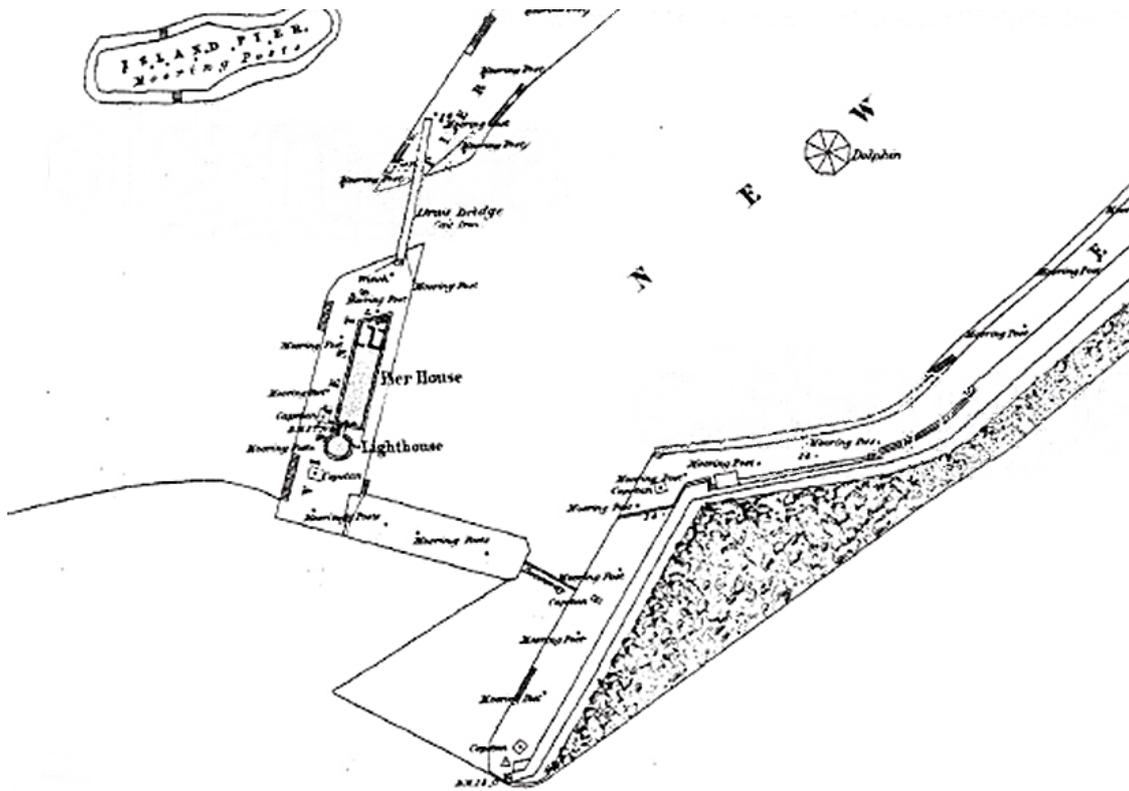
Post-war additions have included some improvements to the harbour area, although the overall layout remains very much the same (Plate 153), but with the rapid decline

Plate 153 Scarborough harbour, 1:2500 Ordnance Survey, 1966
